Ammonia Plant Salety Vol 12. 1969/1970. Frost Heaves and Storage Vessel Foundations

D. M. Morrison and H. T. Marshall Chicago Bridge & Iron Co., Oak Brook, III.

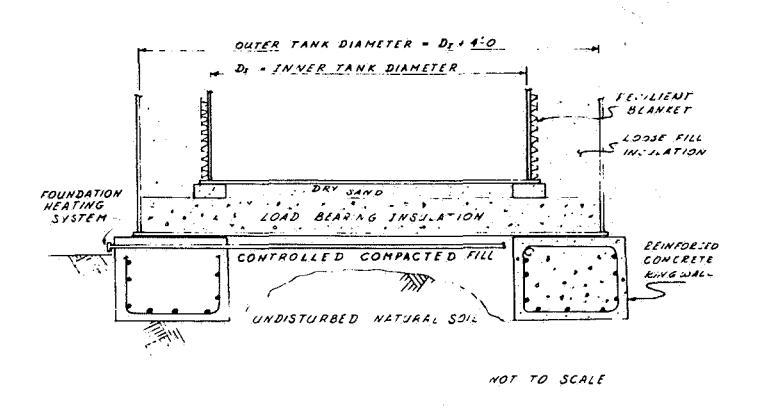
Figure 2 shows a situation in which the subgrade beneath a low temperature tank has not been adequately protected from the subfreezing temperatures of the tank product. The figure shows, qualitatively, the isothermal lines which are generated when the temperature at the base of the structure is significantly lower than the mean soil temperature or the temperature of the ground water.

Figure 2. Isothermal lines beneath a low temperature ammonia tank.

An idealistic view of a system of isothermal lines (lines connecting points of equal temperature) has been presented, Figure 2. It has been demonstrated experimentally, and theories have been developed to show that soil moisture travels in the direction of heat flow. Figure 3 illustrates the suction process by which water is drawn upward to the region of frozen soil where it freezes and thereby contributes to the formation of the ice lenses.
