Failure of a Primary Waste Heat Boiler

Indications are that silica-based castable refractories lose insulating properties when used in reducing-atmospheres, and under the temperature-pressure conditions in the steam-methane section of an ammonia plant.

J. R. Attebery
Terra Chemicals International, Inc.
Sioux City, Iowa

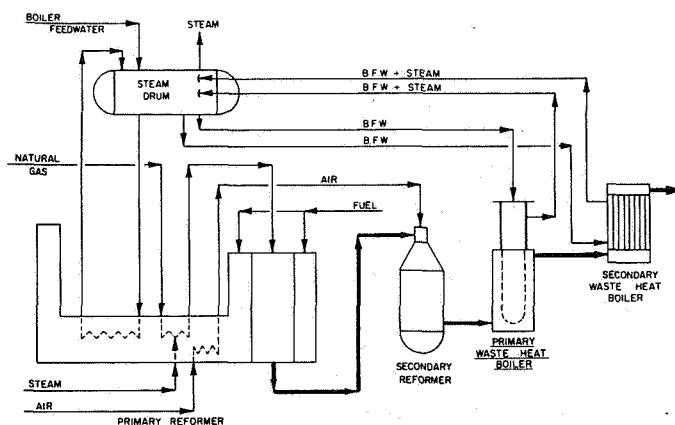
Figure 1. Process flow diagram.

The primary waste heat boiler, located in the process immediately downstream of the secondary reformer, Figure 1, is the major source of heat recovery and steam production in this plant. The boiler recovers waste heat from the reformed process gas, producing 1,500 psig saturated steam. The reformed gas enters the shell at about 1,700°F to 1,800°F and about 400 psig to 500 psig. It leaves at about 900°F. The hydrogen partial pressure is approximately 100 psig to 200 psig. The 1,500 psig steam generated on the tube side is released in the steam drum with the auxiliary boiler and other waste heat boilers. It is a thermal circulation system with an elevated steam drum.
