BRITTLE FRACTURE OF AN AMMONIA SYNTHESIS HEAT EXCHANGER

H.K. KARINEN
Typpi Oy
Oulu, Finland

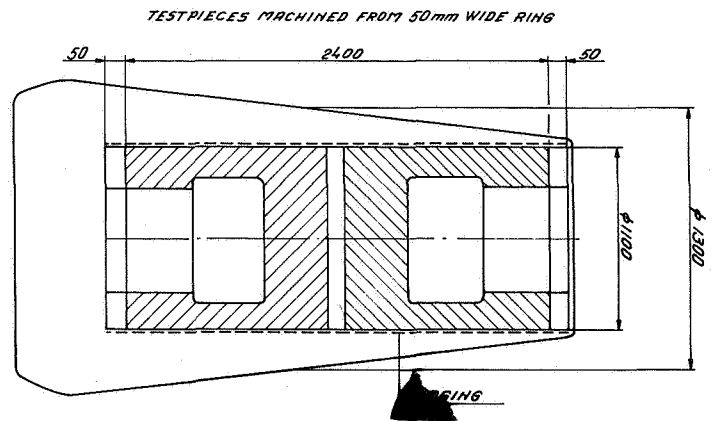
Figure 5. Cast steel ingot.

Preparation of the forging was started from the cast steel ingot, shown in Figure 5. The outside diameter, originally 1,300 mm., was compressed to 1,100 mm., and then the piece was given an ultrasonic inspection. After this, the forging was normalized at 920°C and pre-machined so as to give chambers with a machining tolerance of 5 mm. The next stage was hardening at 950°C, maintaining this tem-
