# Solving a Steam Generating Tube Failure

A case history of a tube failure in the primary reformer furnace of a 600-ton/day ammonia unit, telling how the problem was analyzed, repairs were made, and steps taken to prevent a recurrence.

C.C. Song  
and  
W. Unruh,  
Esso Chemical Canada  
Redwater, Alberta

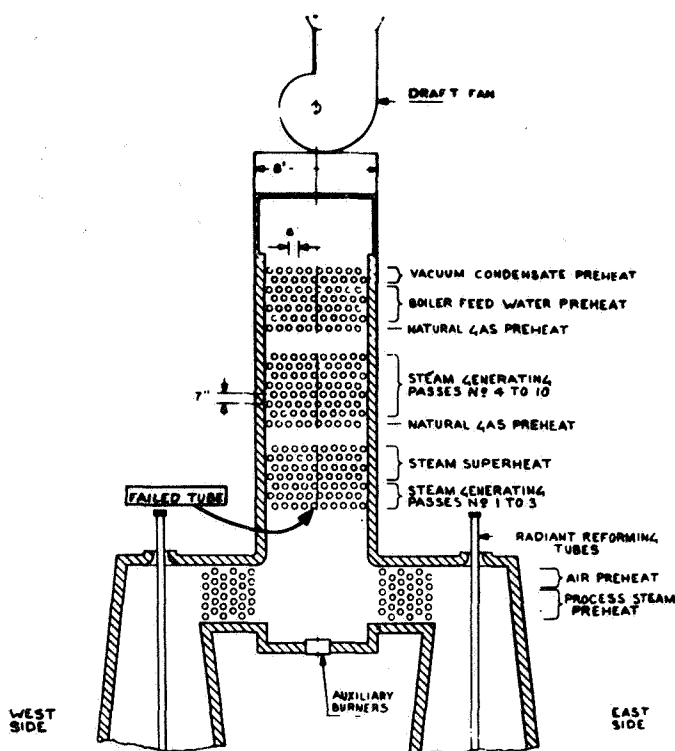
Figure 1. Reformer furnace convection section, cross-sectional view.

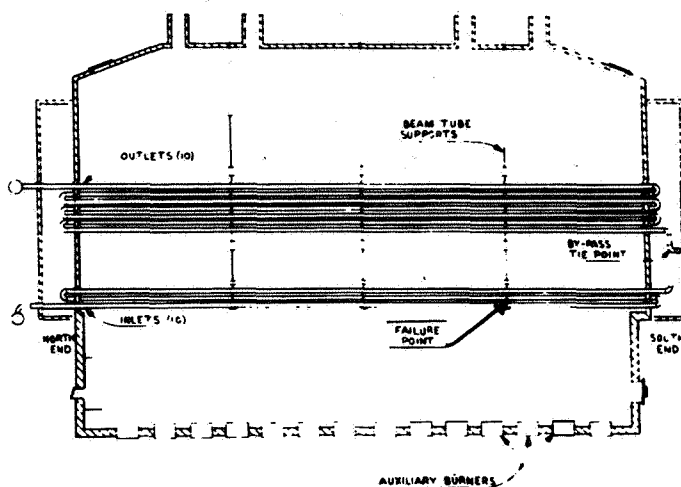
Figure 2. Reformer furnace convection section, side-sectional view, showing auxiliary burners and steam generating tubes.

Each level consists of 10 parallel tubes. The top two rows heat the vacuum condensate; rows 3 to 6 contain boiler feed water; gas preheating is accomplished in rows 7 and 15; steam superheating occurs through levels 16 to 19; and steam is generated in rows 8 to 14 and 20 to 22. Failure occurred in row 22, which is the first pass of the steam generating tubes.

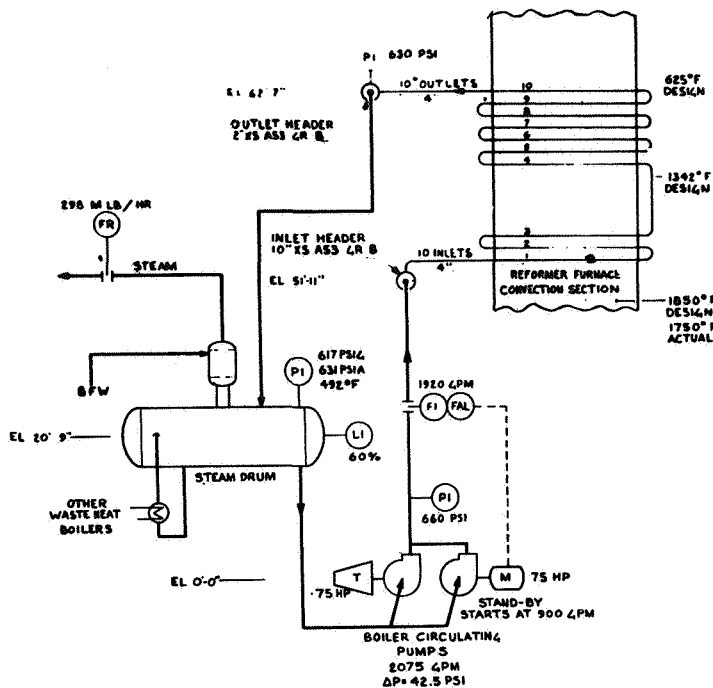
Boiler feed water from the secondary reformer waste heat boiler is circulated through the 10 steam generating tube passes by a pump at 600 lb./sq. in. gauge. Steam is generated at a design rate of 82,000 lb./hr. and a vaporization rate of 10% (see Figure 3). The first tube pass in row 22 is located 9 ft. above 14 auxiliary burners. The flue gas temperature at this point ranges between 1700 to 1750°F.

Figure 3. Steam generation loop.
