Ammonia Plant Heat Exchanger Problems

Useful data and recommendations for avoiding future failures result from a detailed investigation of five problems encountered in a Dutch processing facility.

R.M. Osman
Exxon Chemical Co.
Florham Park, N.J.

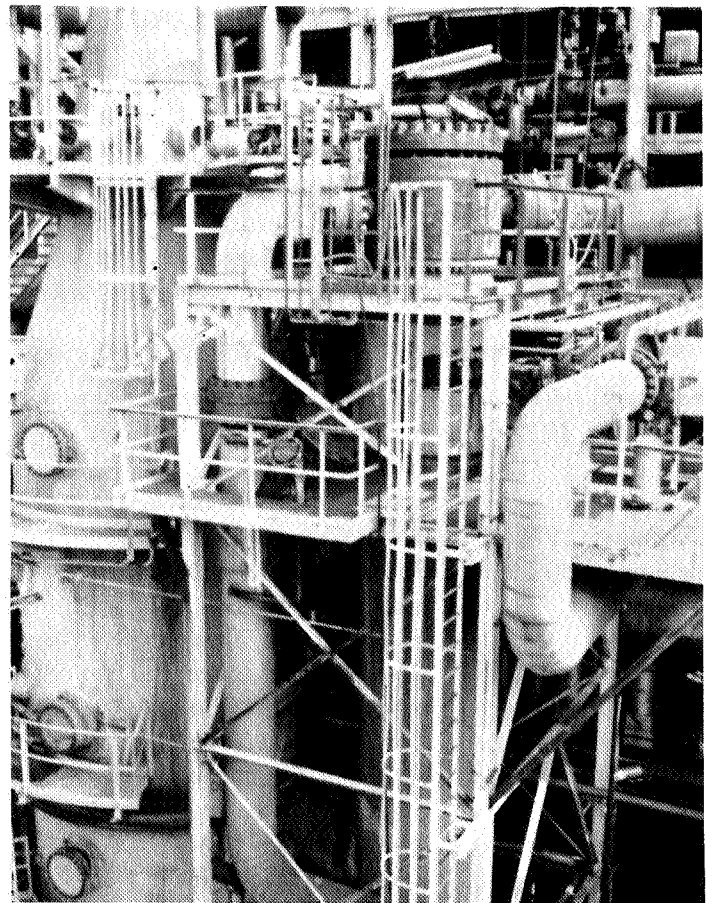
The secondary reformer effluent waste heat boiler at Rozenburg, shown photographically and schematically in Figures 3 and 4, has a vertical U-tube design. 1,500-lb./sq. in. gauge boiler feedwater flows through C-½Mo tubes, and hot secondary reformer effluent flows on the shellside. Hot gas entry is directly to the bottom U-bend area.

Figure 3. Photo of reformer effluent waste heat boiler shown in service next to secondary reformer.

Unfortunately, there have been several tube failures in this boiler. Tube plugging has been required on six separate occasions, several times forcing the plant down for immediate repairs. Purchase of a spare bundle was also necessary, as were two partial and one complete bundle retubing. Table 1 presents an abbreviated summary of the history of the various waste heat boiler bundles.

The first tube failures occurred in January, 1969, only a few months after startup. The event that triggered the failures was gross overheating due to a large secondary reformer effluent temperature excursion. All of the failures were located in the outer three rows of U-bends.

While out of service, the No. 2 bundle had its three outer rows retubed in a 5 Cr-½ Mo material, instead of the original C-½ Mo. This change was intended to protect the outer rows against gross overheating, as had been experienced in January, 1969. This bundle was reinstalled in May 1973, although the No. 1 bundle had not yet developed any leakers.

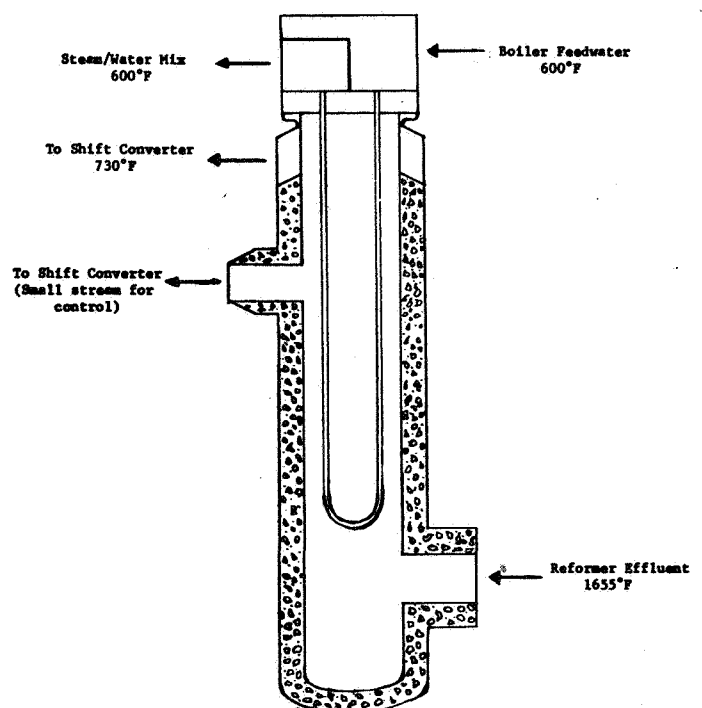
The temperature of the reformer effluent impinging on the U-bends is around 1,655°F. The tubeside design tem-

perature is 650°F, although the C-½ Mo tubes have the same allowable stress up to about 750°F, and the temperature must exceed 850°F before their strength falls significantly. Because the incoming gas temperature is well above what the tube metal can tolerate, successful operation of this exchanger depends on the cooling effect of the boiling water flowing through the U-bends. Since the design water

Figure 4. Schematic of reformer effluent waste heat boiler.

Considering the facts available, one can put together a pretty good picture of the failure mechanism. The following factors all work together to cause tube failures at the outer row U-bends:

Thus one can conclude that, when corrosion and bending have reduced the wall thickness, and when waterside fouling and high heat flux have raised the metal temperature, tube failure at the U-bends results.

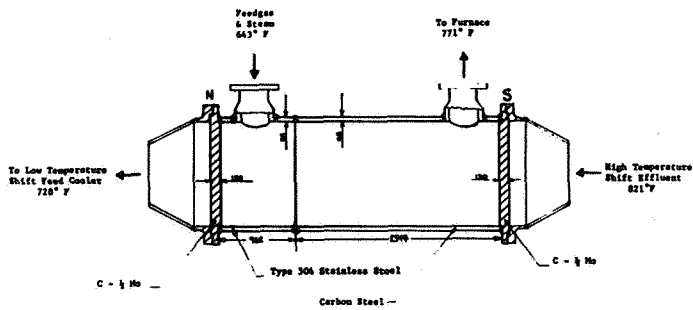
Figure 11. Mechanical design and operating conditions of original feedgas preheat exchanger (dimensions are in mm.).

The Rozenburg ammonia plant preheats a feedgas/steam mixture with high temperature shift converter outlet gas in a single-pass, fixed tubesheet exchanger. Shift converter effluent flows through the tubes and the feedgas/steam mixture flows on the shellside. Tubes are C-½ Mo, whereas the shell is part carbon steel and part Type 304 stainless steel. The bimetallic shell is intended to balance the axial thermal expansion of the shell vs. that of the somewhat hotter tubes, because Type 304 stainless steel has a higher thermal expansion coefficient than carbon steel or C-½ Mo. Figure 11 is a sketch of this exchanger, showing the mechanical design and the operating conditions.

on ASME Section VIII Division 2 (more sophisticated analysis than Division 1) code criteria, showed that the maximum stress intensity at the outer surface of the joint is 105,000 lb./sq.in. vs. a maximum code allowable of only 54,300 lb./sq.in. This, of course, explains the observed cracking. A contributing factor may have been the poor type of shell to tubesheet joint shown in Figure 11, which in fact is no longer permitted under the Dutch pressure vessel code.

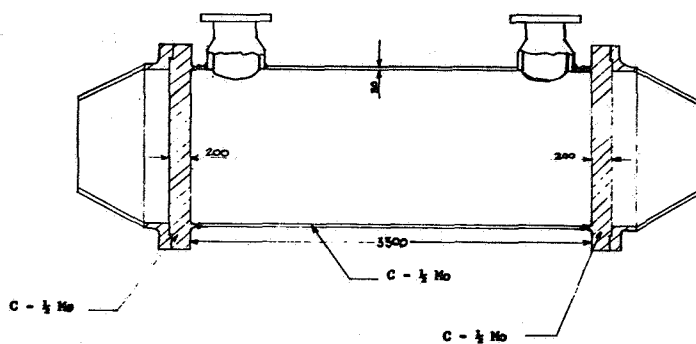
Figure 13. New mechanical design of feedgas preheat exchanger eliminating bimetallic shell construction (dimensions are in mm.).

A complete new replacement exchanger is currently on order. The new design, in Figure 13, eliminates the need for a stainless steel shell section by going to a much thicker tubesheet, and to C-½ Mo for the shell material. C-½ Mo is

much stronger than the original carbon steel at the design metal temperature (820°F) and therefore the shell design was able to employ a thinner and more flexible shell to reduce the tubesheet loading from axial thermal expansion differences. With tubesheet and shell made from the same material, the radial thermal expansion problem at the joint is eliminated. In addition, shell to tubesheet joint construction has been improved to conform to the latest Dutch code requirements.

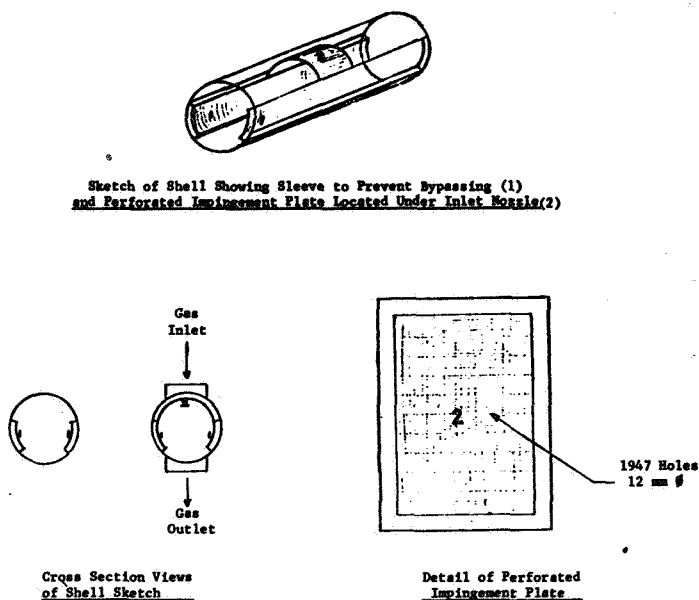
Performance of this exchanger had always been poor, with heat transfer coefficients typically running at around 65-70% of design. A check of the design coefficient indicated that it was reasonable, assuming ideal crossflow on the shellside. However, a check of the exchanger internals, seen in Figure 14, showed that the original design relied only on a highly perforated (approximately 20% open area) impingement plate, located directly underneath the inlet nozzle, plus the bundle pressure drop, to provide axial distribution of shellside flow. Both the inlet and outlet nozzles are in the center of the bundle, and full disk tube support baffles (total of four) effectively isolate the center of the bundle from the ends. Examining the layout, it was considered that the shellside flow distribution was probably very poor, and that this would account for the observed low heat transfer coefficient.

Figure 14. Original layout of low-temperature shift feed cooler.

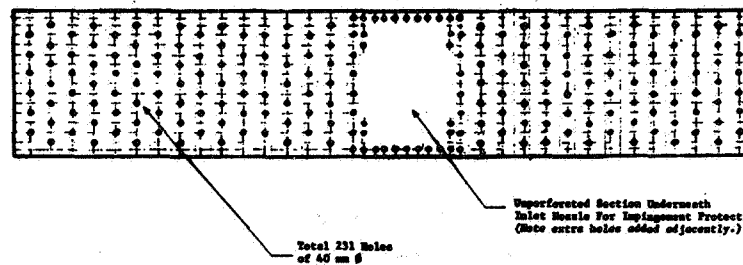
The inlet distributor change proved quite successful in improving the heat transfer performance of the exchanger. The heat transfer coefficient rose 56% above what had been experienced with the old distributor, and in fact slightly exceeded the design value. Unfortunately, however, there was also an unlooked for "side effect." Within three months after the distributor change, the plant had to be shut down for repair of heavily leaking exchanger tubes.

Figure 15. Layout of improved shellside inlet distributor for low-temperature shift feed cooler.

To correct this deficiency, a new inlet distributor was designed, as shown in Figure 15, and installed in March,
