Corrosion in a Naphtha Reformer

A satisfactory solution reported in this case history of an approach to some unusual failures in an ammonia plant in India, now returned to operation

N. B. Tendolkar, V. Sitaraman, and A. Ponnuswamy,
Madras Fertilizers Ltd.,
Manali, Madras, India

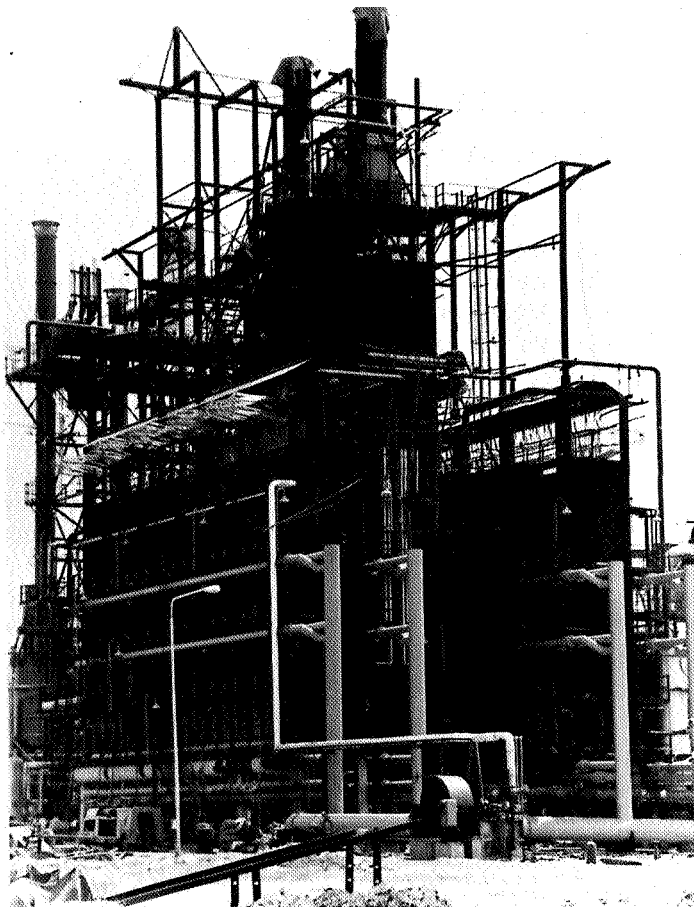
Figure 1. Rear view of the primary reformer, showing inlet pigtails at top and partially insulated outlet pigtails at bottom. One of the two forced-draft fans is in foreground. Induced-draft fans are at the top.

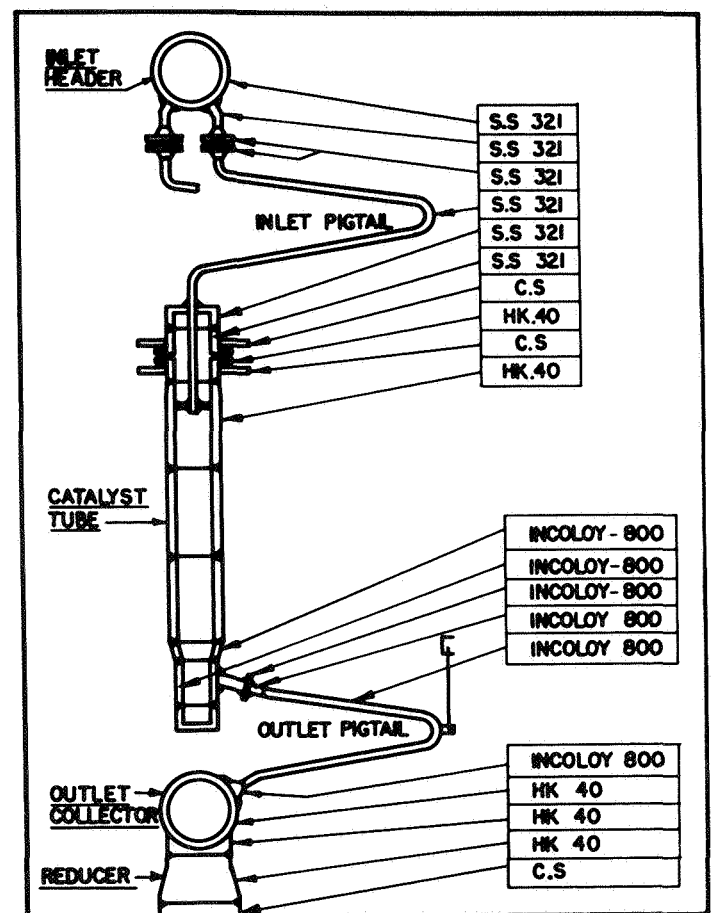
Figure 2. Primary reformer materials of construction chart.

The catalyst tube arrangement and materials of construction are shown in Figure 2. The top of the tube is welded to a schedule 80 HK-40 stub end with a loose

carbon steel flange which is bolted to a carbon steel loose flange of the inlet pigtail. The bottom of the catalyst tube is welded to an Incoloy assembly to which is welded the Incoloy-outlet pigtail. The other leg of the outlet pigtail terminates at the HK-40 collector. The collector tee is welded to the refractory-lined transfer header through a centrifugally-cast HK-40 reducer.
