Fatal Accident in CO₂ Removal System

Remedial action after unusual incident in hot potassium carbonate service includes change to stainless from carbon steel for large elbow that had ruptured

T. R. Visvanathan,
Madras Fertilizers Ltd.,
Manali, Madras, India

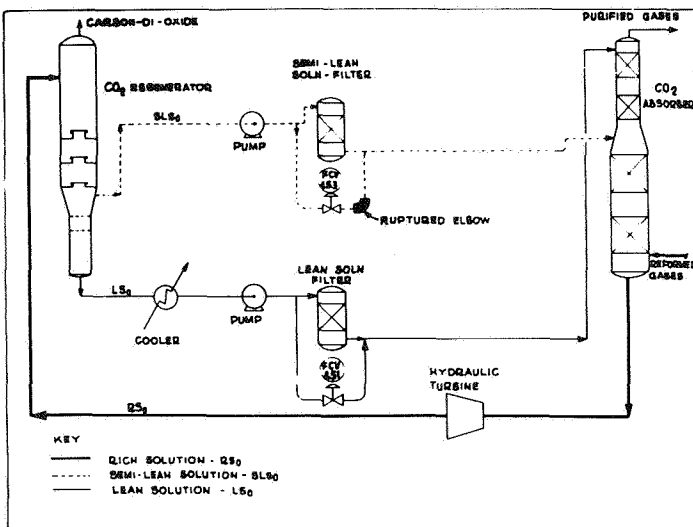
Figure 1. Carbon dioxide removal system, simplified flow diagram.

Referring to Figure 1, the converted gas from the shift reactors is scrubbed under a pressure of 28 kg./sq. cm. with a 25% potassium carbonate solution containing a corrosion inhibitor and a catalyst to promote carbon dioxide absorption and regeneration. The rich solution from the absorber goes into the regenerator operating at about 2 kg./sq. cm., at a temperature of 108°C through a

letdown turbine. From the regenerator a semi-lean solution is pumped to the middle of the absorber at a temperature of 117°C through the control valve FCV-453 located at the ground level with carbon steel elbows on either side. A lean solution taken from the bottom of the regenerator is cooled and pumped to the top of the absorber at 70°C.
