# Rupture in Ammonia Shift Conversion Unit

Investigation of incident showed direct cause was corrosion, itself a result mainly of poor water distribution and a lack of good pH control

G. B. Casey,  
Irish Nitrogen Ltd.,  
Arklow, Ireland

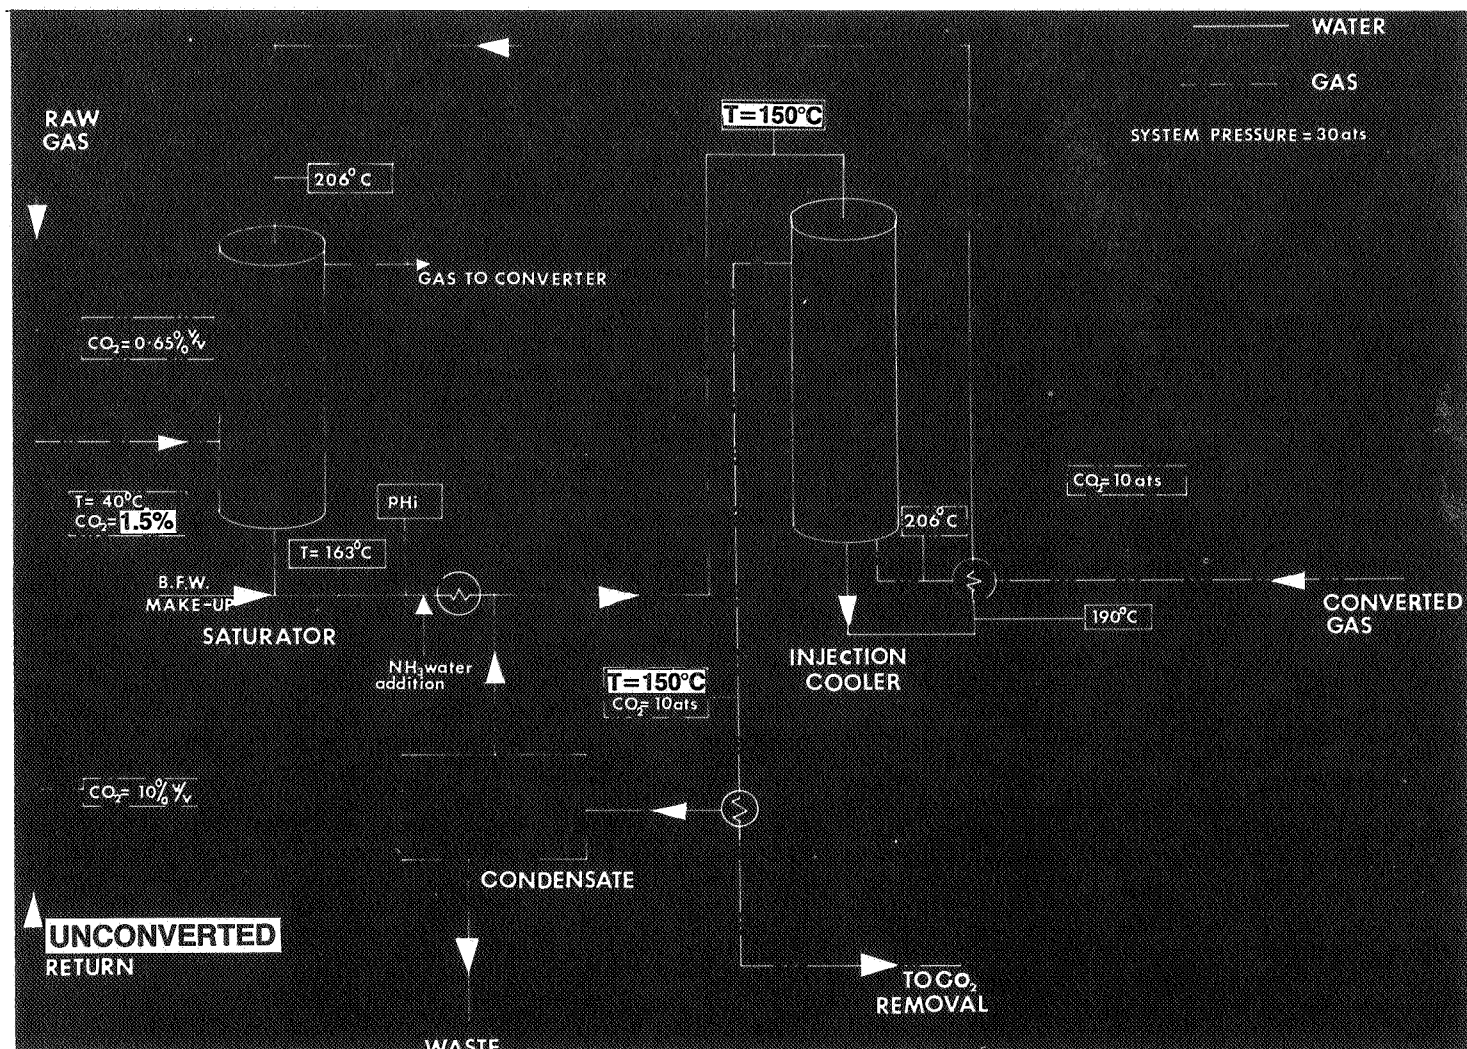
Figure 1. Flow diagram showing water circulation in shift plant.

Water is circulated in the system from the saturator to the injection cooler as shown in Figure 1. Make-up to the system is either condensate from the gas or boiler feed water. Before the explosion, the pH measuring point was after the saturator and pH was controlled by NH<sub>3</sub> water addition through metering pumps.

The circulating water system on the unit, shown in Figure 1, is particularly prone to corrosion because of the presence of CO<sub>2</sub> in the water which comes from the shift gas. The pH was controlled in the system by the addition of a 10% ammonia water solution to the system after the pH-sample point at the saturator outlet.
