Solving Corrosion Problems in Steam Reforming

A case history is a BASF steam reforming methanol/ammonia plant, in which an improvement in the design of the waste heat boilers has eliminated plant breakdowns

M. Appl and K. Feind,
BASF AG, Ludwigshafen/Rhine,
West Germany

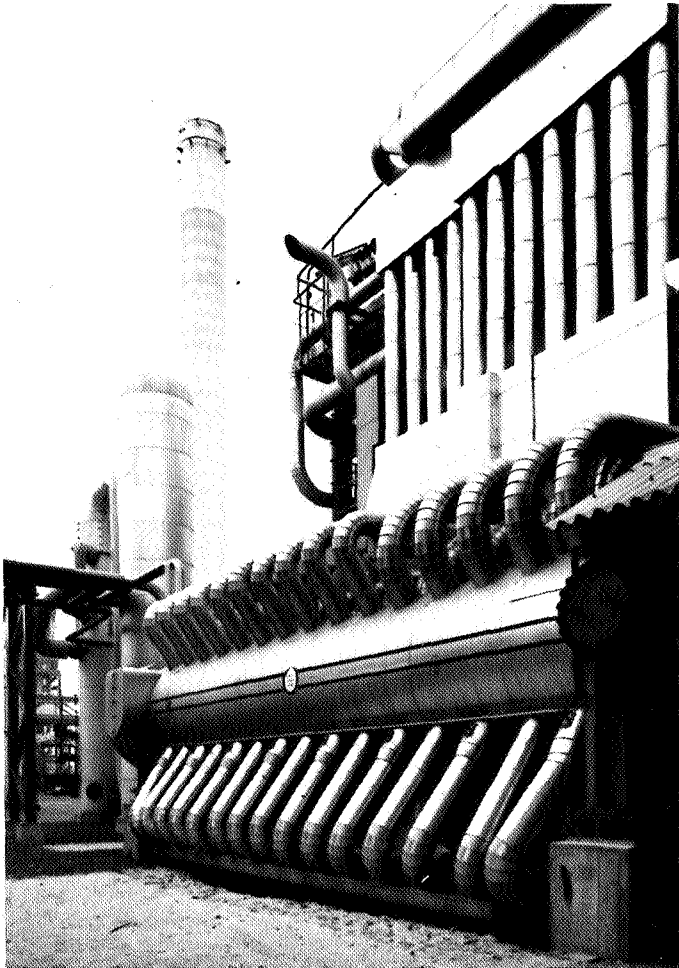
The methanol plant cooler is located immediately behind the primary reformer. Gas flowing through the tubes contains about 70 mol-% hydrogen; the remainder is carbon monoxide, carbon dioxide, and methane. Boiling water flows by natural circulation through the cooler jacket from the boiler drum located above it, as shown in Figure 1. Operating conditions for the old and new design coolers are listed in Table 1.

Figure 1. The methanol plant cooler at Ludwigshafen.

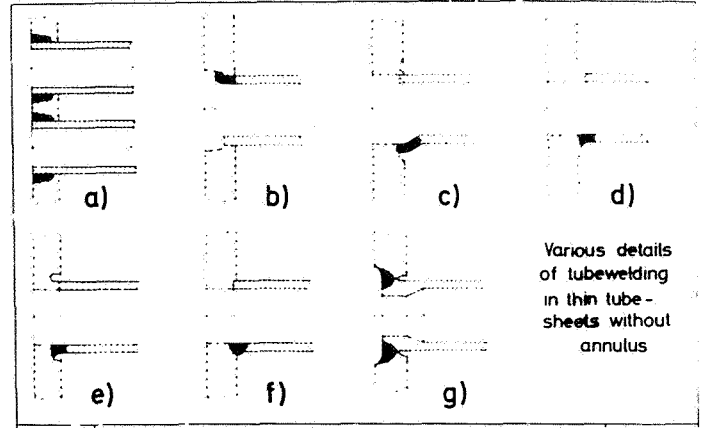
Figure 8. Various details of tube welding in thin tube sheets without annulus.

These conclusions aroused thoughts on how the tubes could be connected on the gas outlet side to the tube sheet without annulus and how they could be secured over a thicker joint weld and tube wall. Various means of weldings without annulus are shown in Figure 8. For various reasons, they were not considered for our new cooler.

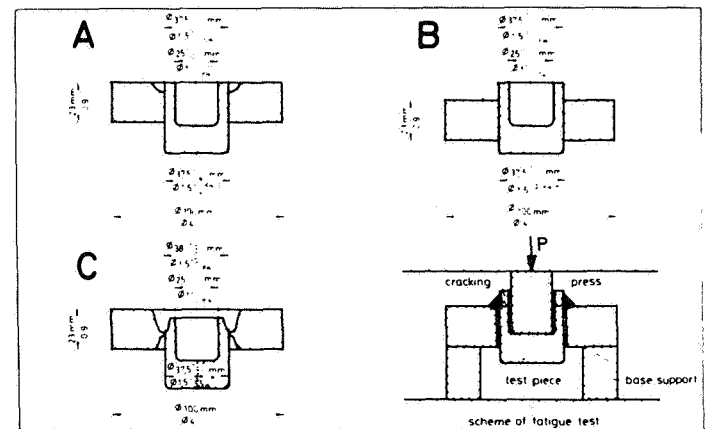
Figure 9. Test pieces for high-frequency pulsator test.

Fatigue tests were carried out on three different designs, designated A, B and C in Figure 9. The material from which the test pieces were made was 15Mo3. Before the test, the test pieces were stress-annealed at 600°C for one hour. The tests were carried out in a high-frequency pulsator at room temperature. The frequency of loading was 164 Hz., and corrosion effects were not included. A constant load of 7,000 kg. was applied, and cyclic loads of 900 and 3,000 kg. were superimposed on it. A value of 7,000 kg. was selected as being approximately equal to the axial load on the tubes in the waste heat boiler.

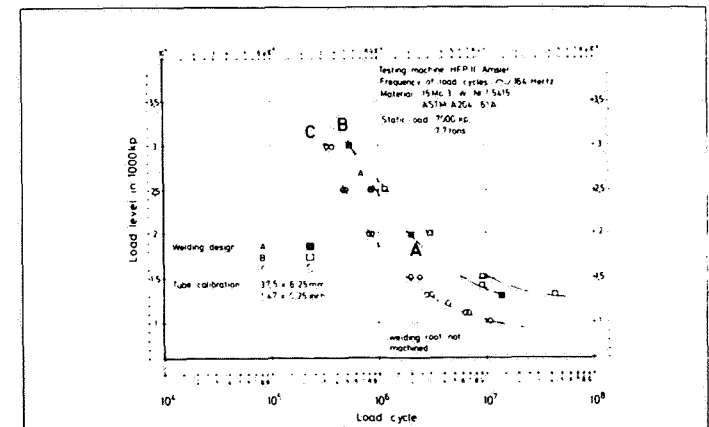
Figure 10. Fatigue test (DIN 50100).

Wöhler curves representing the results of the tests are reproduced in Figure 10. The cyclic load superimposed on the constant load of 7,000 kg. has been plotted against the number of load cycles to failure. Each plotted point represents a test piece that has failed.

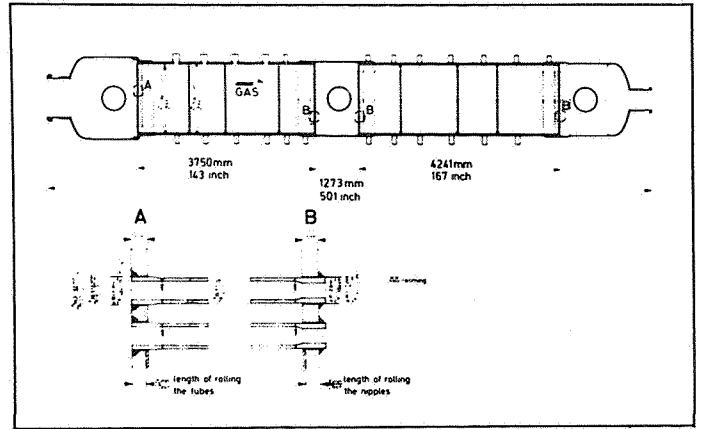
Figure 11. Methanol plant waste-heat boiler (second design).

This investigation made a considerable contribution towards the design of the new gas cooler for the methanol plant, which is shown in Figure 11. The main difference from the old design is that the bundle of tubes has been split into two parts with intermediate tube sheets. This reduces the load imposed on the welds dependent on the length of the tube bundle.

The sketch in Figure 11 illustrates how the tubes are welded into the tube sheet of the first bundle on the outlet side and into that for the second bundle on the inlet and outlet sides. By means of welding-neck nipples, the wall of the tube was thickened from 4 to 7 mm. at the weld.

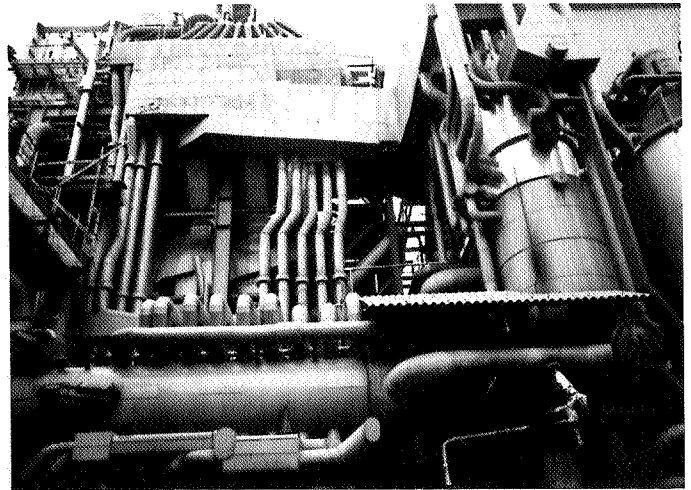
In the ammonia plant, the waste heat boiler is in the gas stream between the high-temperature shift conversion and a water-tube type cooler in series with the primary

Figure 12. Waste heat boiler in the BASF ammonia plant.

reformer, as seen in Figure 12.

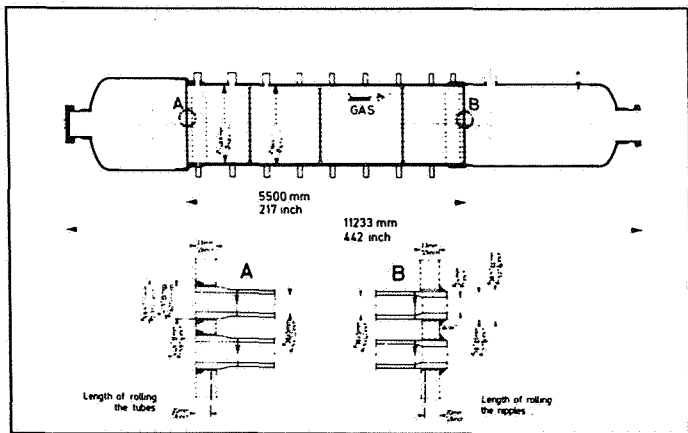
The nature of the damage and its analysis corresponded exactly to that previously determined in the cooler of the methanol plant. All damaged tubes were in the upper part of the tube sheet, as was the case in the first repair on the methanol plant gas cooler.

Figure 15. Ammonia plant waste-heat boiler (second design).

Here, too, it was decided in 1972 to construct a new cooler. This equipment was installed in summer, 1973, during a one-month shutdown of the ammonia plant. Since then, it has been running without trouble. The main dimensions of the new cooler and the design of the tube sheet and the tube-to-tube sheet weld are shown in Figure 15.

Again, the main difference between the old and the new gas cooler is that the bundle of tubes has been shortened, in this case by 4 m. to a length of 5.5 m. The wall thickness of the tubes was increased from 4.5 to 5 mm., and nipples were used for welding the tubes into the two tube sheets. The wall thickness of the nipples on the tube sheets at the gas inlet end is 7 mm. The same material has been used for the tubes, nipples and tube sheets: 16Mo5. Another significant modification is the elimination of the bypass tubes in the bundle.

diameters and wall thicknesses. Instead, an external gas bypass tube was installed with a throttle-clack valve in the cooler outlet as before. Again, the welding-neck nipple on the tube sheet at the gas outlet end was fillet welded. This strengthened the tube-to-plate weld and assumed the shape that the fatigue tests had proved to be the most favorable.

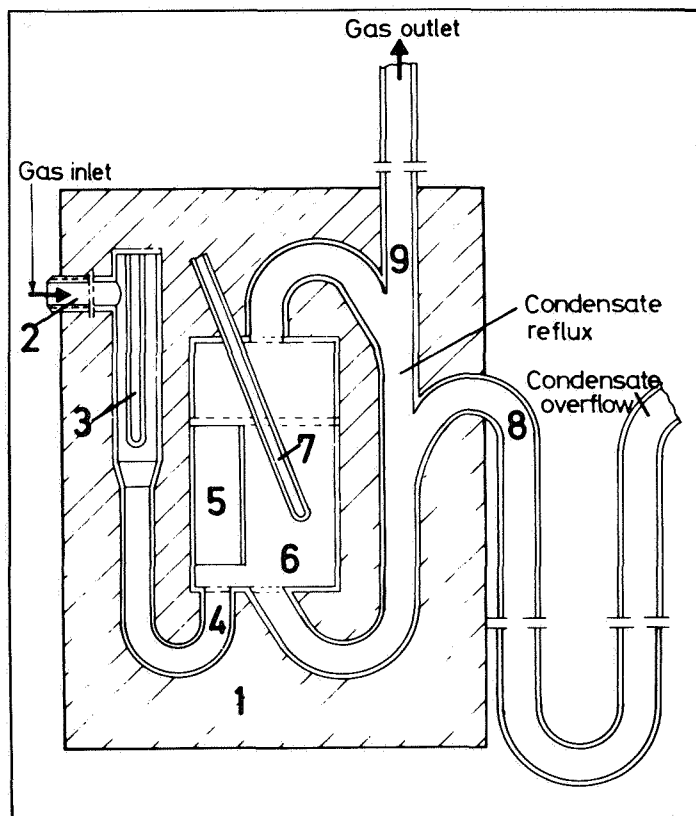
Figure 16. Measuring saturation temperature of steam/gas mixtures.

A method BASF considers reliable for the early detection of leakages in waste heat boilers is the measurement of the moisture content of the gas in front of and behind the cooler concerned. For this reason, the saturation temperature of the gas was monitored in front of and behind the two coolers. The gas flowed continuously through the sampling points. The instrument used was a type for which BASF had been granted a patent in 1957 (German Patent No. 1002963). A sketch is shown in Figure 16.

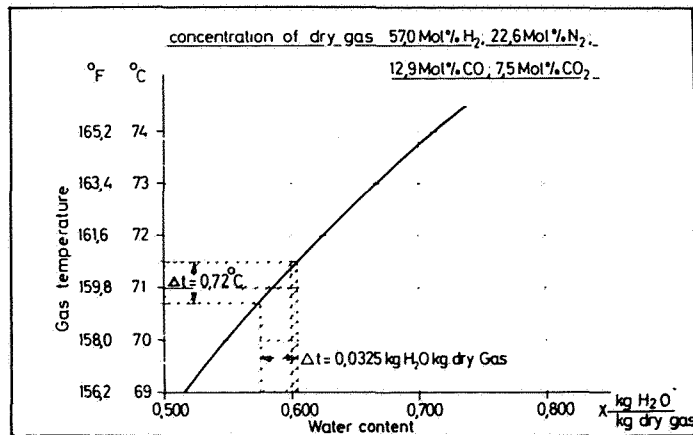
Figure 17. Saturation characteristic of ammonia plant gas at atmospheric pressure.

The saturation curve at atmospheric pressure for the gas in the ammonia plant after the secondary reformer is shown in Figure 17. If the temperature of the gas at the outlet drops by 20°C as a result of the influx of boiling water, the moisture content of the gas will increase by $\Delta x = 0.0325 \text{ kg. H}_2\text{O/kg. of dry gas.}$

According to the curve in Figure 17, this increase in moisture content will raise the saturation temperature from 70.7°C to 71.4°C, i.e., by 0.72°C. Therefore, if a reliable indication is to be obtained on any leakages, the saturation temperature must be measured as accurately as possible. That is why two identical measuring instruments were installed—one in front of and one behind the cracked gas cooler. Thermocouples are fitted for measur-
