Ultrasonics as a Detection Tool

Mid-wall creep fissuring in cast HK40 reformer furnace tubing can be detected using ultrasonics and specialized techniques.

Richard E. Marlow
Conam Inspection, Inc.
Richmond, Calif.

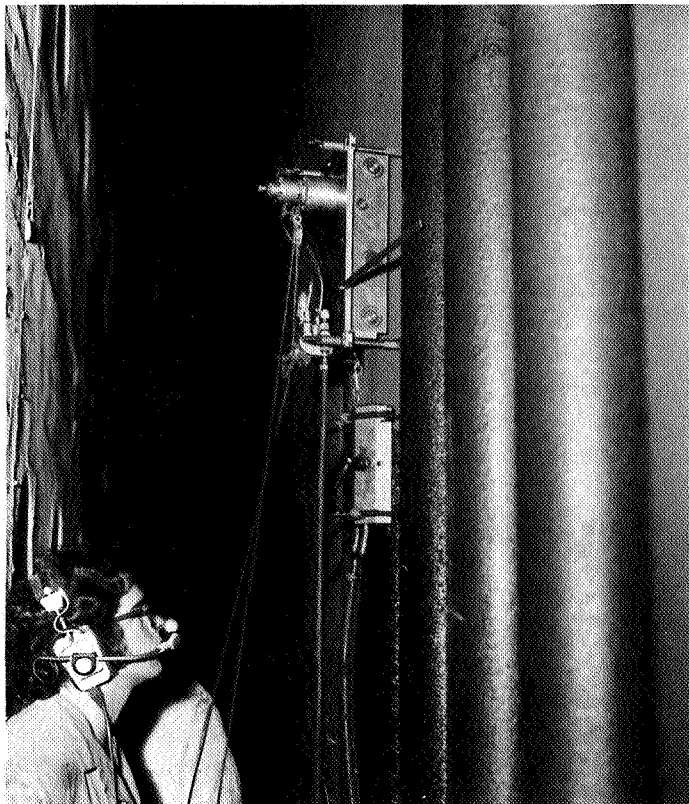
Test unit in operation in a furnace.
