ATR REPORT-2021

**INDIAN FARMERS FERTILISERS CO OPERATIVE LTD.
PARADEEP UNIT**

ATR REPORT: 2021

DAP PLANT

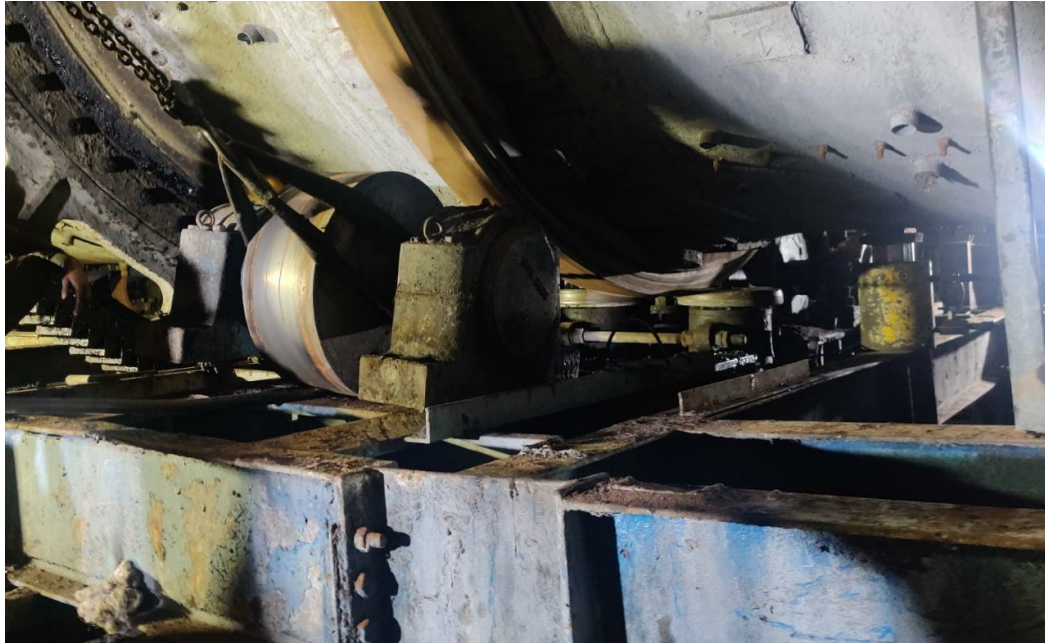
3. Convex surface of both thrust and plane riding ring was made true by grinding (FLSmith grinding team)

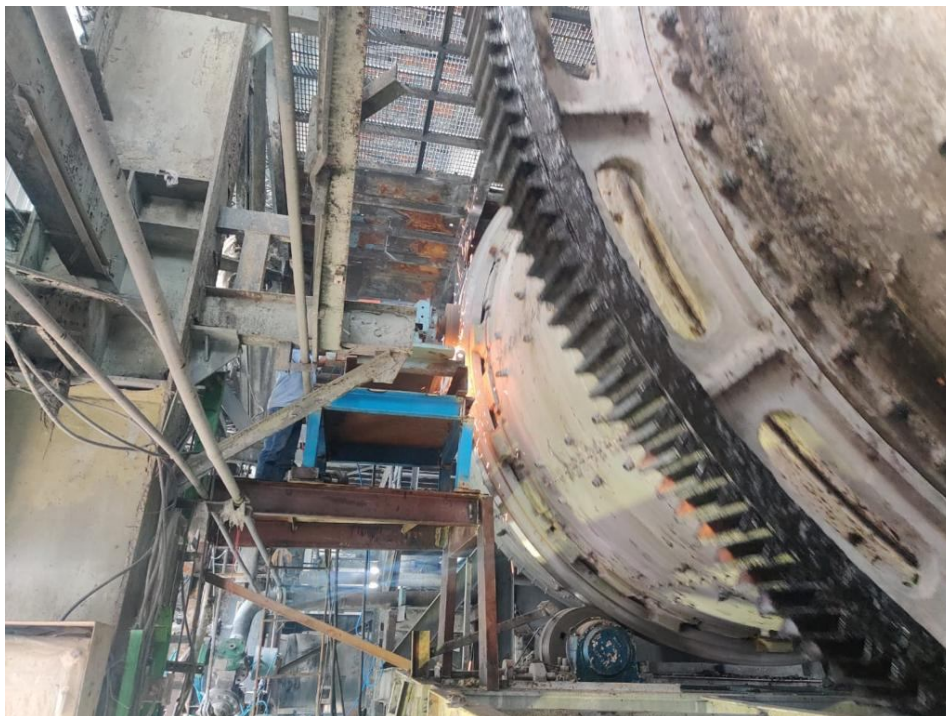
2. Bearings of granulator girth gear pinion were inspected, clearance found beyond acceptable limit and hence replaced. Torque tube hub teeth are worn out, hub was replaced with a new one.
3. Main gearbox Lubrication system flushed and oil cooler was cleaned.

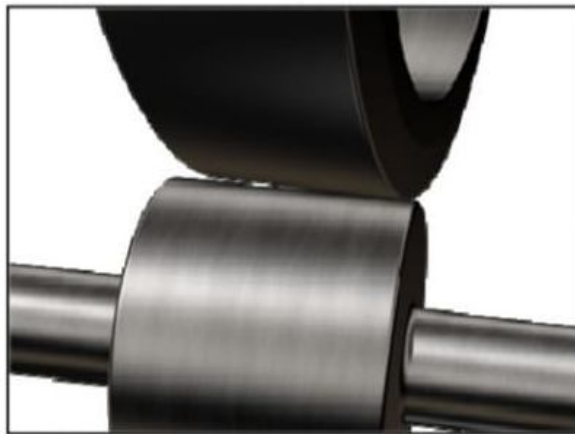
Fig. 7: Support roller inclination

All the support rollers are thrusting the granulator towards uphill except support I LHS roller which is thrusting the granulator towards downhill direction.

Example of a case, where slope difference between Granulator (illustrated by tyre slope) and support rollers exist, may lead to tapered wear patterns in the tyre and rollers, uneven loading on the tyre stopper blocks, bearings and filler bars.

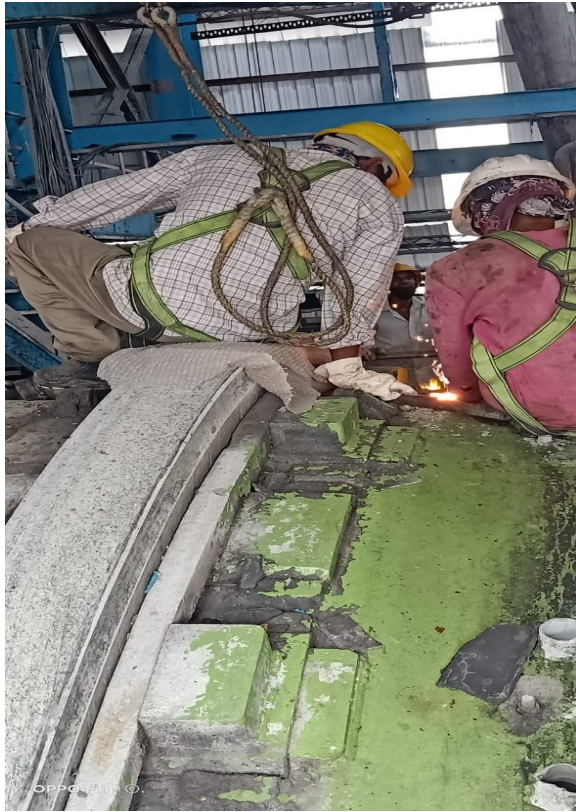
Old tyre pad cutting

- 4 nos Support roller with new bearings replaced, Train C side uphill support roller fitted with old roller with machined face.
- Downhill tyre with wear ring & tyre pads replaced.

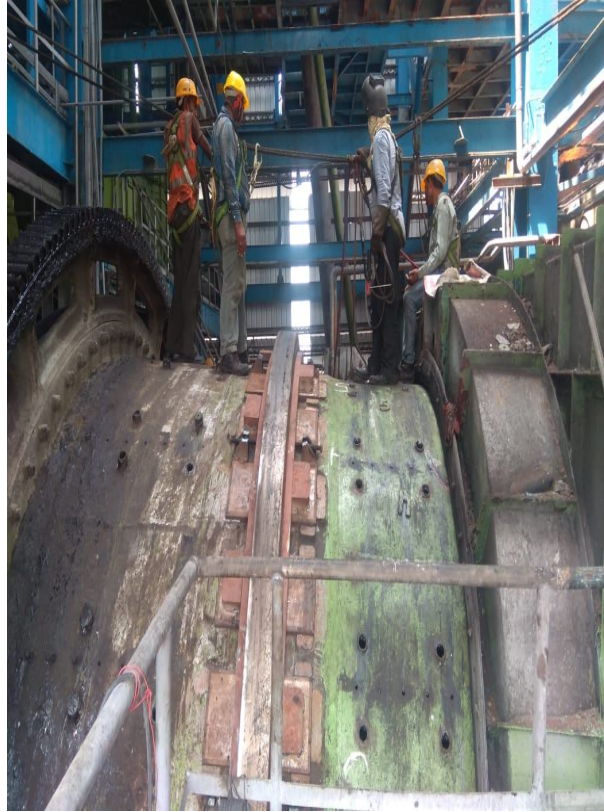
New tyre with pad

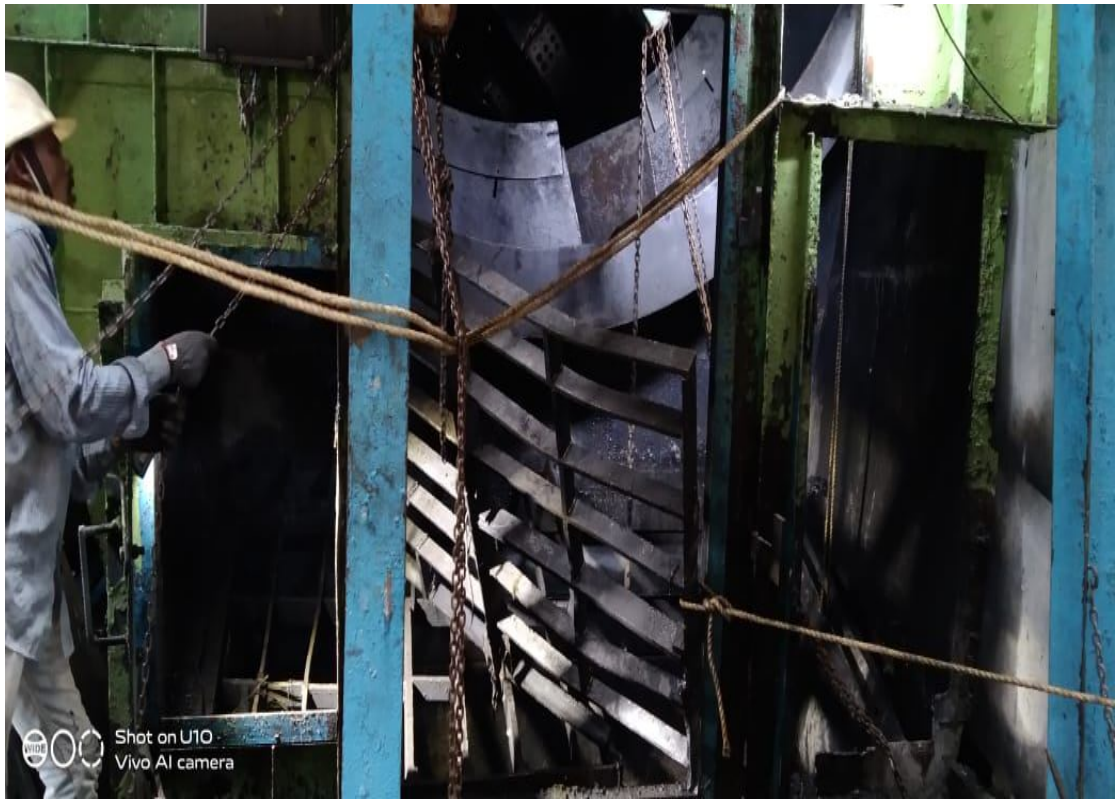
Grizzly replacement

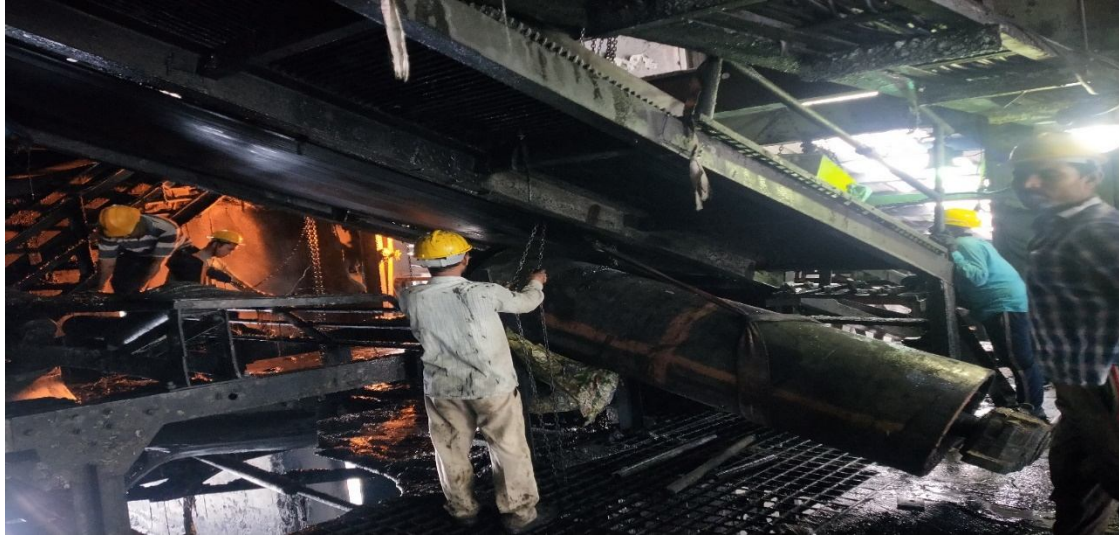
Tail pulley shifting

- **FINES CONVEYOR:** In fines conveyor skirt rubber fixed. Head, bend and tail pulley damaged rubber lagging replaced by new lagging. All bearings clearance checked and lubricated .all damaged idlers replaced. Take up bend column replaced.

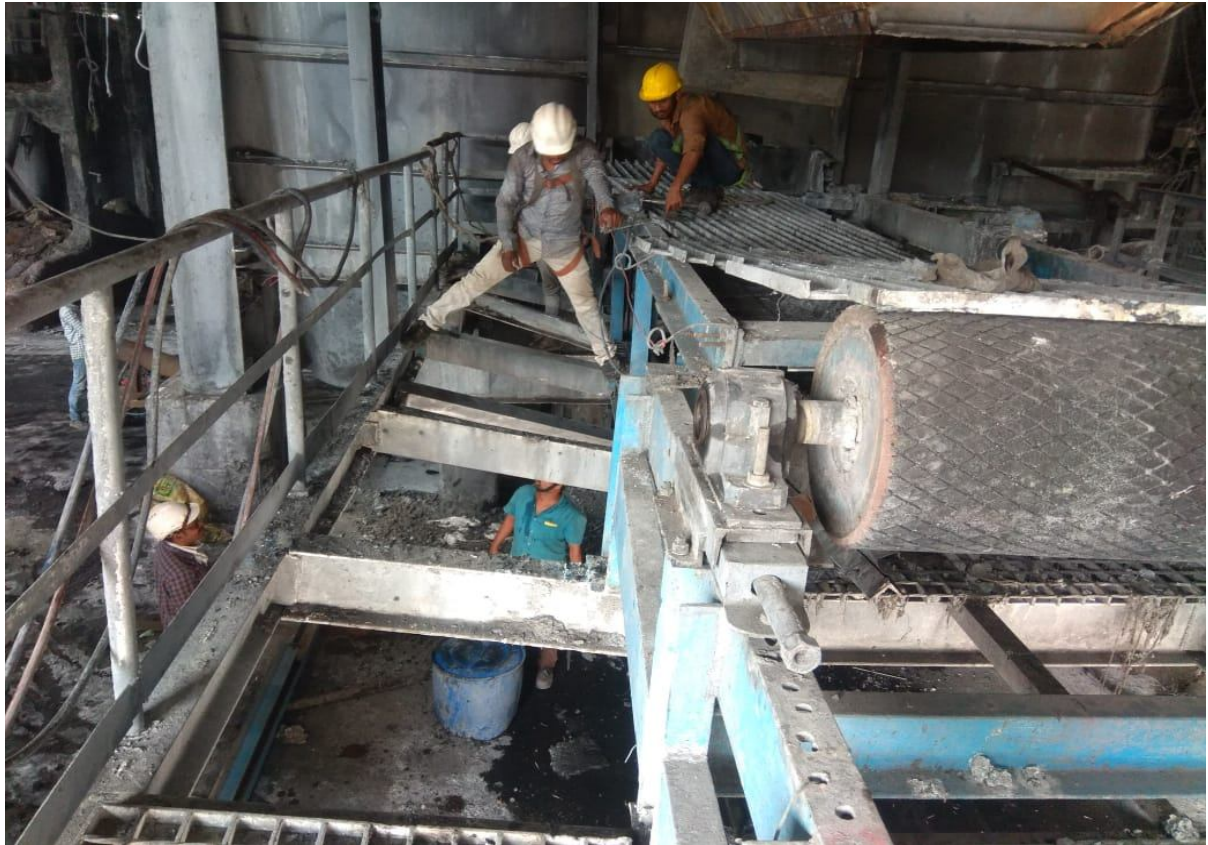
DDC side inclined platform leveling under progress

DDC, RM AND PRODUCT STORAGE CONVEYOR: In all conveyors skirt rubber replaced by skirt rubber and all damaged pulley lagging replaced by new lagging. All bearings and gearboxes inspected and lubricated. In DDC conveyor all idlers replaced by HPPE idlers. DDC tail pulley pad plate welding done for strengthening. DC side inclined platform leveled.

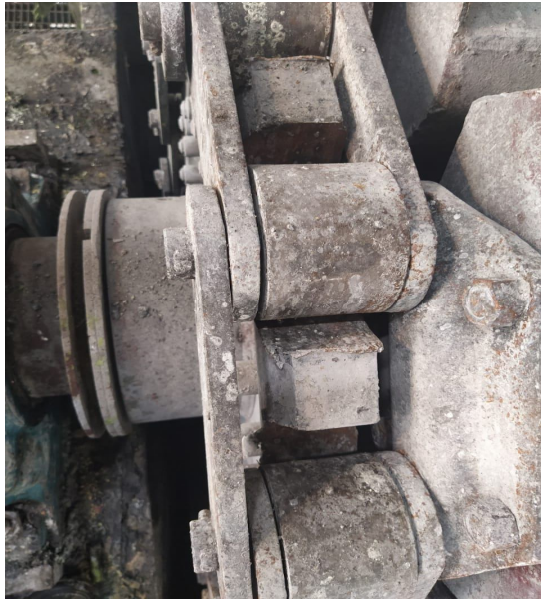
- **Secondary elevator:** secondary elevator bucket and chains inspected and 16 damaged buckets replaced and 6 nos of damaged chain pair links replaced.
- Its drive sprocket is worn out hence replaced with spare sprocket shaft assembly with new bearing & blocks
- Gearbox and bearings inspected and lubricated.
- Tail sprocket with CI block replaced.

Old sprocket

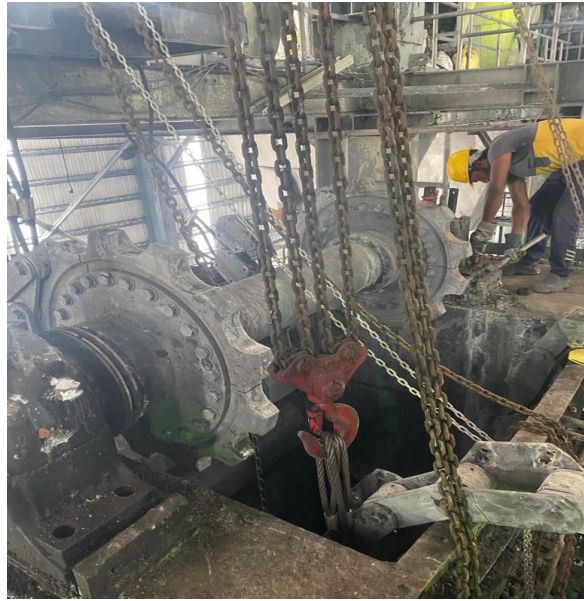
New sprocket

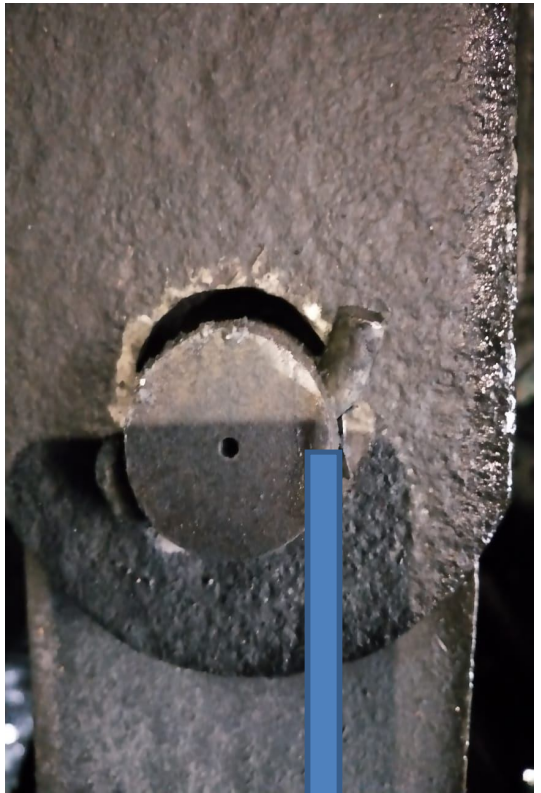
Damaged chain link of elevator

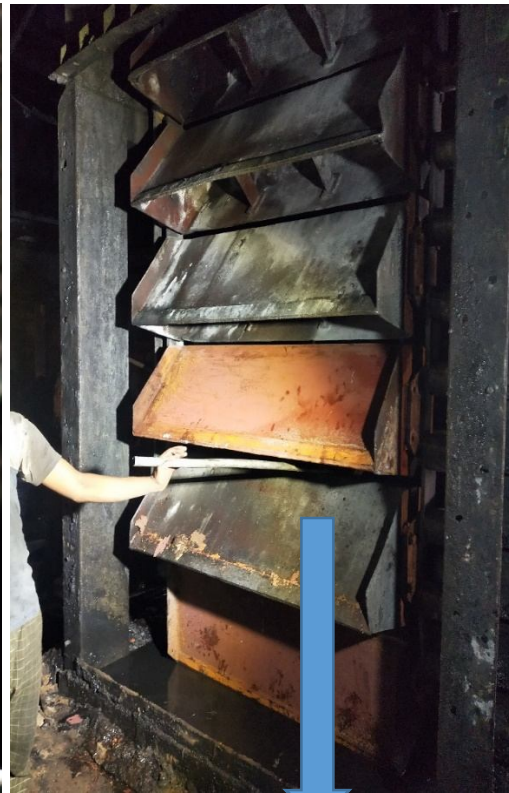
Replaced bucket of elevator

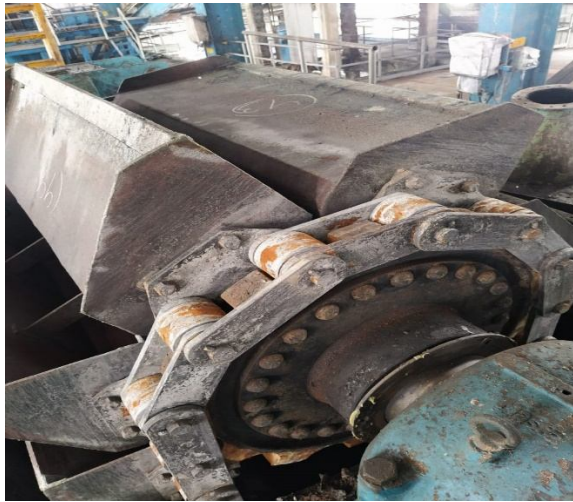
Head sprocket inspection

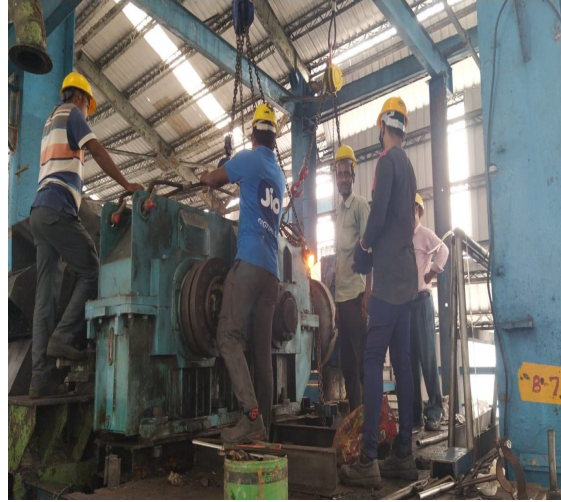
Gear box fitting

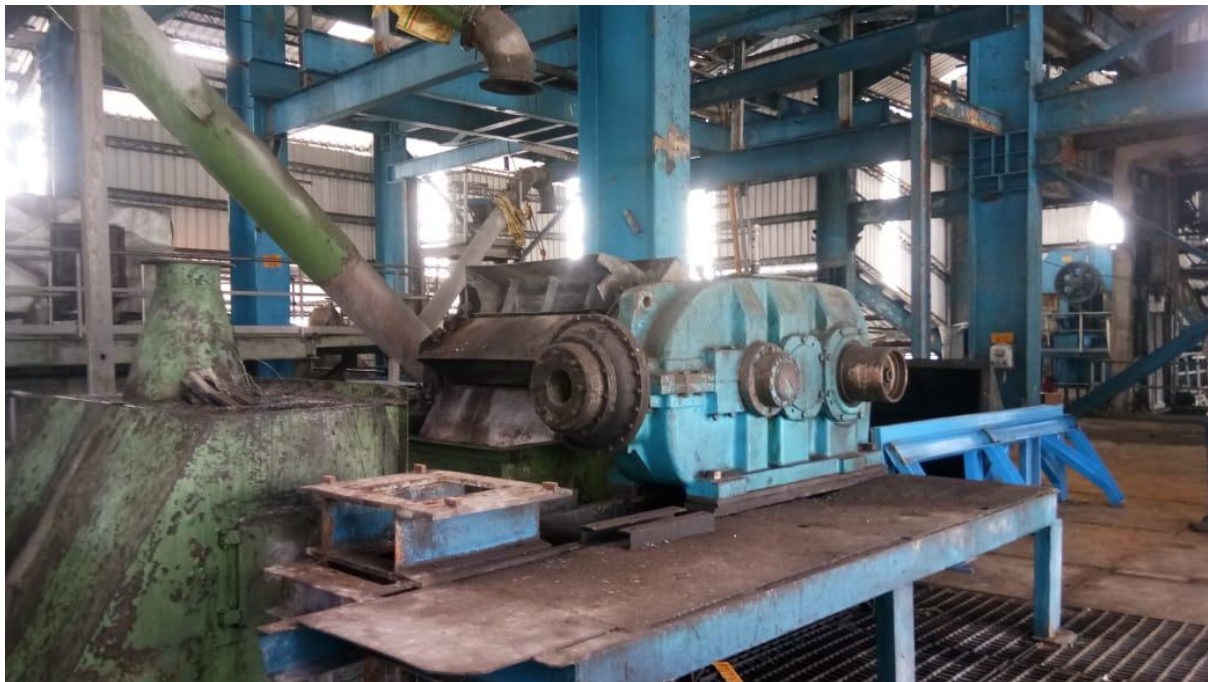
Product screen elevator new base frame fitting under progress

Product screen elevator: Drive sprocket, gearboxes and head shaft bearings inspected and lubricated. And chain & bucket inspected by manually turning the elevator. CI blocks changed. Tail sprocket shaft build up by welding & grinding in position. Gear box base frame replaced.

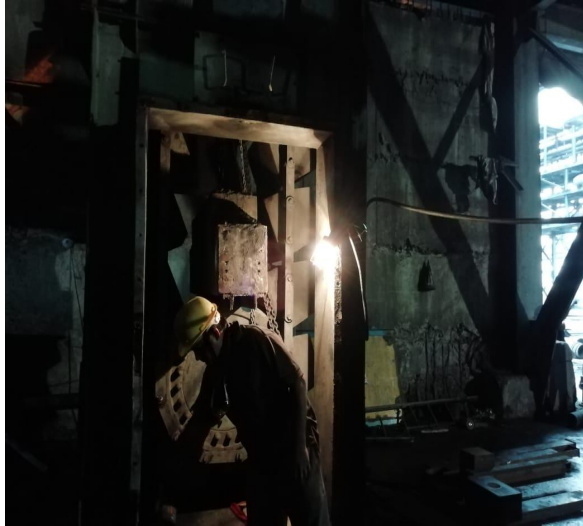
Chain inspection

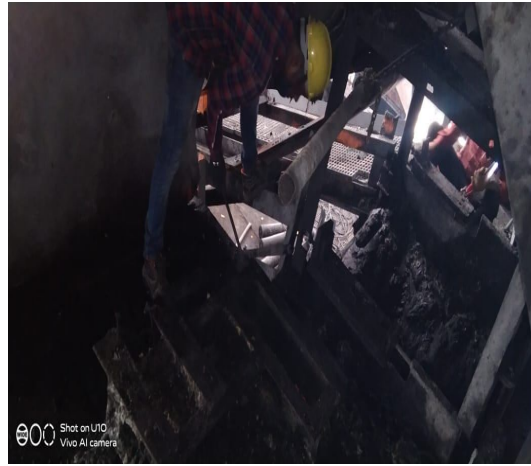
Hopper dismantling

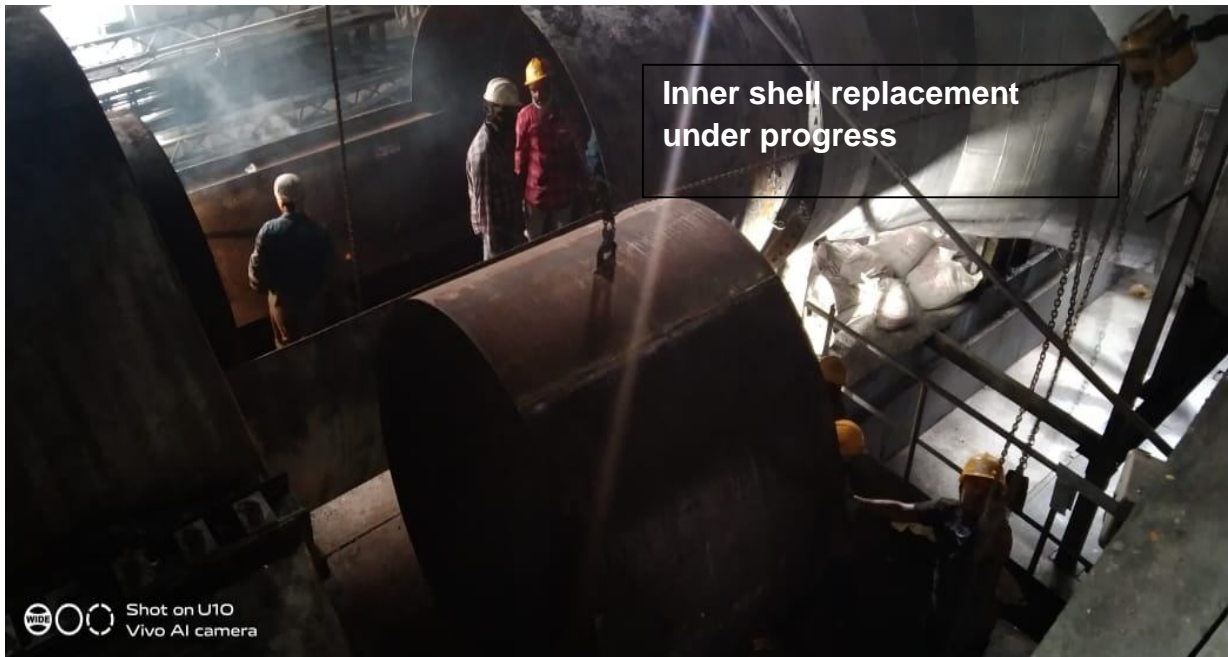
COMBUSTION CHAMBER: It's inner shell completely changed due to ovality & refractory (Fire brick & insulating brick) placed. Heat resistant paint applied on outer shell of combustion chamber. Dryer deduct area corroded plate replaced.

Inner shell replacement under progress

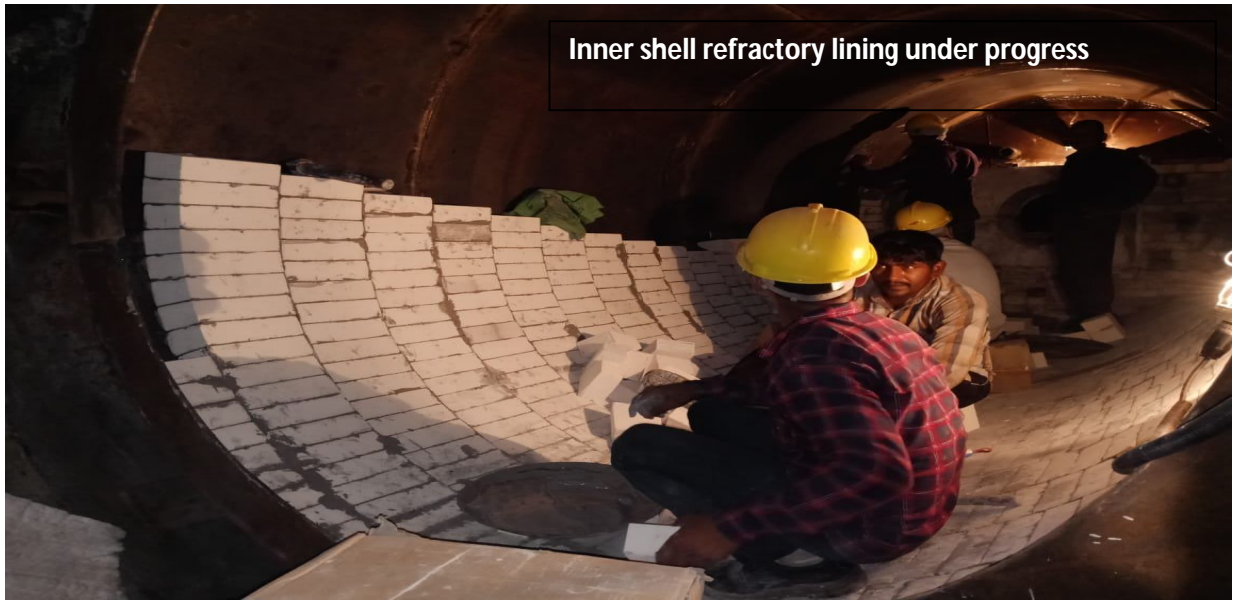
Inner shell refractory lining under progress

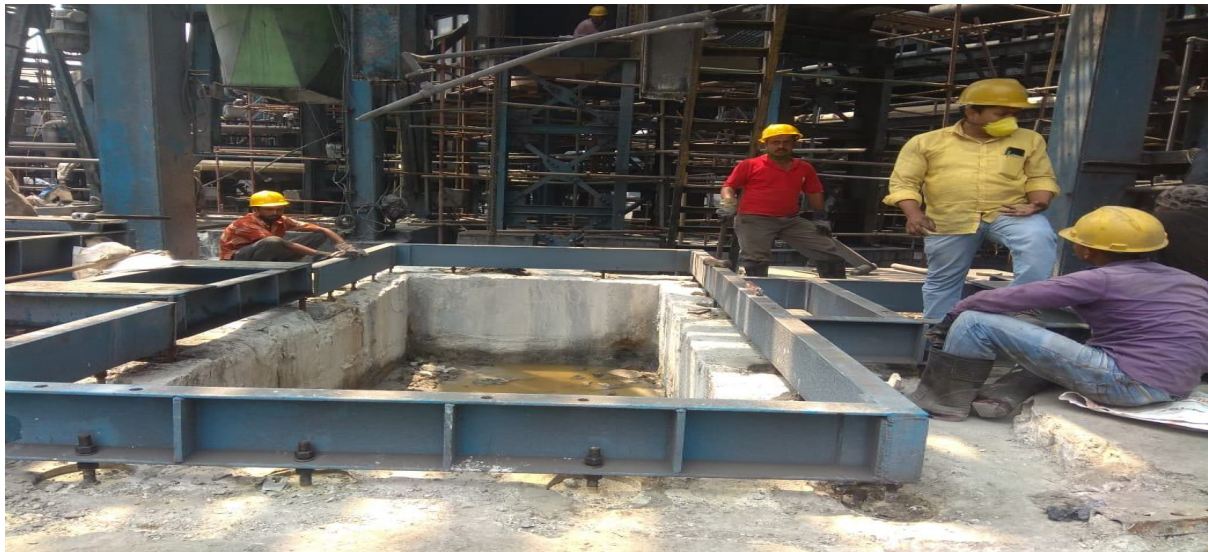
Fumes fans: Fumes fan old corroded base was dismantled & new fabricated base erected with core grouting (Shrinkomp cement grout), Balanced impeller replaced. Damper cleaned & flap bearing greasing done. Fan discharge duct replaced with SS 316L duct. New cone with clearance within 10 mm erected. Fan inlet box MOC upgraded to SS 316L.

New fabricated base frame erected

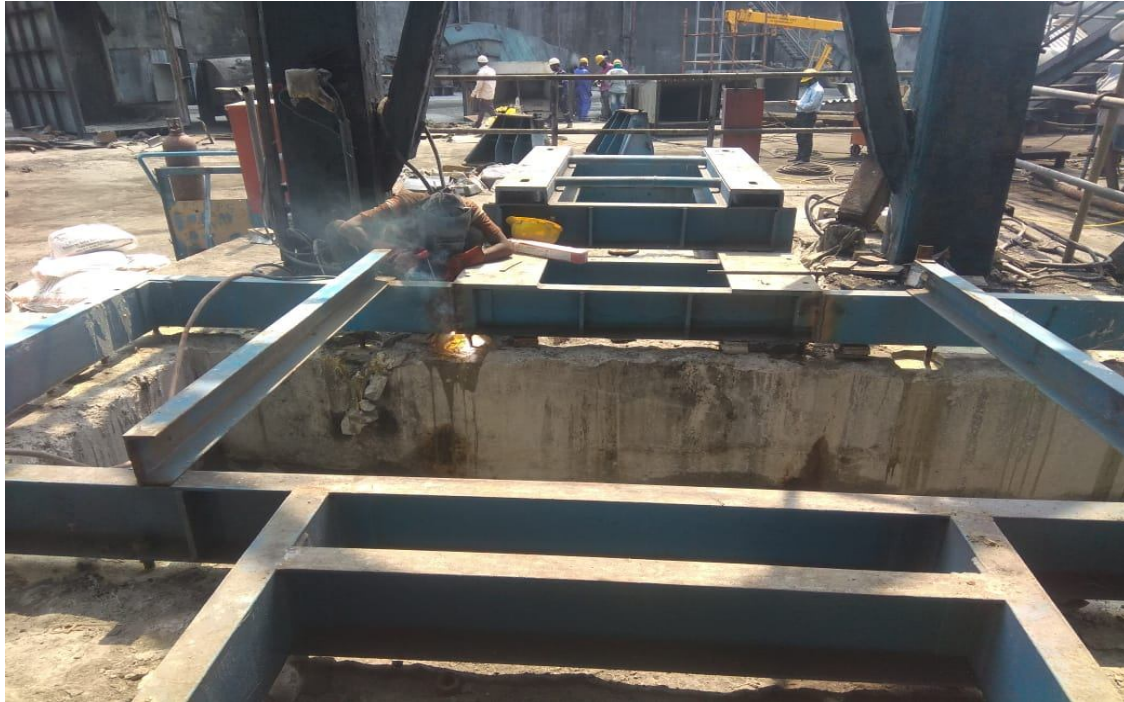
Dryer exhaust fan: Dryer exhaust fan old corroded base was dismantled & new fabricated base erected with core grouting (Shrinkomp cement grout), Balanced impeller replaced. Damper cleaned & flap bearing greasing done. Discharge bellow replaced. Fan discharge duct replaced with SS 316L duct. New cone with clearance within 10 mm erected. Fan inlet box MOC upgraded to SS 316L.

New fabricated base frame welding under progress.

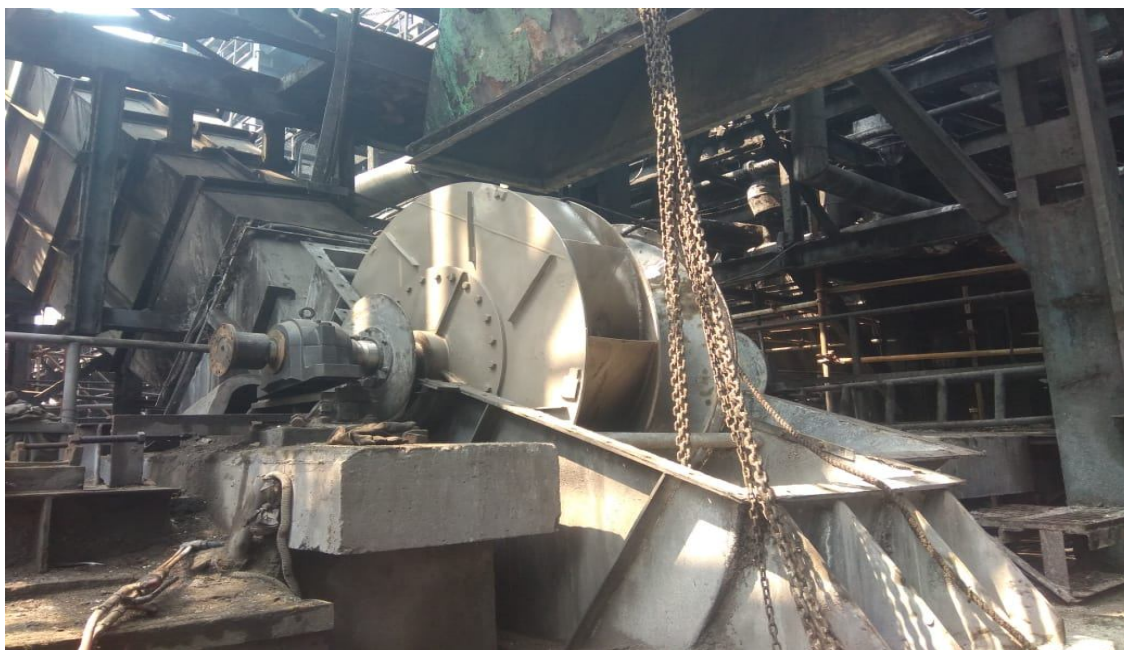
Dust Fan: Dust fan balanced impeller replaced. Cracked casing welded, damper cleaned & flap bearing greasing done. Discharge & inlet bellow rubber replaced.

Dust fan impeller erection under progress.

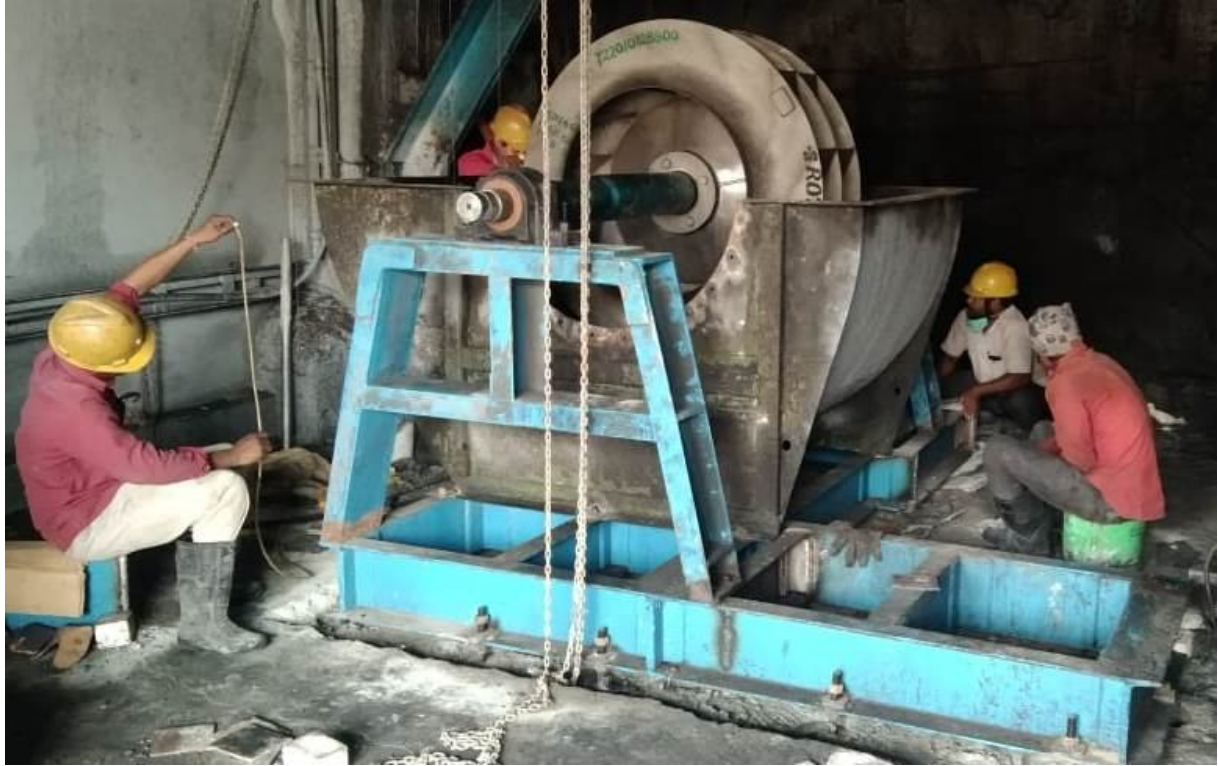
Quench Air fan: Quench air fan old corroded base was dismantled & new fabricated base erected with core grouting (Shrinkomp cement grout), Balanced impeller (SS316L) replaced. New Damper replaced. New pedestal replaced.

New impeller with fabricated base & pedestal erection under progress.

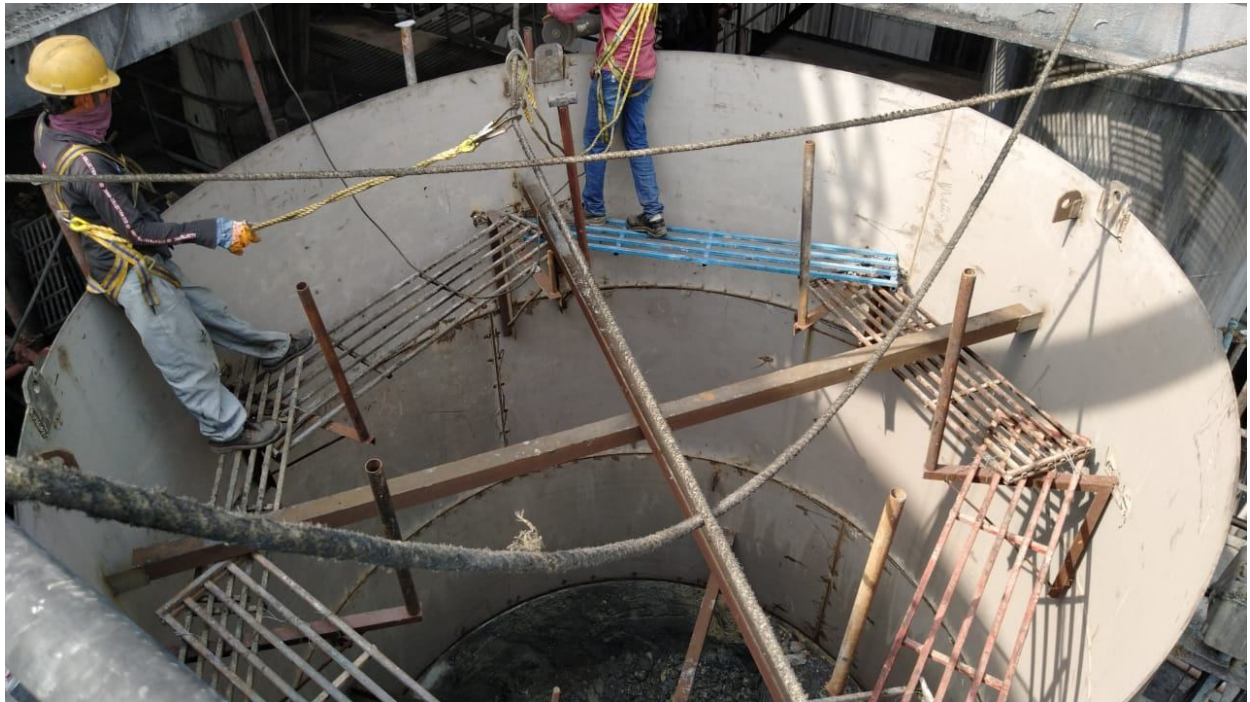
Pre scrubber separator: Pre scrubber separator MOC upgraded to SS316L.
Expansion bellow replaced.

Pre scrubber separator shell fitting under progress.

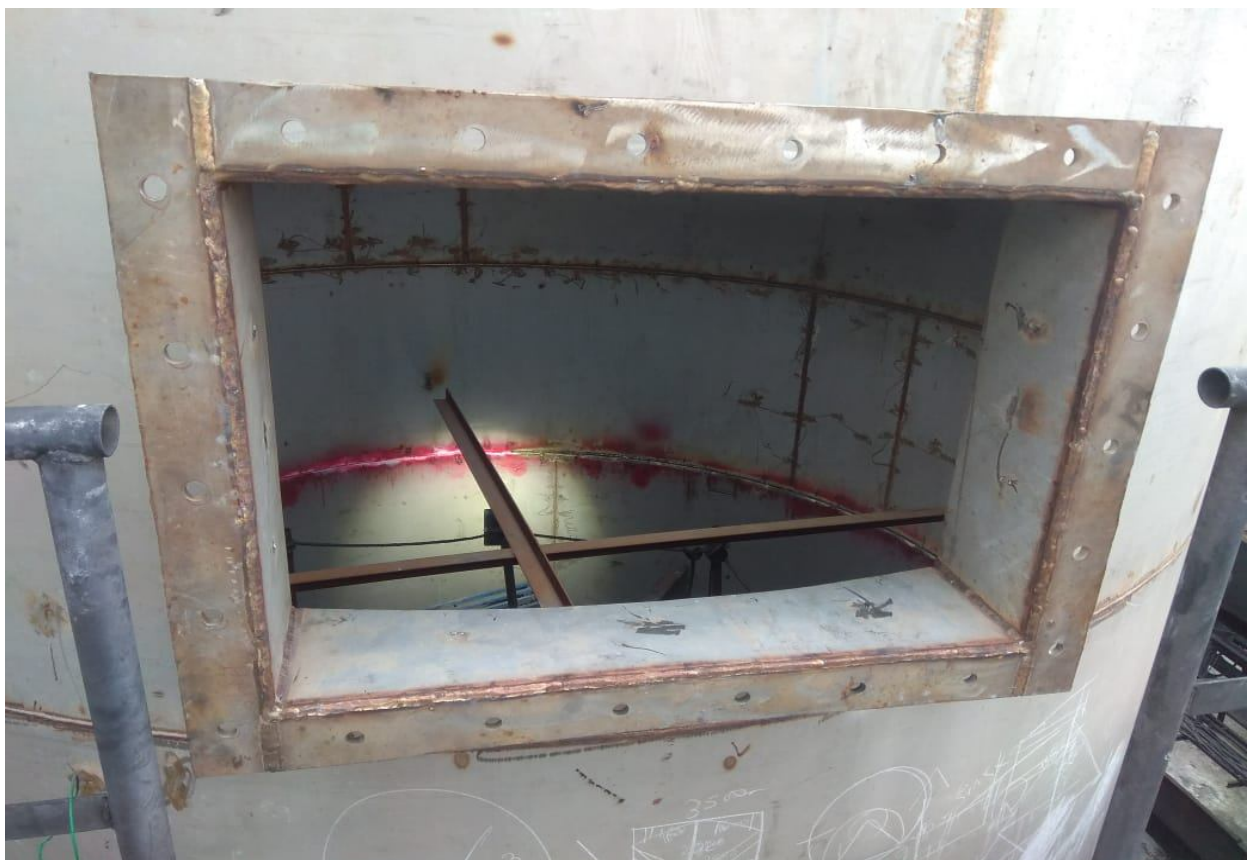
Rectangular manhole provided in place of circular.

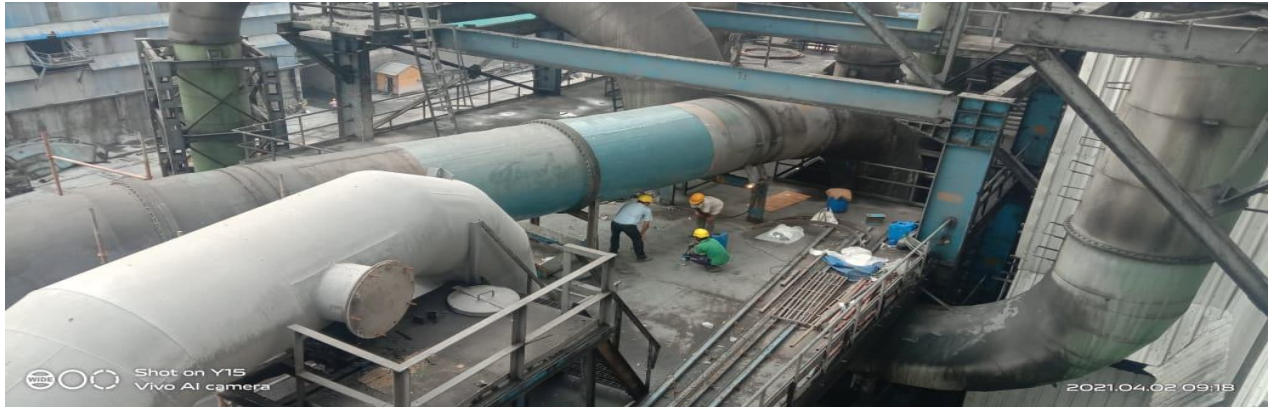
Pre scrubber to fumes scrubber damaged duct FRP lined.

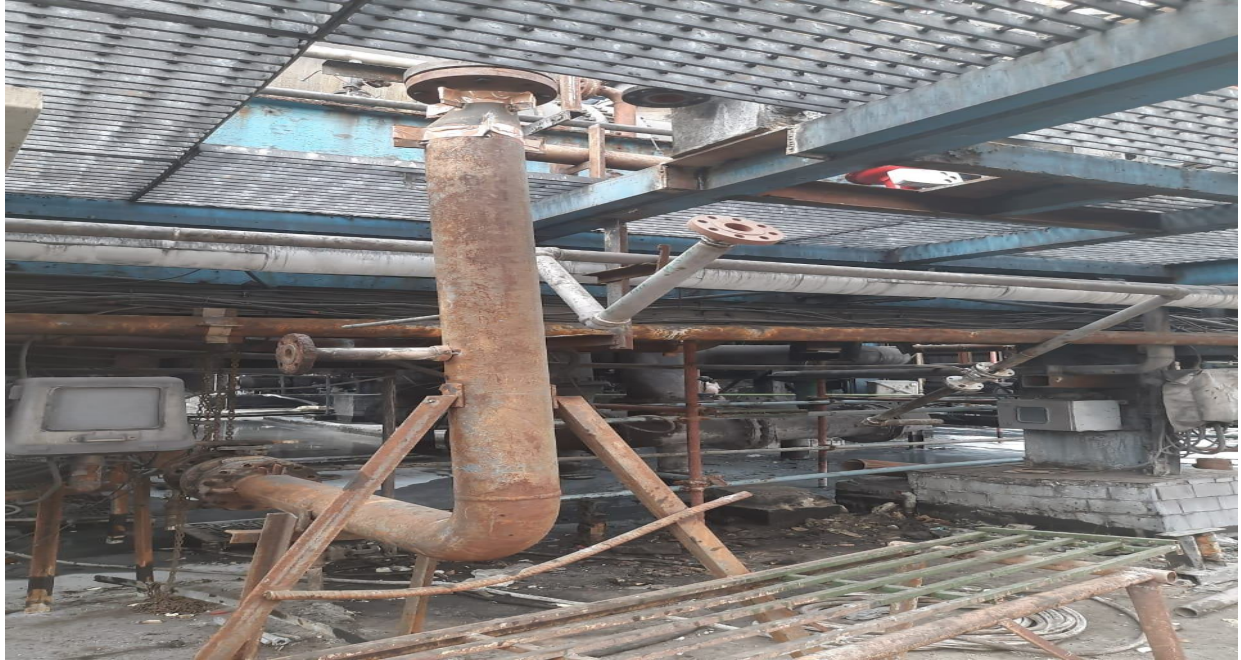
Ammonia Pre Heater elevation: Ammonia pre heater was elevated from ground floor to a height of 3 mtr for collection of condensate which was earlier drained to storm water drain.

Ammonia line inlet fitting under progress.

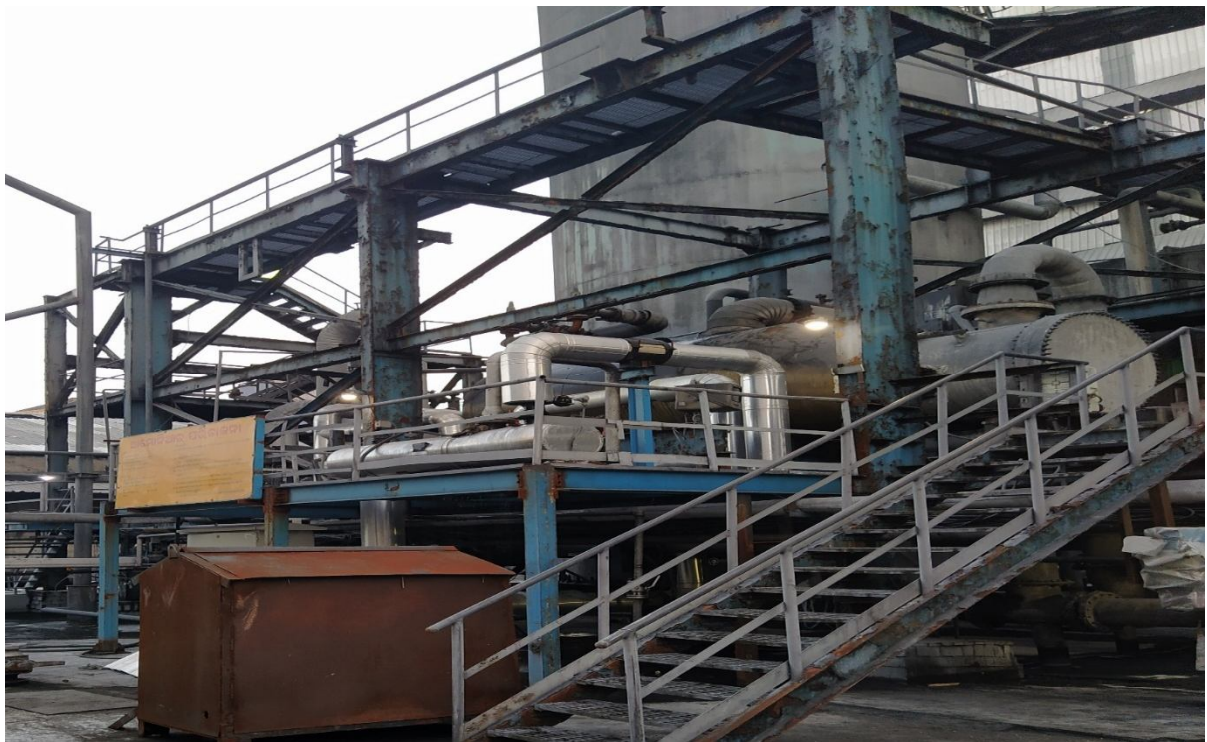
Ammonia preheater elevated.

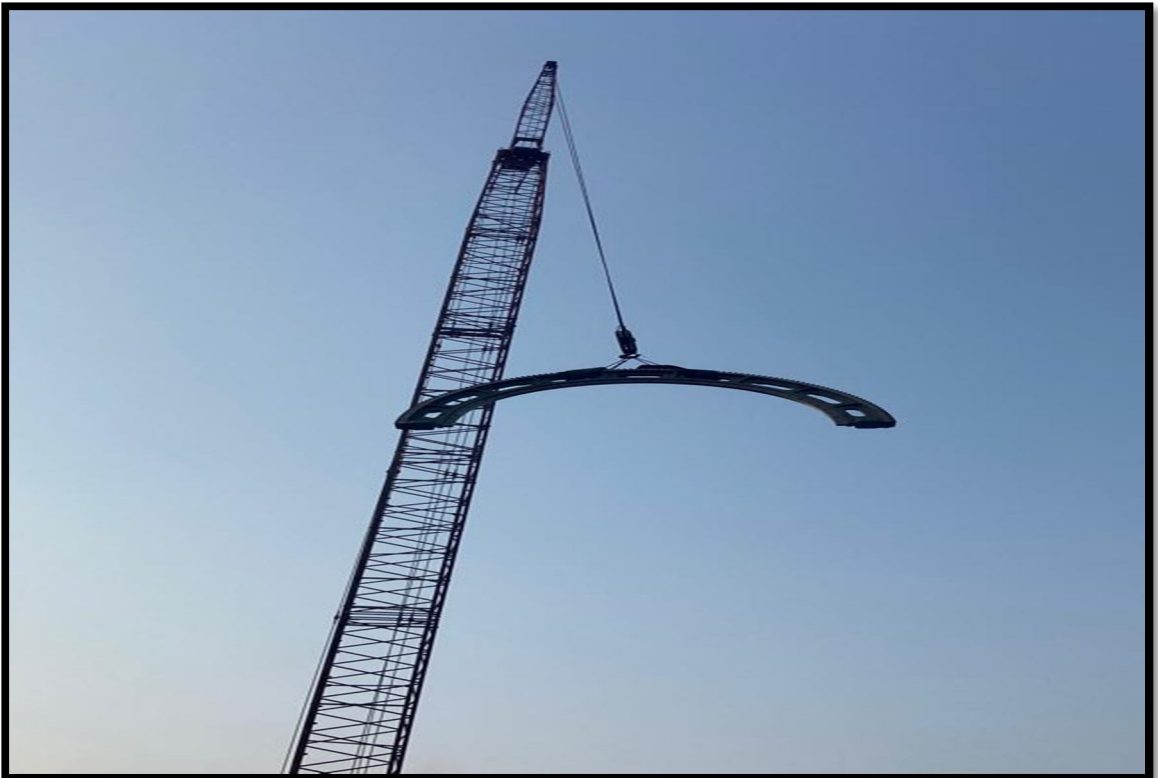
Existing girth gear dismantled.

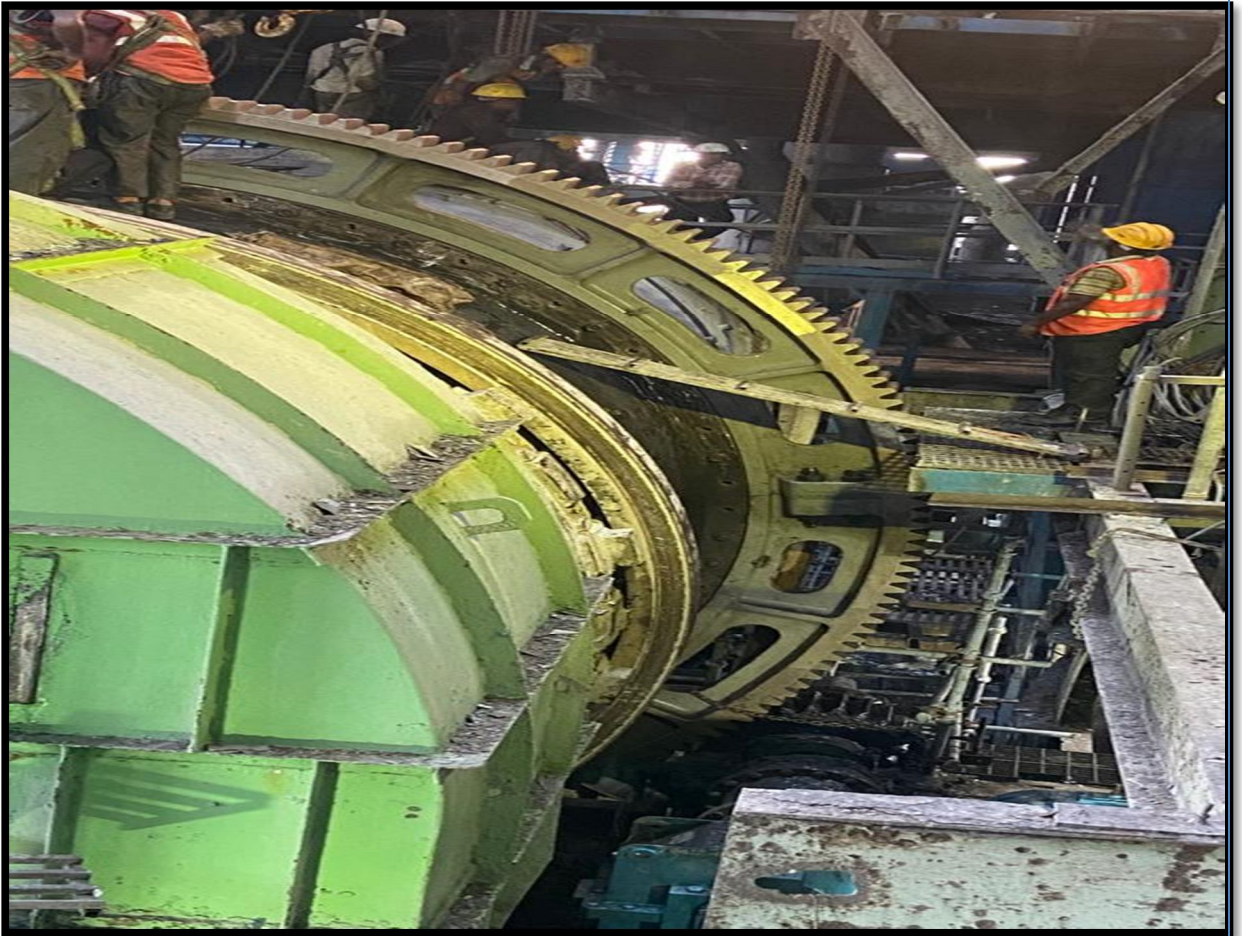
New Girth Gear Erection

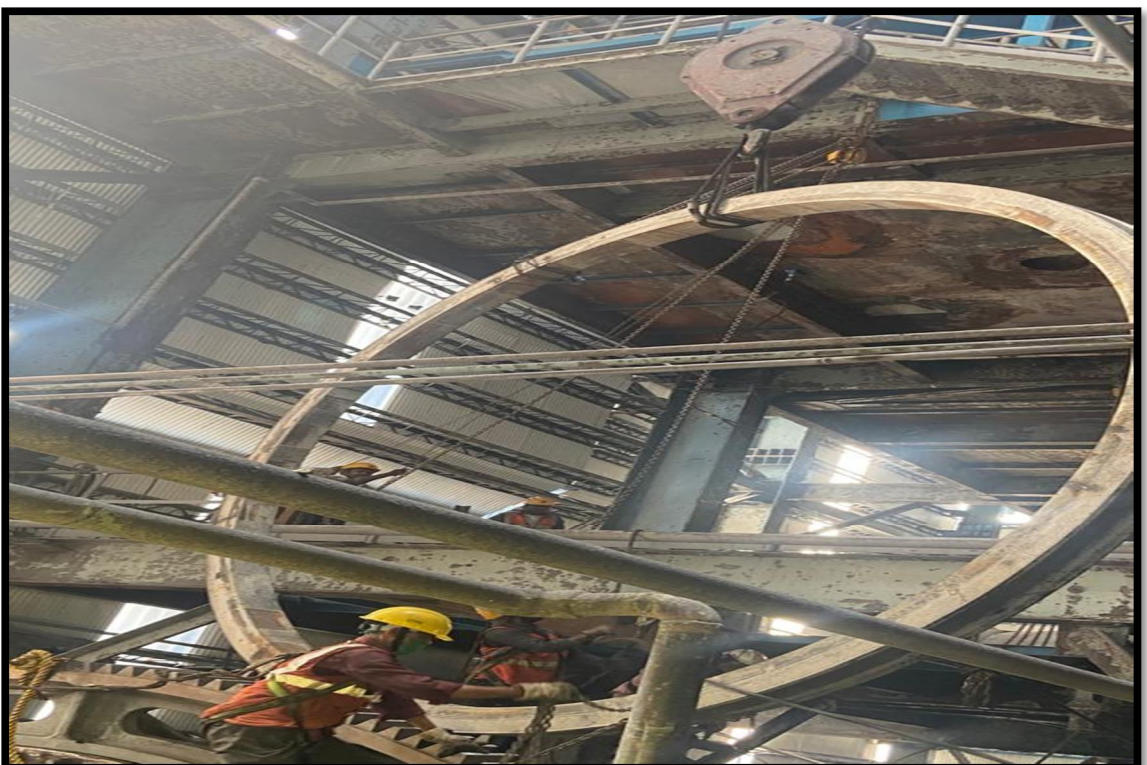
Plain riding ring existing dismantling
