ATR REPORT-2021

**INDIAN FARMERS FERTILISERS CO OPERATIVE LTD.
PARADEEP UNIT**

ATR REPORT: 2021

DAP PLANT

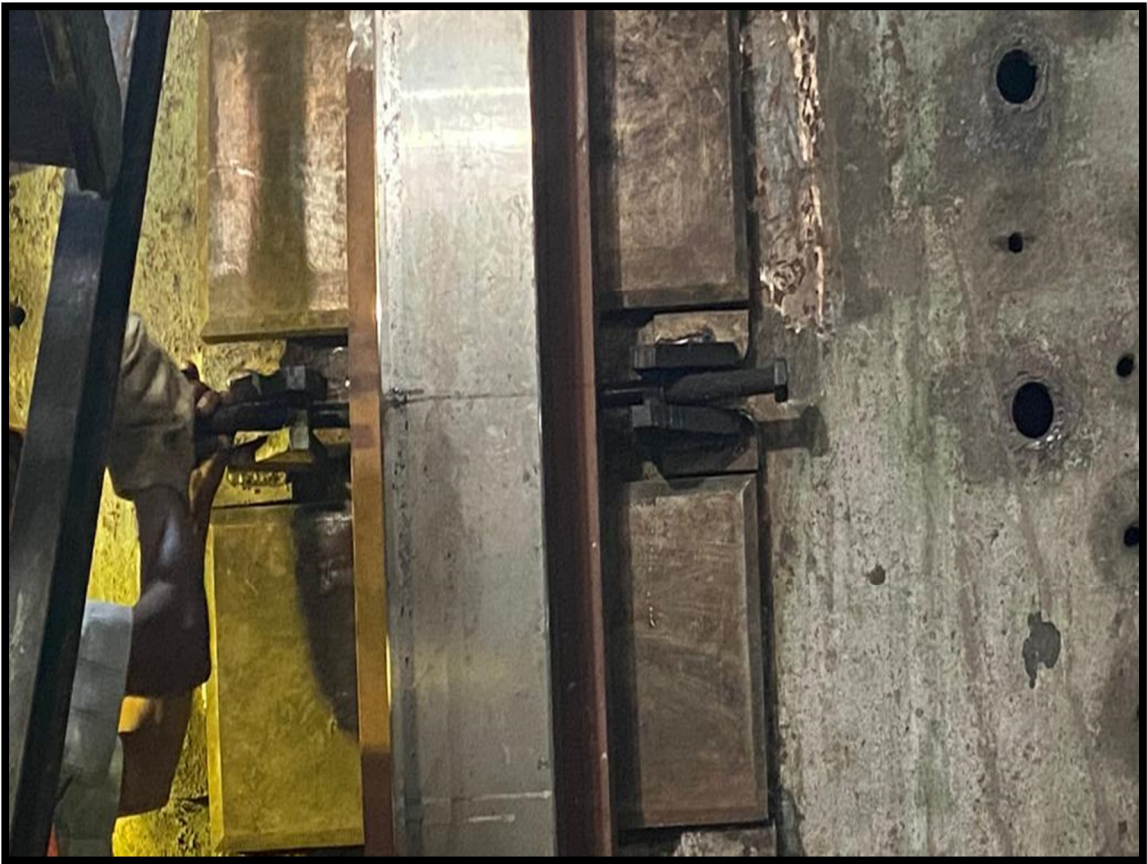
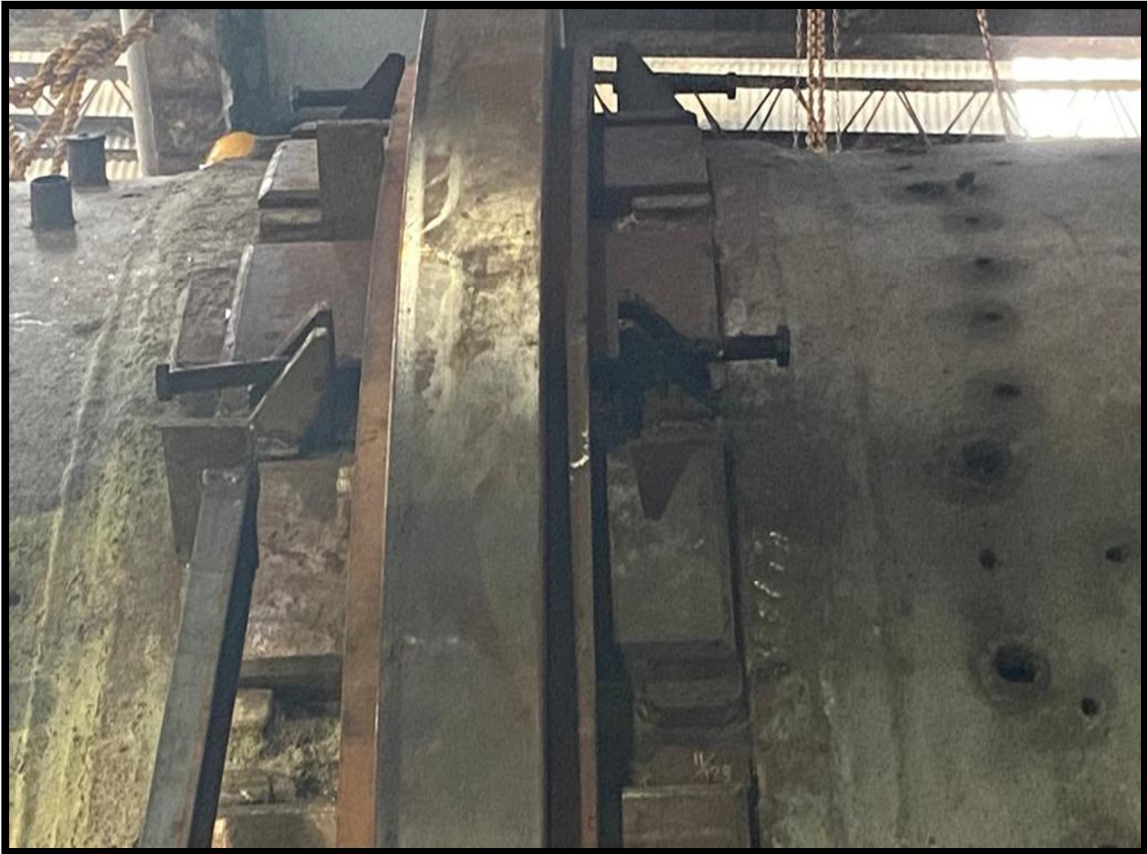
Plain riding ring new erection with chair pad

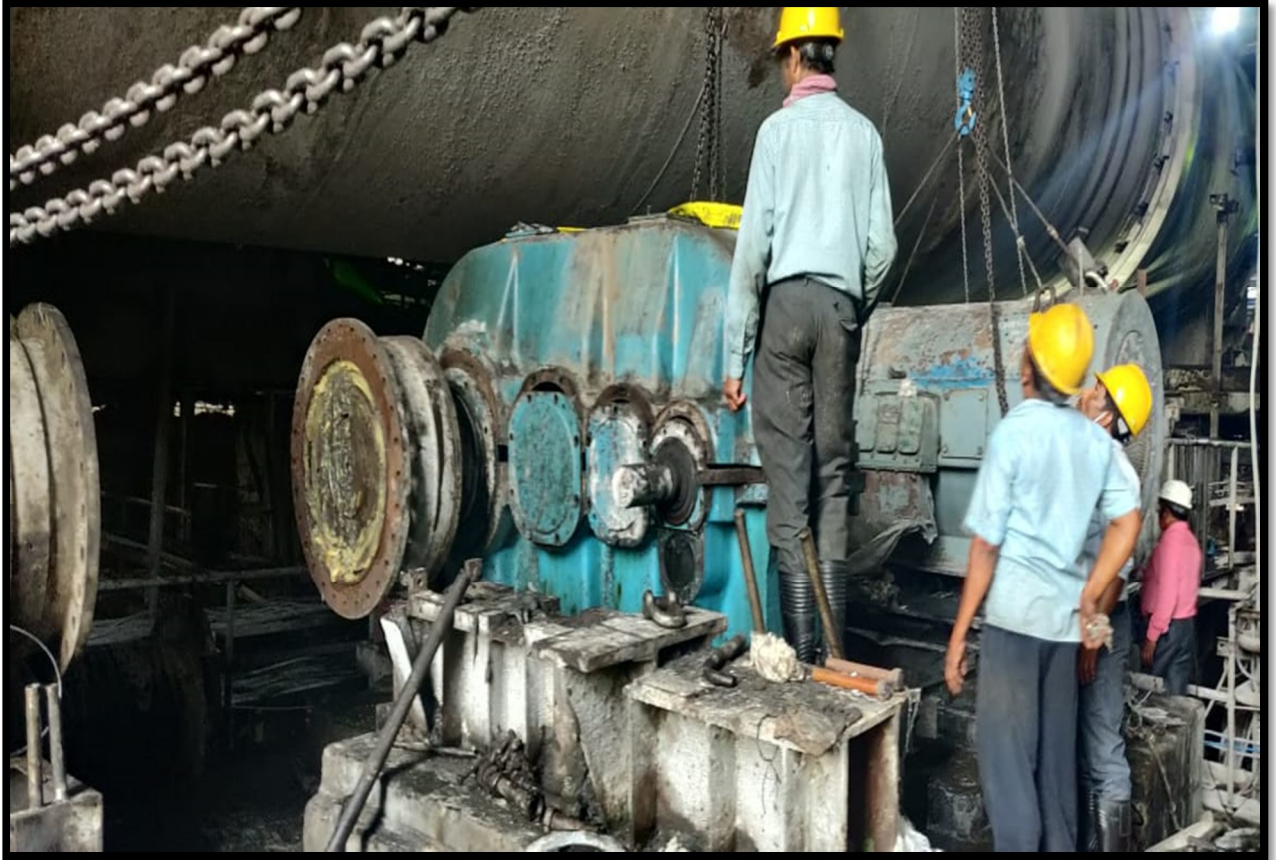
Dryer torque tube dismantling and motor alignment

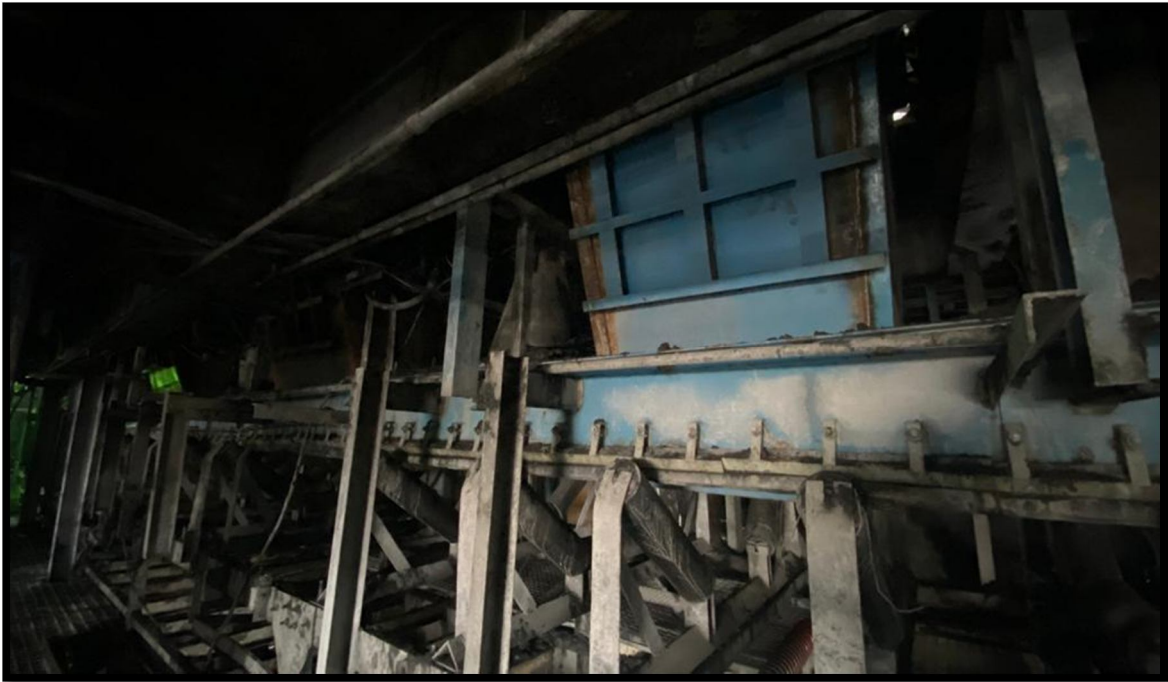
Chainmill hopper

1. All chain mill casing with rotor replaced with new.
2. All chain mill chute replaced as new.
3. All accessories like plumber block, anti-vibration pad, liner, etc. replaced as new.

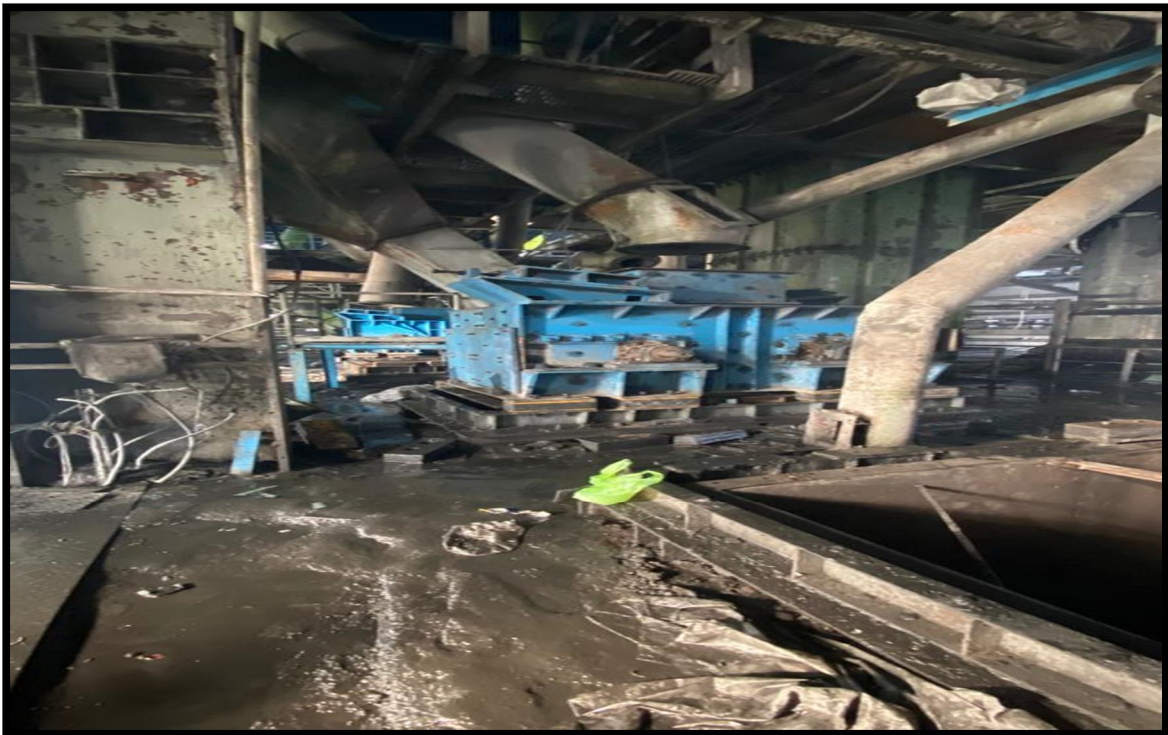
Chainmill erection

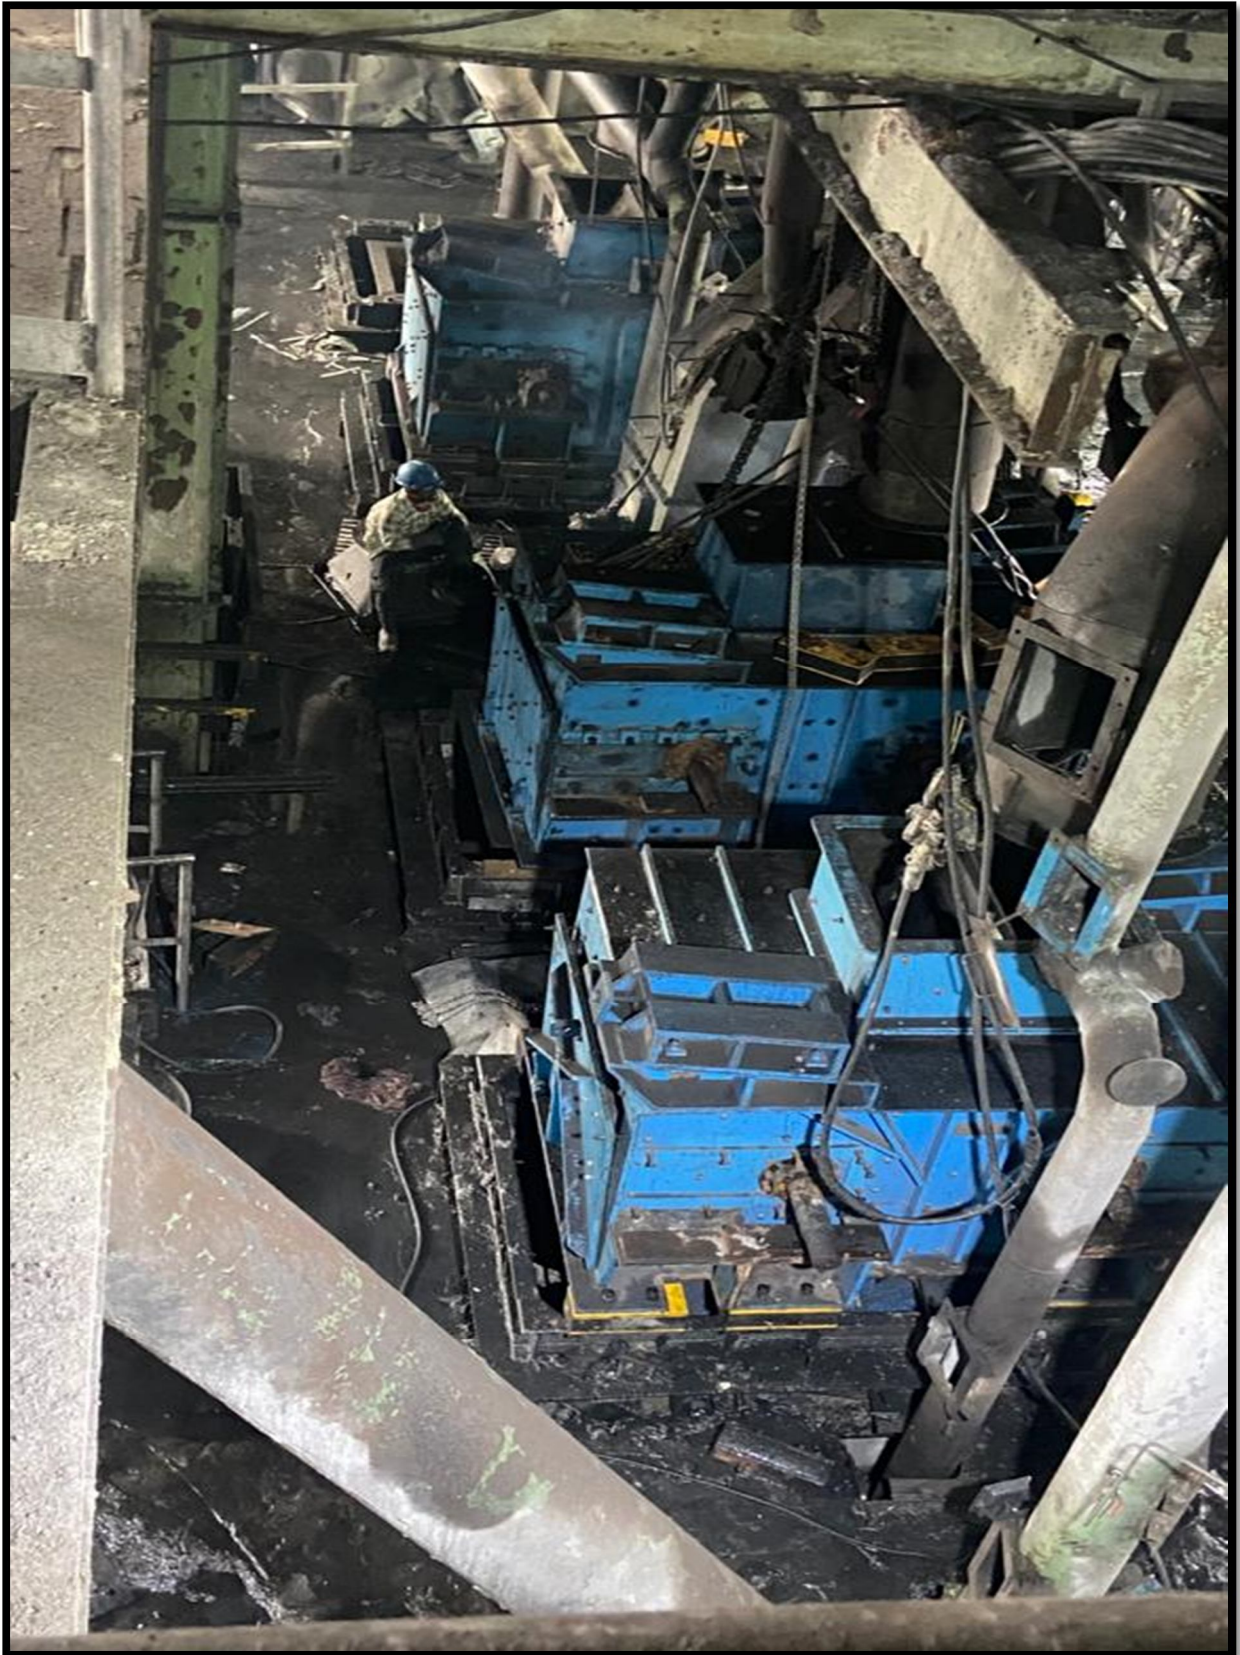
Chainmill Erection

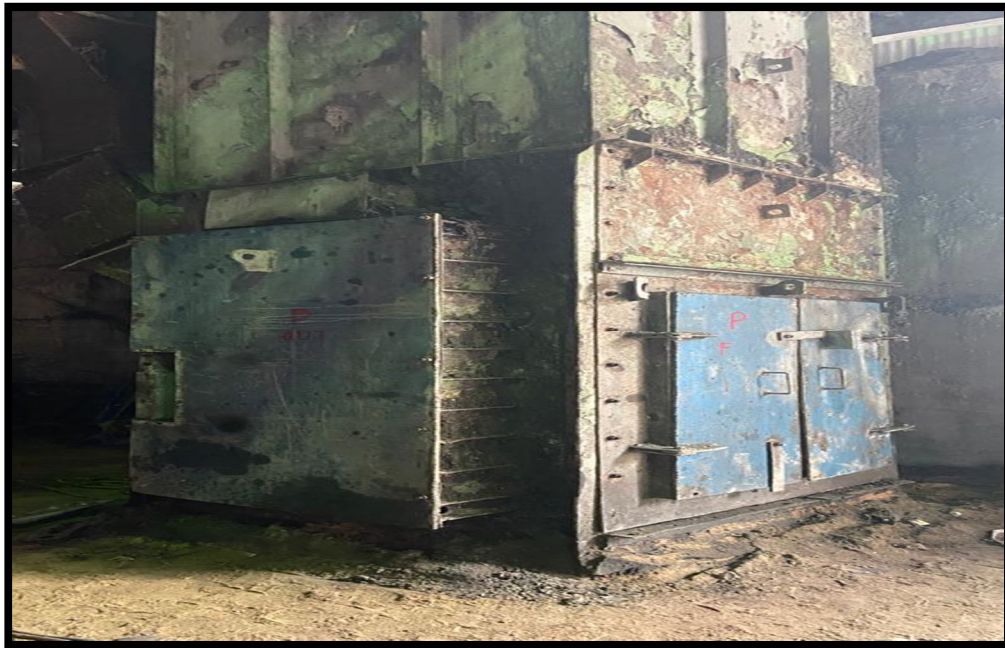
Product Elevator boot area damaged door replaced

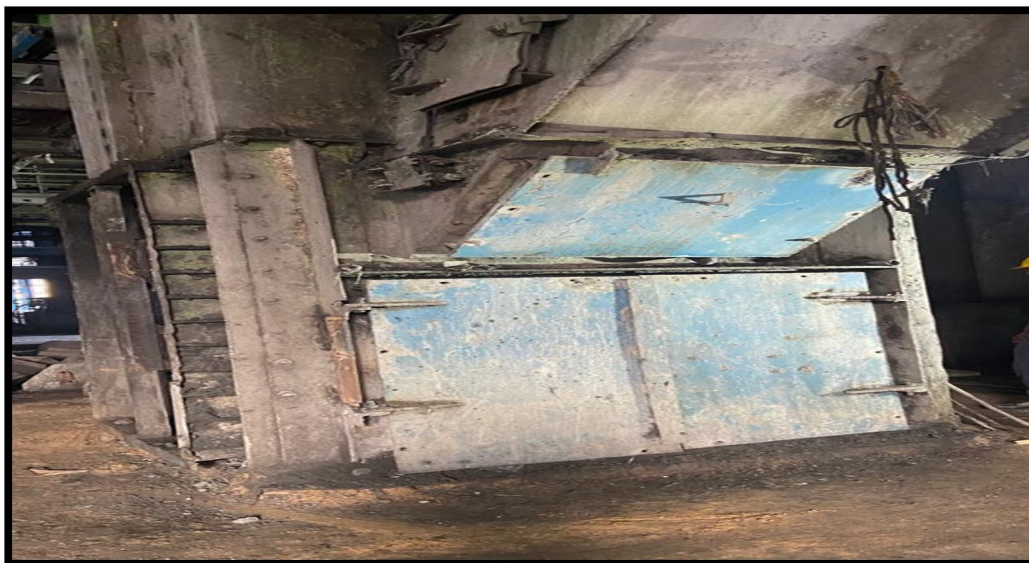
Secondary Elevator damaged door replaced

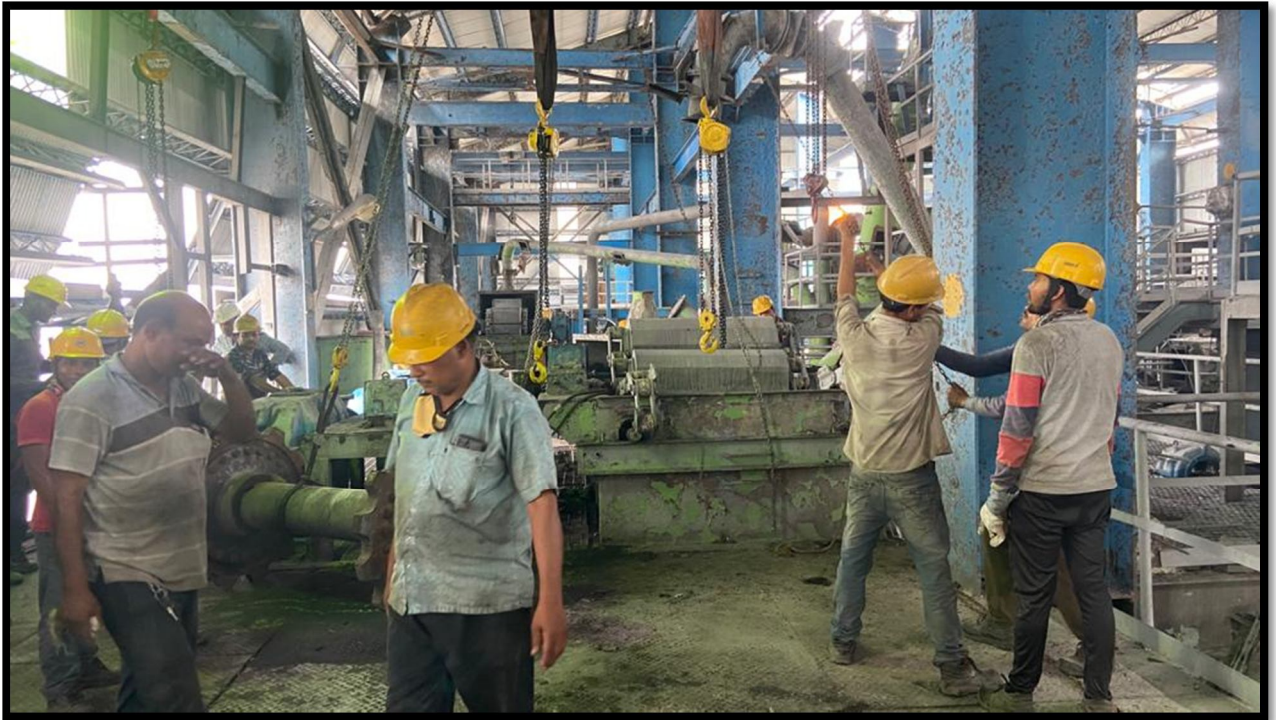
Product Screen Elevator head sprocket replacement

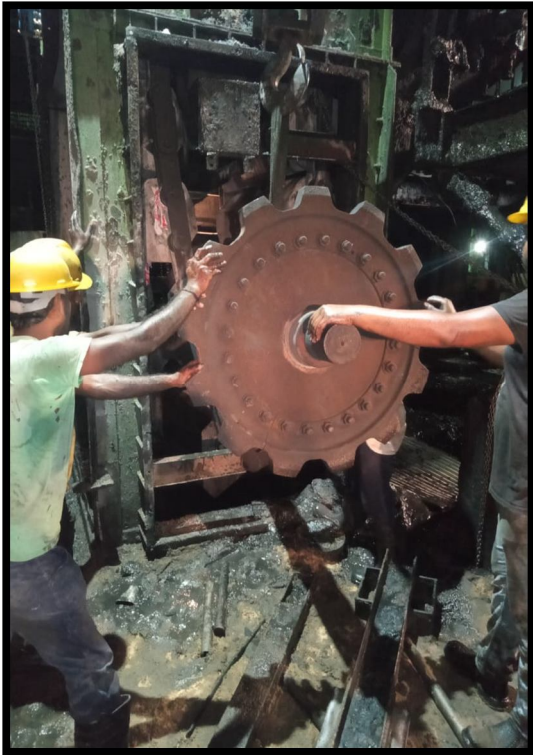
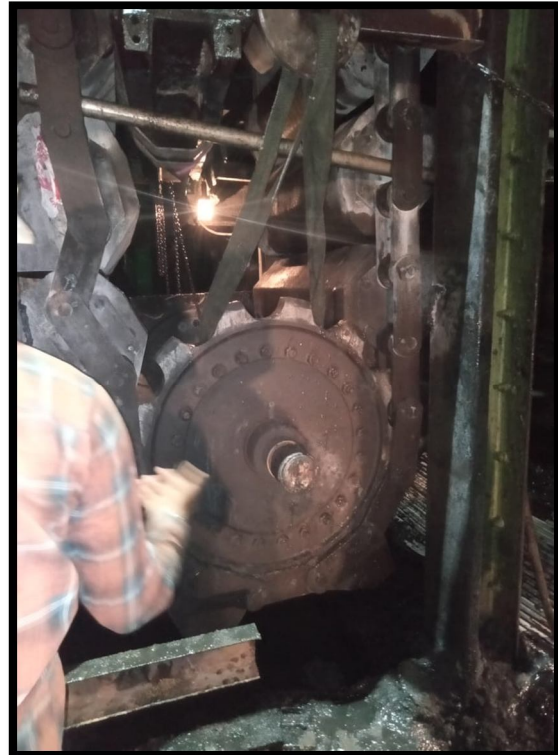
Secondary Elevator tail sprocket replacement

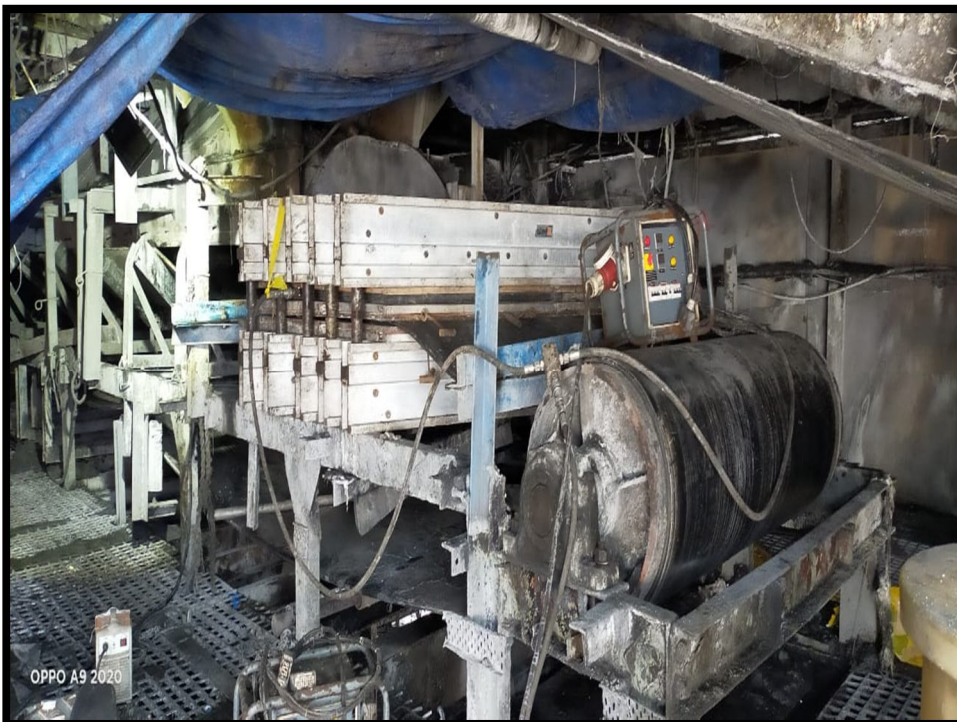
Fines Belt Jointing

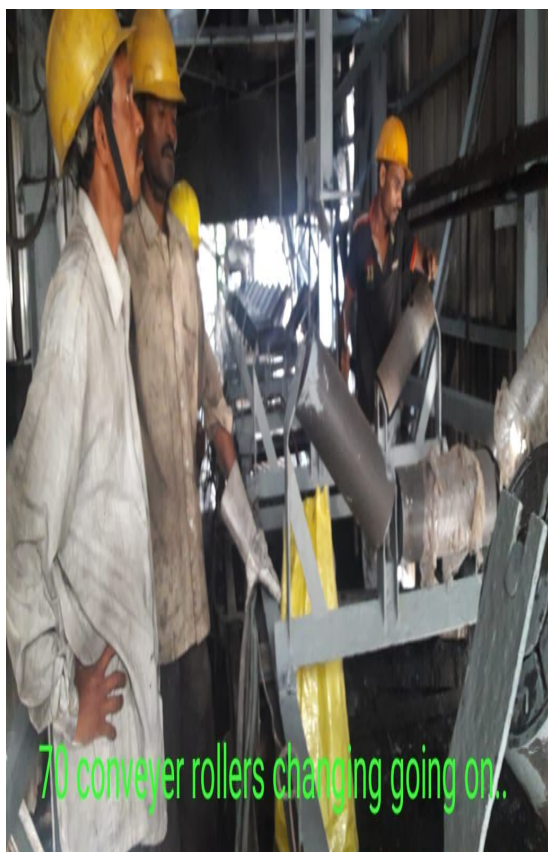
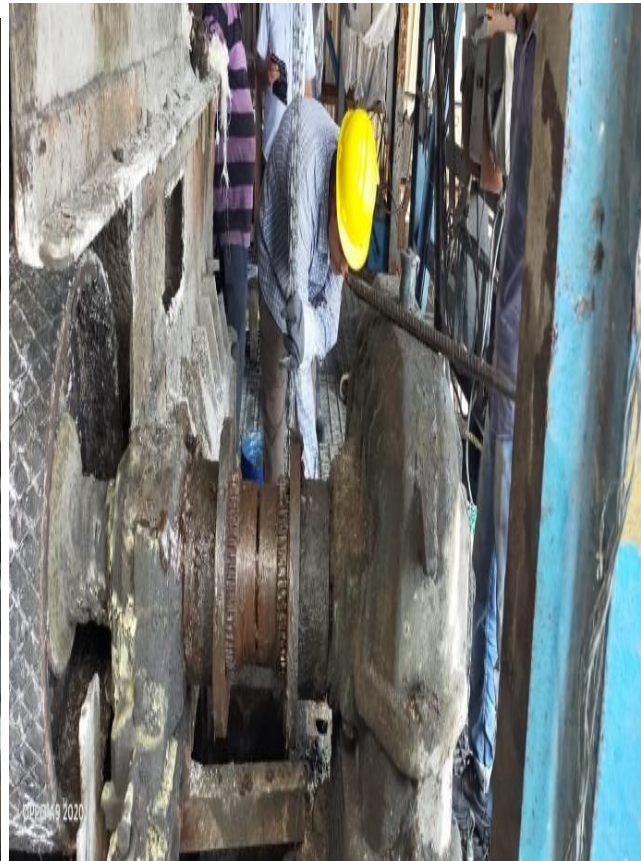
Product Conveyor idler replacement.

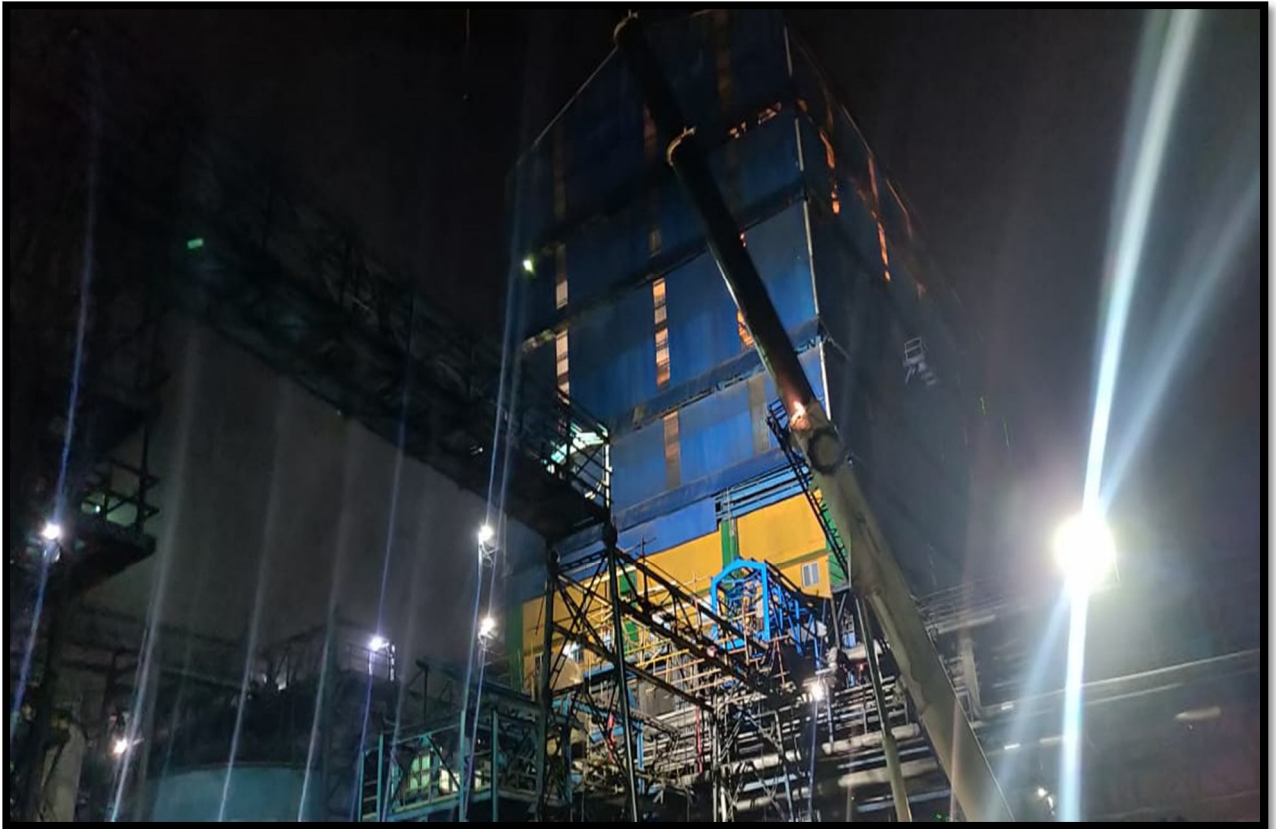
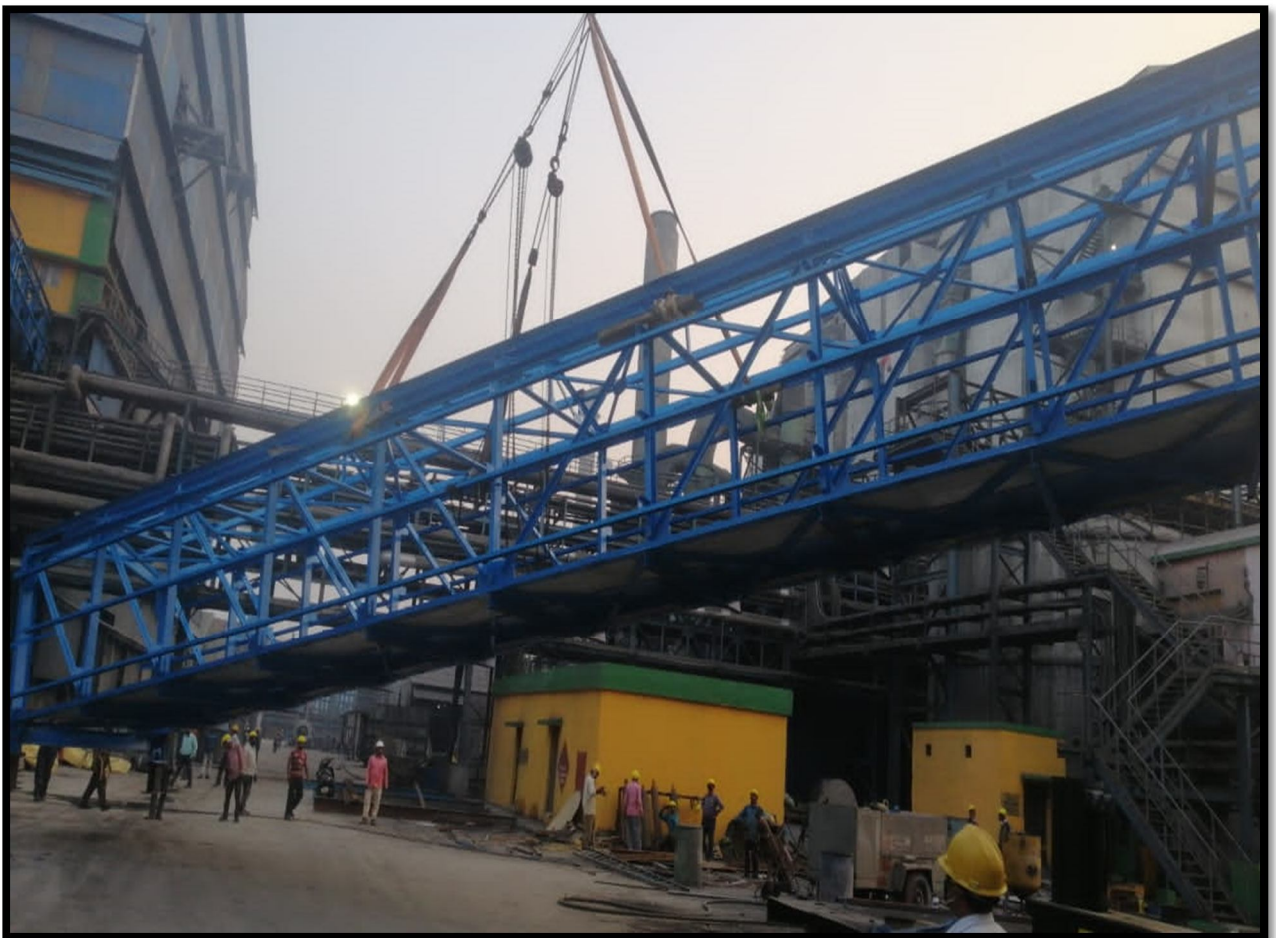
Product Conveyor gallery erection

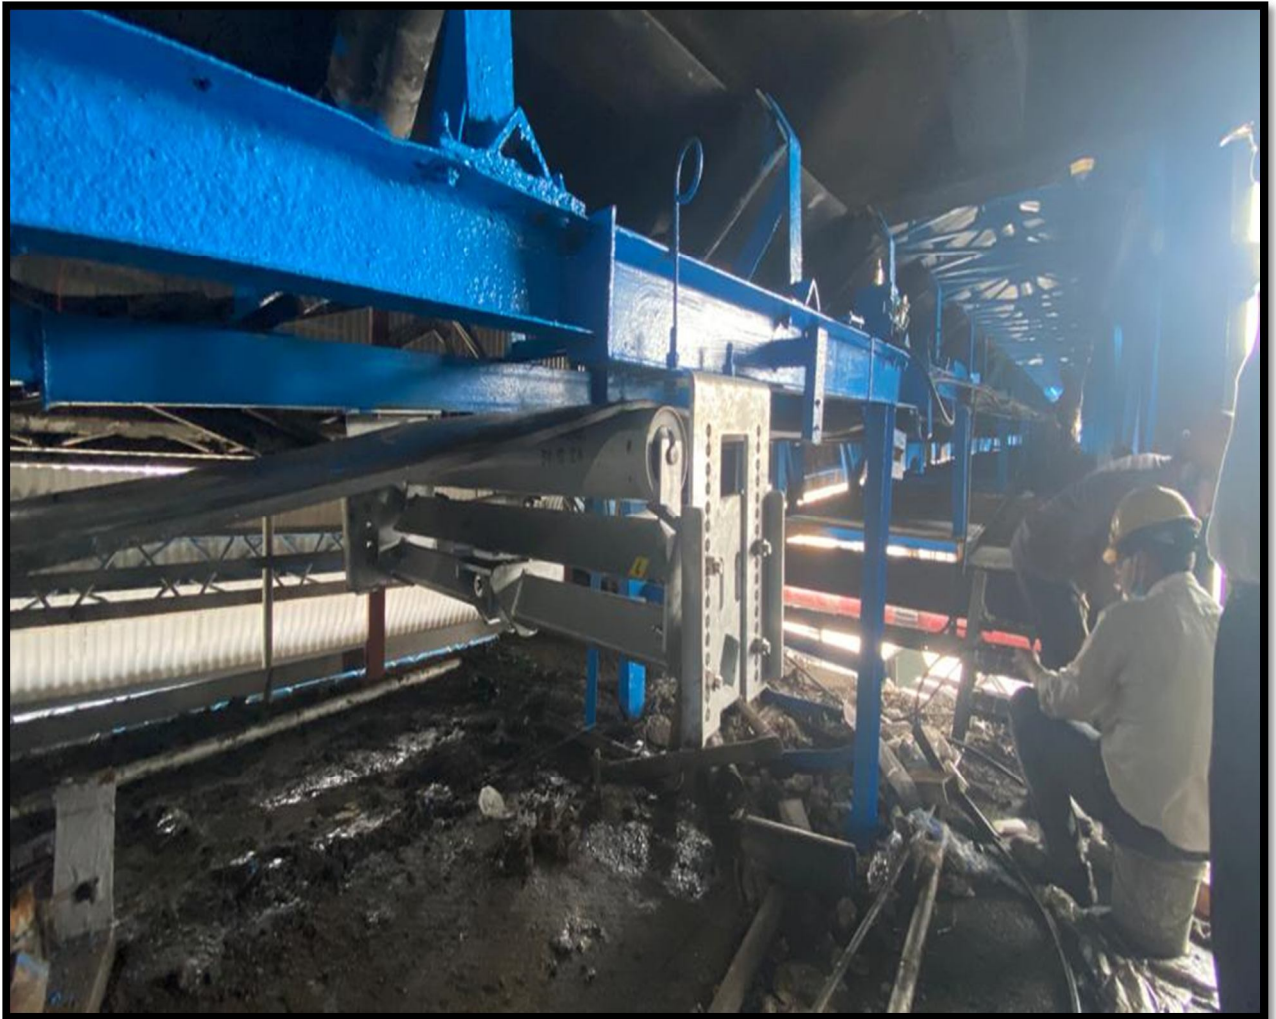
Product Conveyor return belt tracker

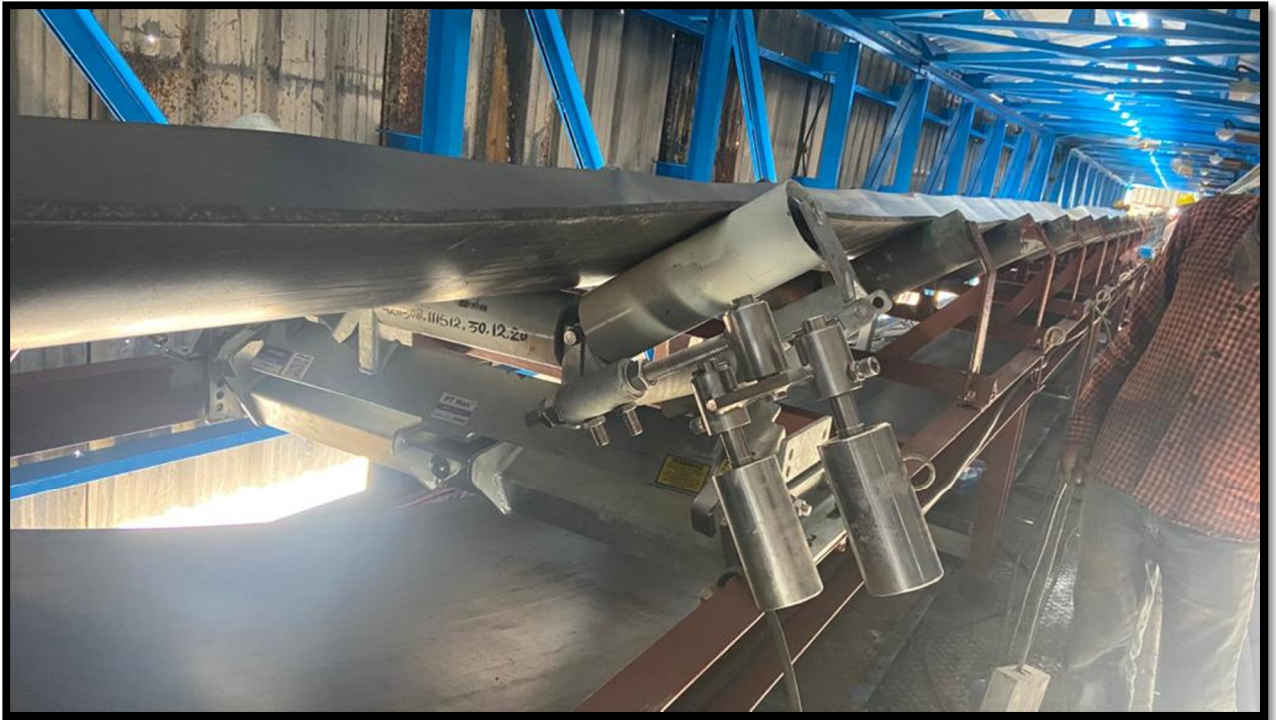
Product Conveyor carrying idler tracker

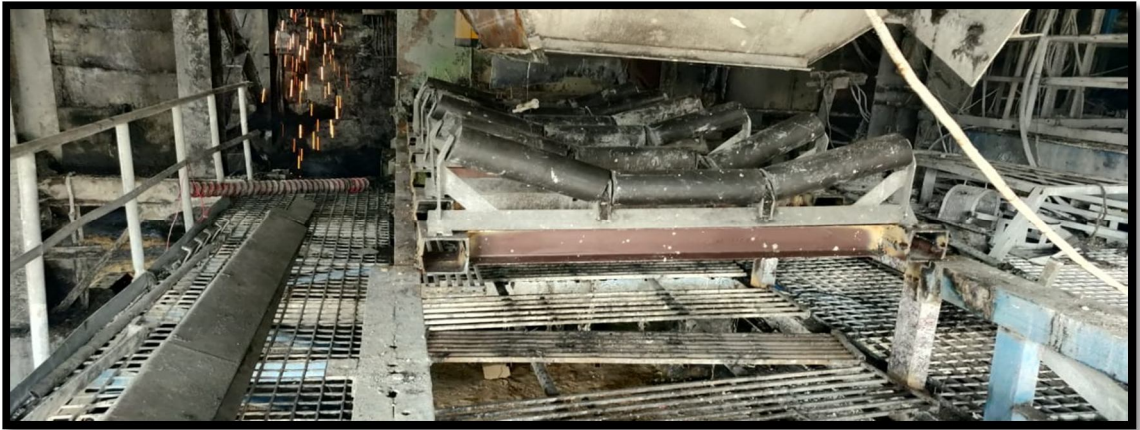
DDC idler bracket and structure

- All damaged carrying & return idlers replaced with HPPE idlers.
- All pulley bearing insp. / lubrication done.
- Damaged carrying & return idler with frame replaced & tail pulley base structure repaired & leveled its screw take up overhauled.
- DDC damaged skirt replaced with plain skirt rubber for sealing dust.
- Gear box oil flushed & coupling bolt inspected / replaced.
- Head pulley side scrapper provided to avoid deposition on pulley.
- Conveyor Belt (Endless, joint- hot pre vulcanized) replacement done with new one.
- Conveyor structure and stringer made new.

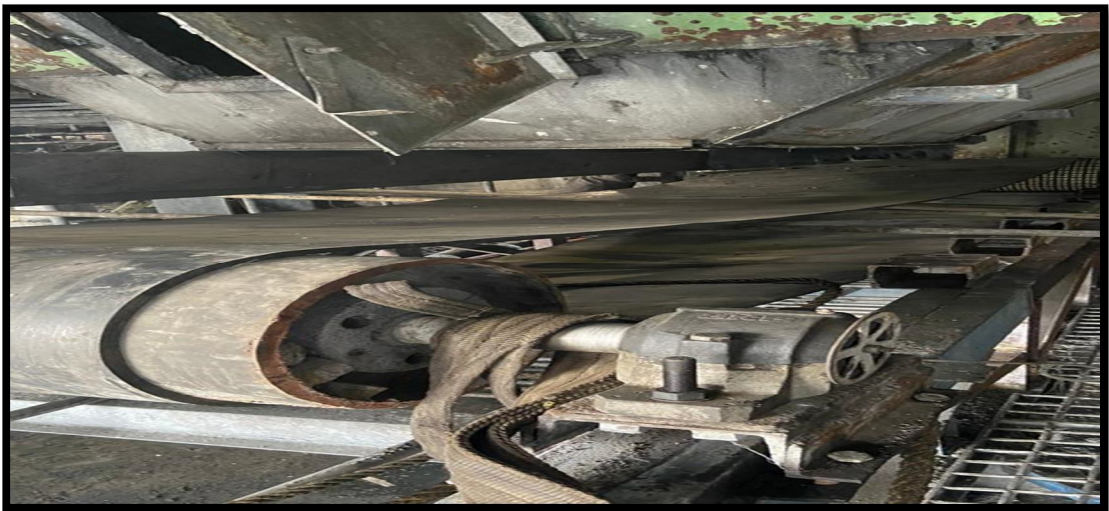
DDC belt

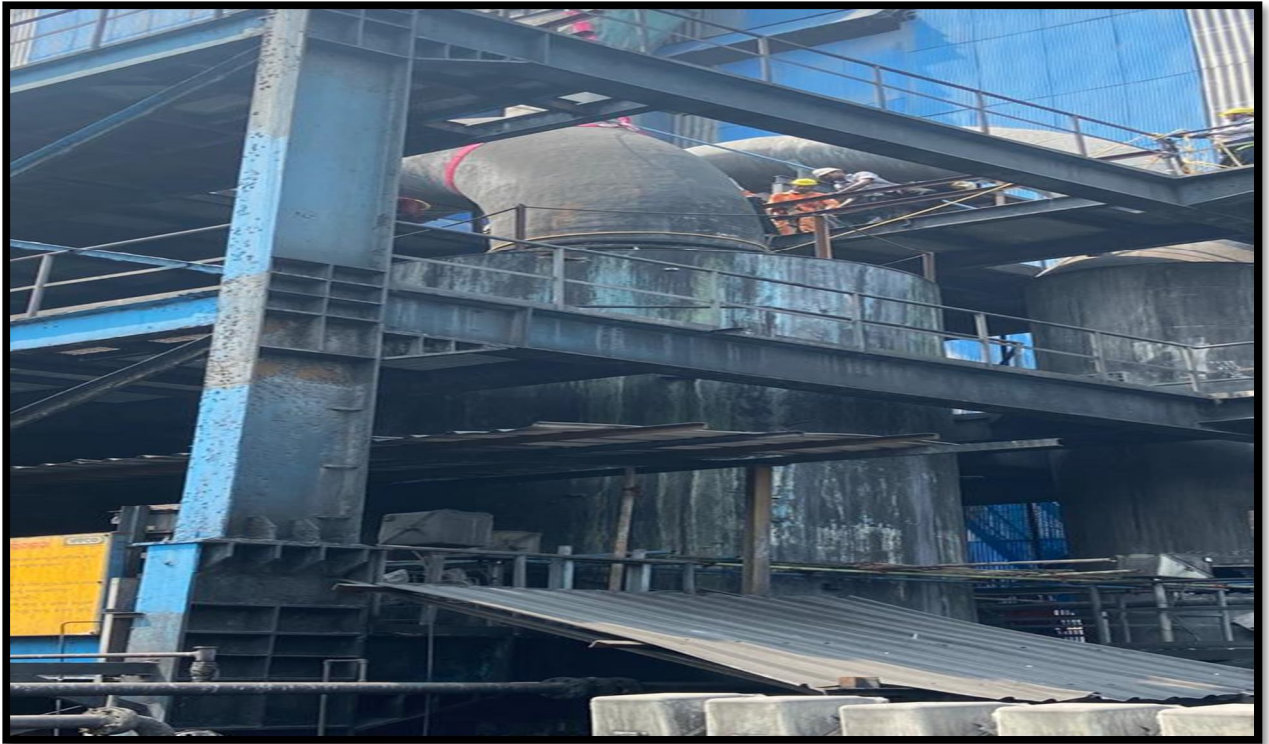
Dismantling and erection of pre scrubber separator shell

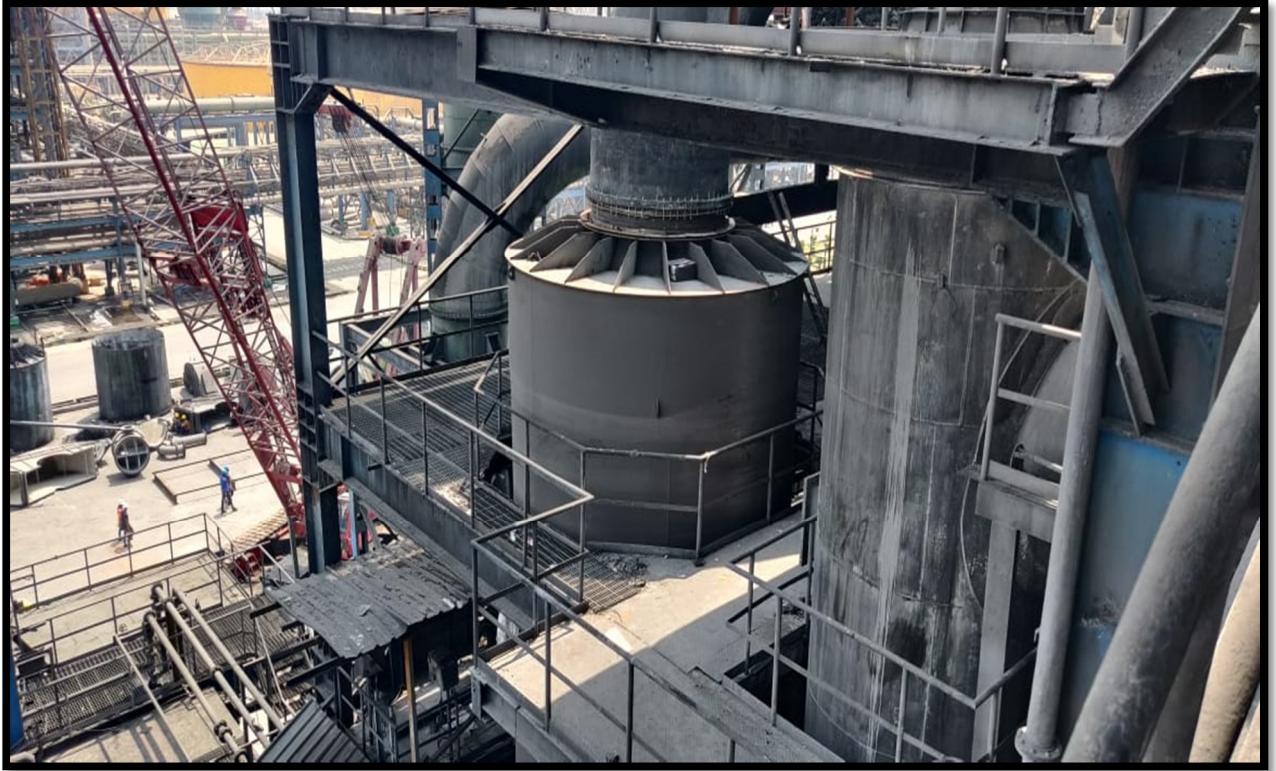
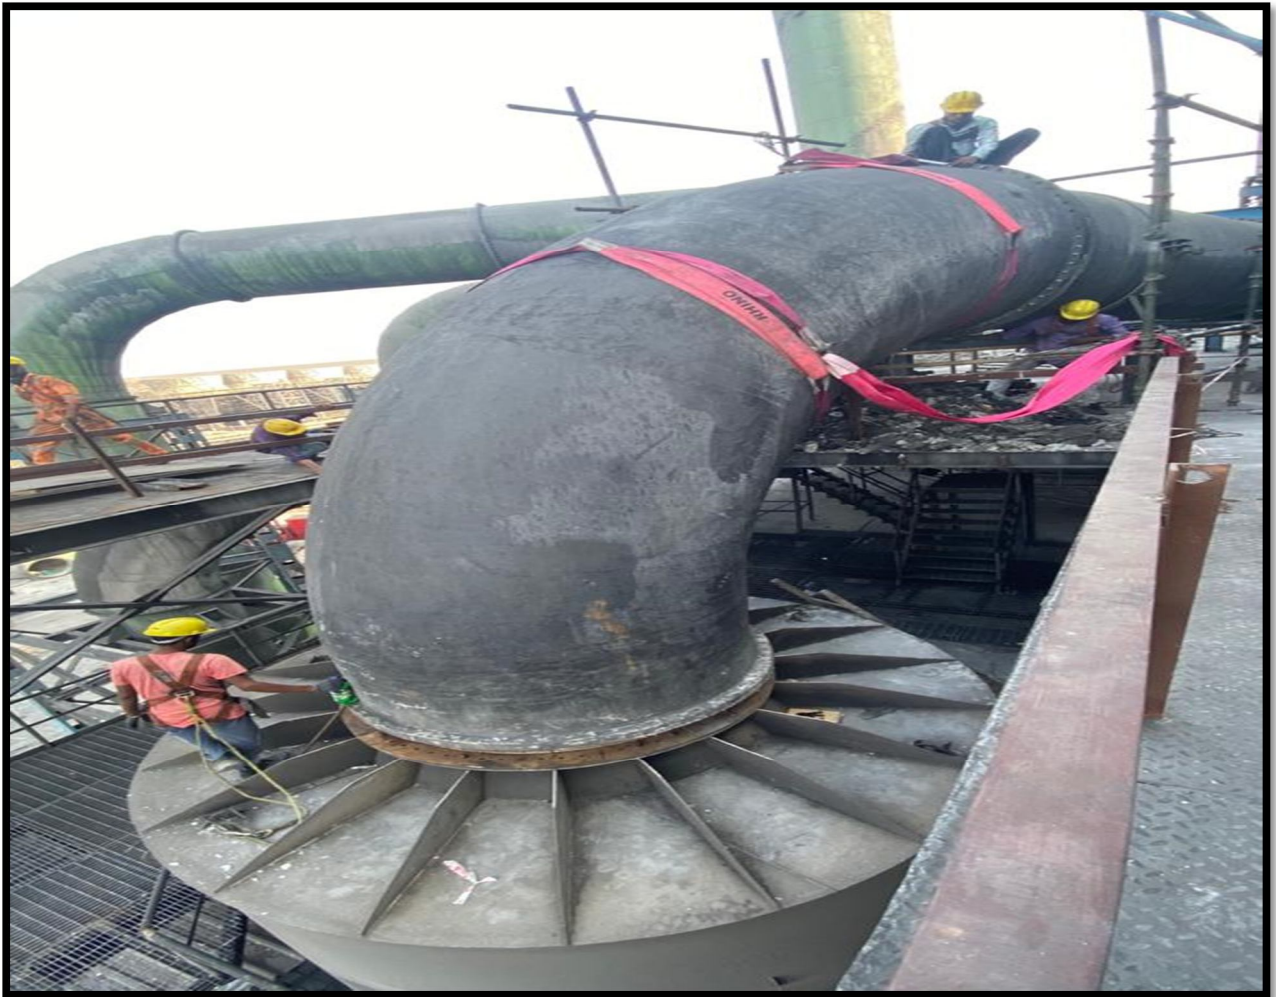
Erection of Pre Scrubber shell

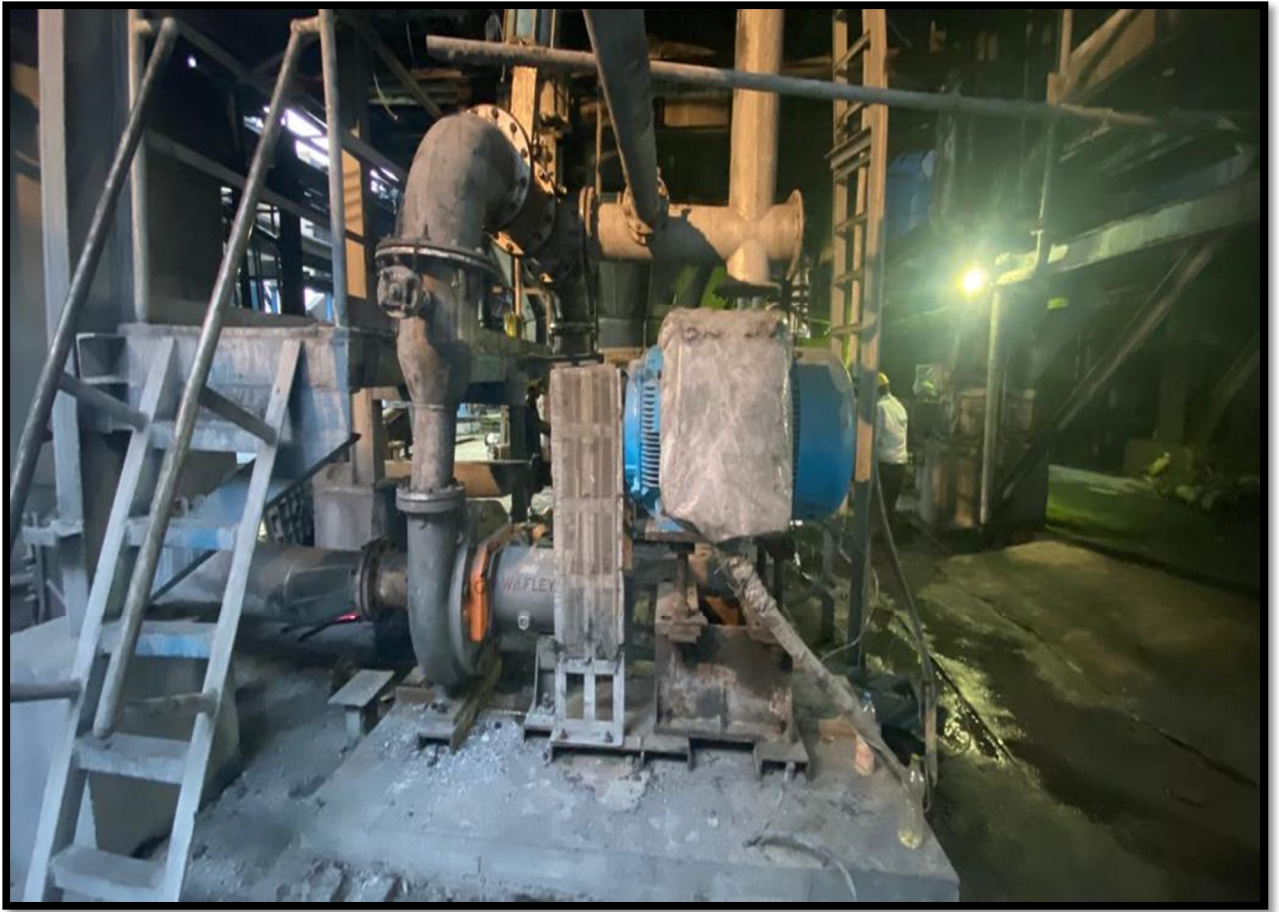
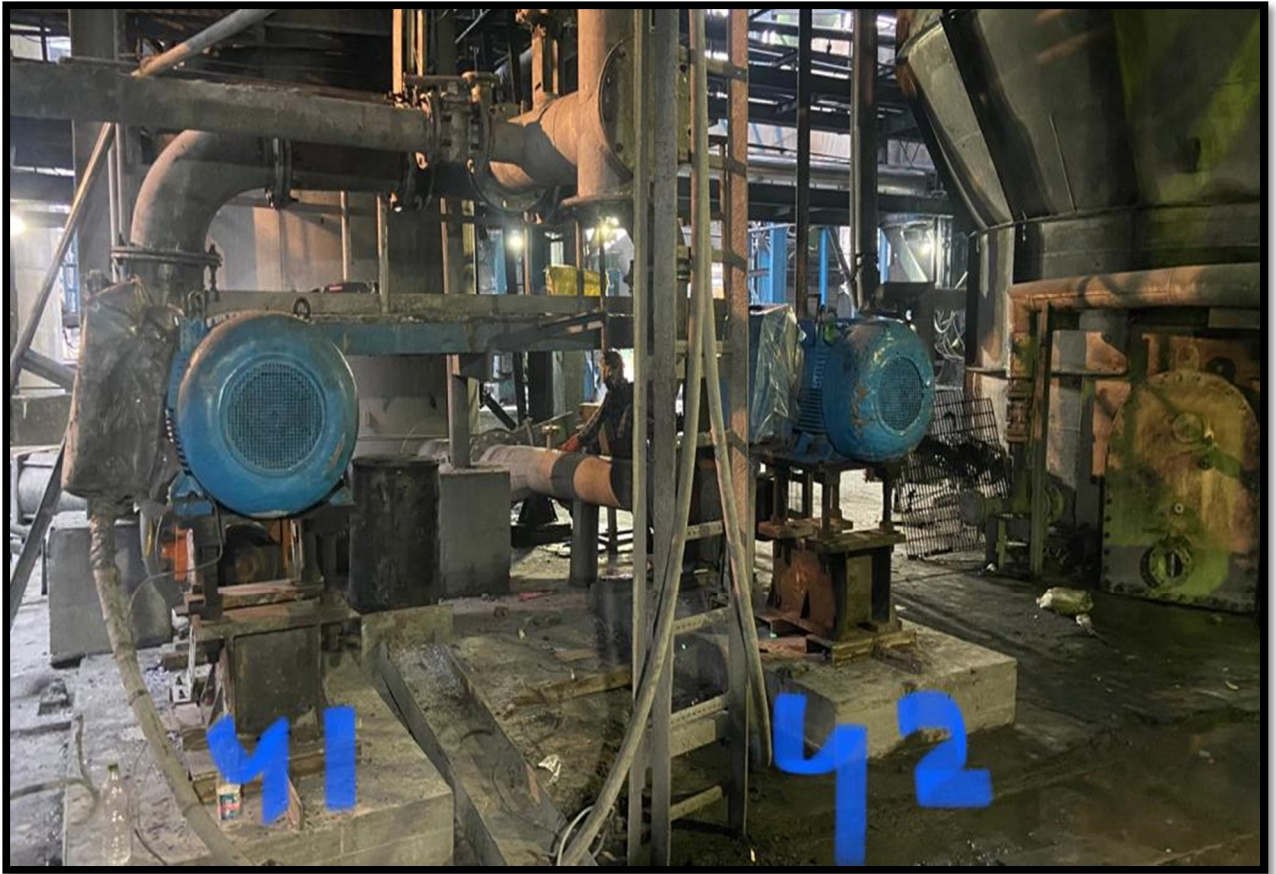
40s new pump replaced and line modification
