ATR REPORT-2021

**INDIAN FARMERS FERTILISERS CO OPERATIVE LTD.
PARADEEP UNIT**

ATR REPORT: 2021

DAP PLANT

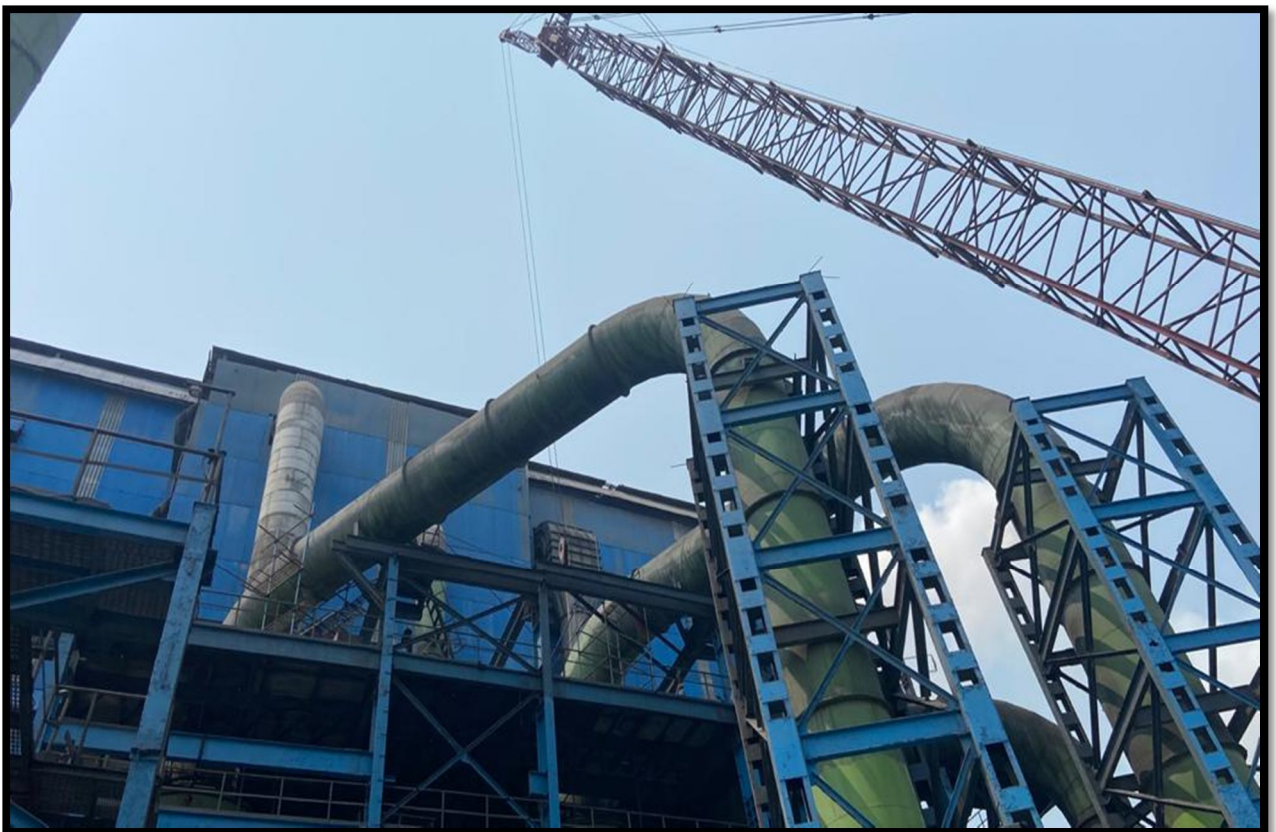
Suction line below replacement

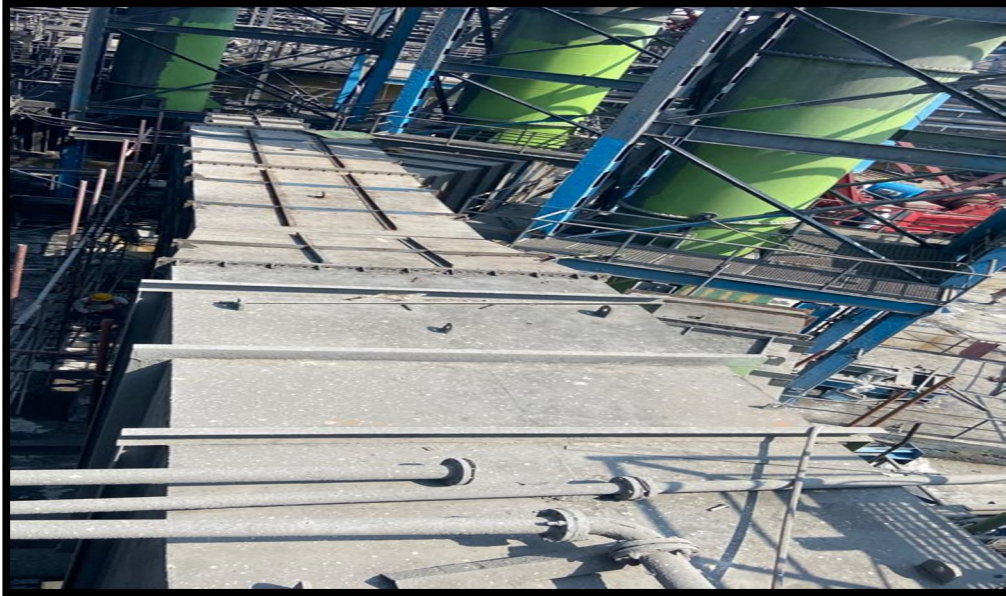
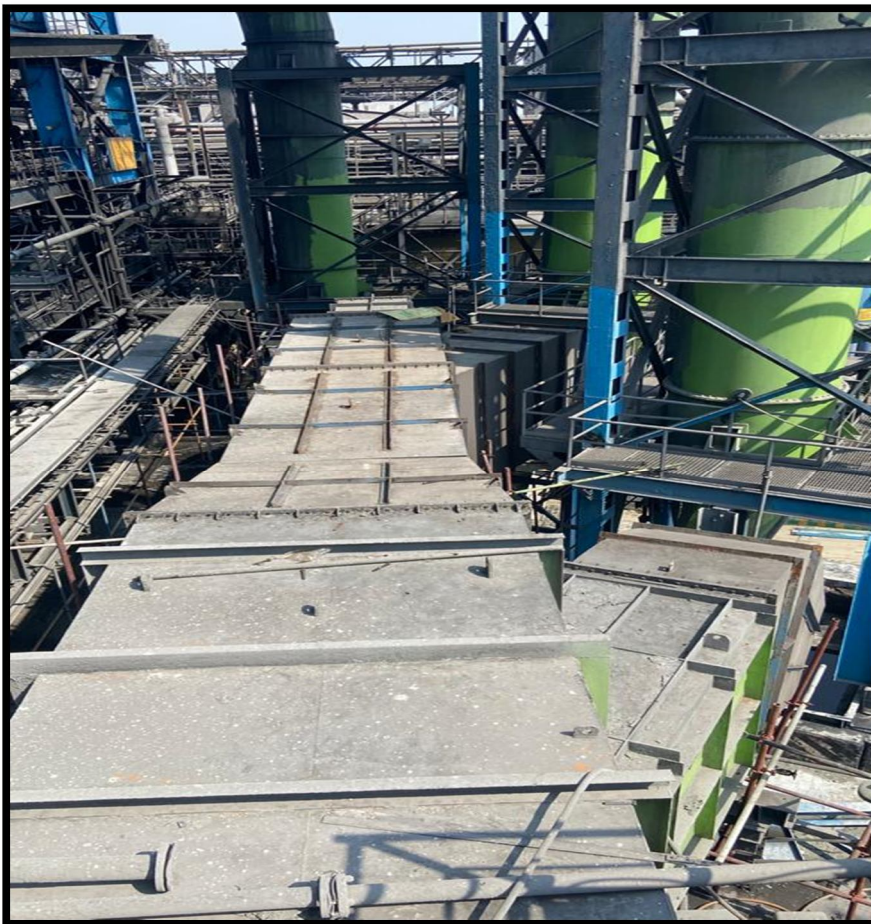
TG Common Duct

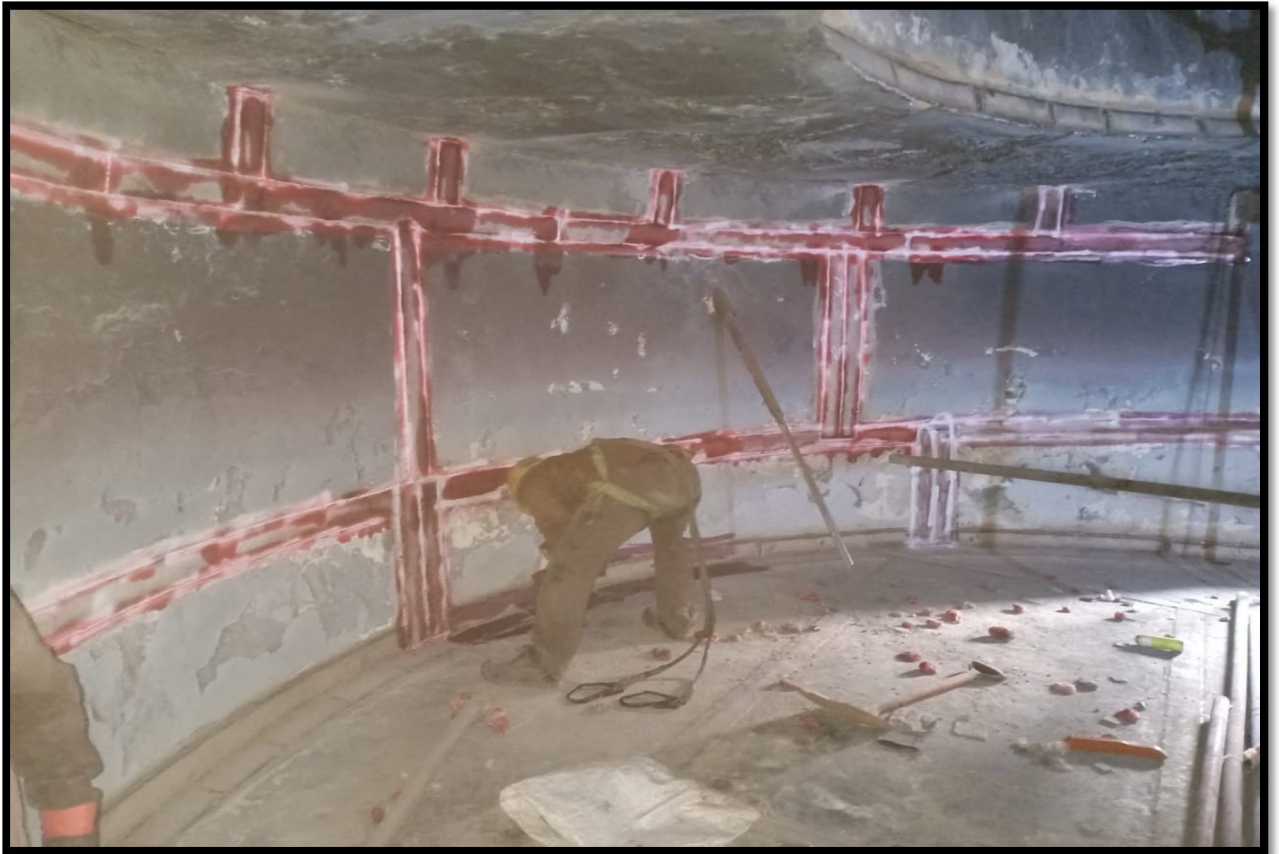
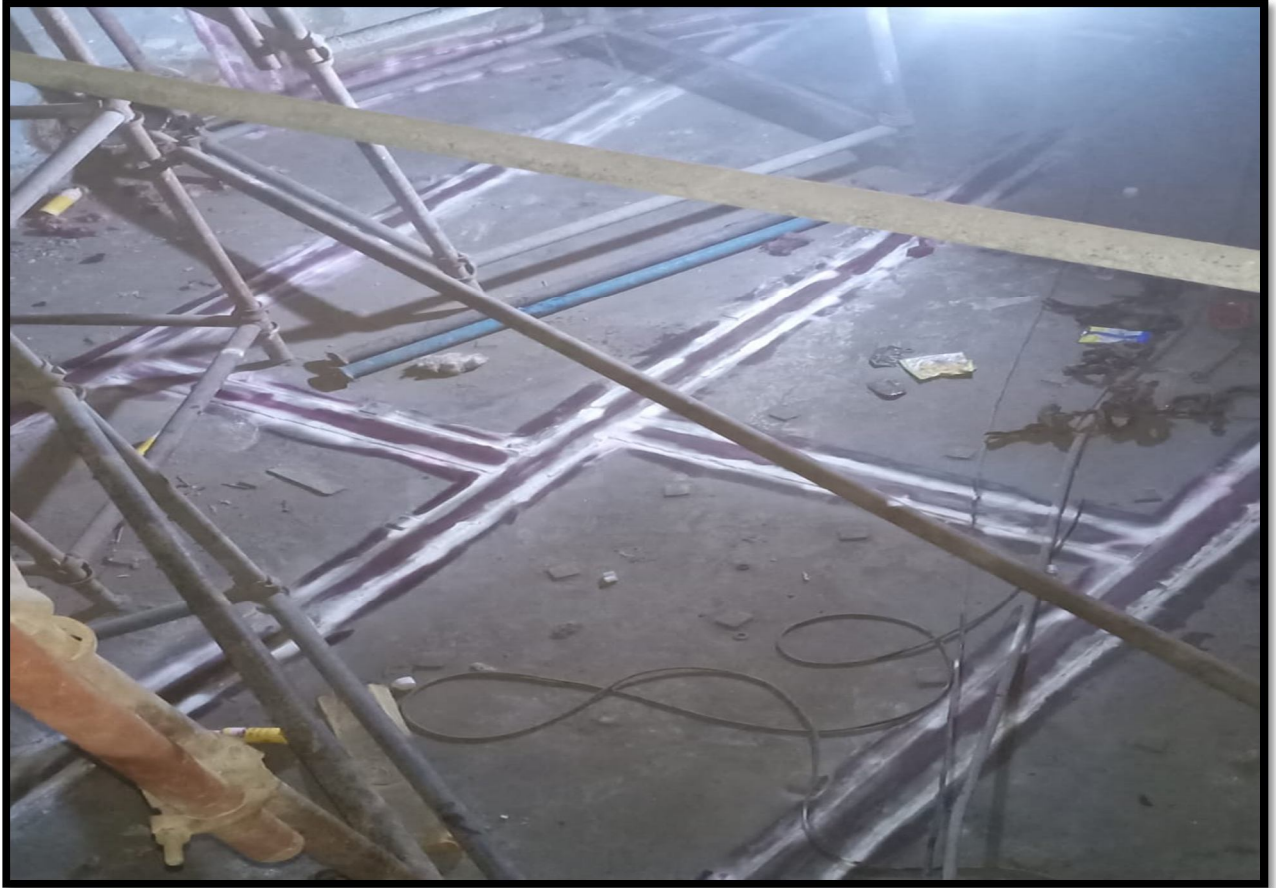
TG stag inside repaired by 316L strip welding.

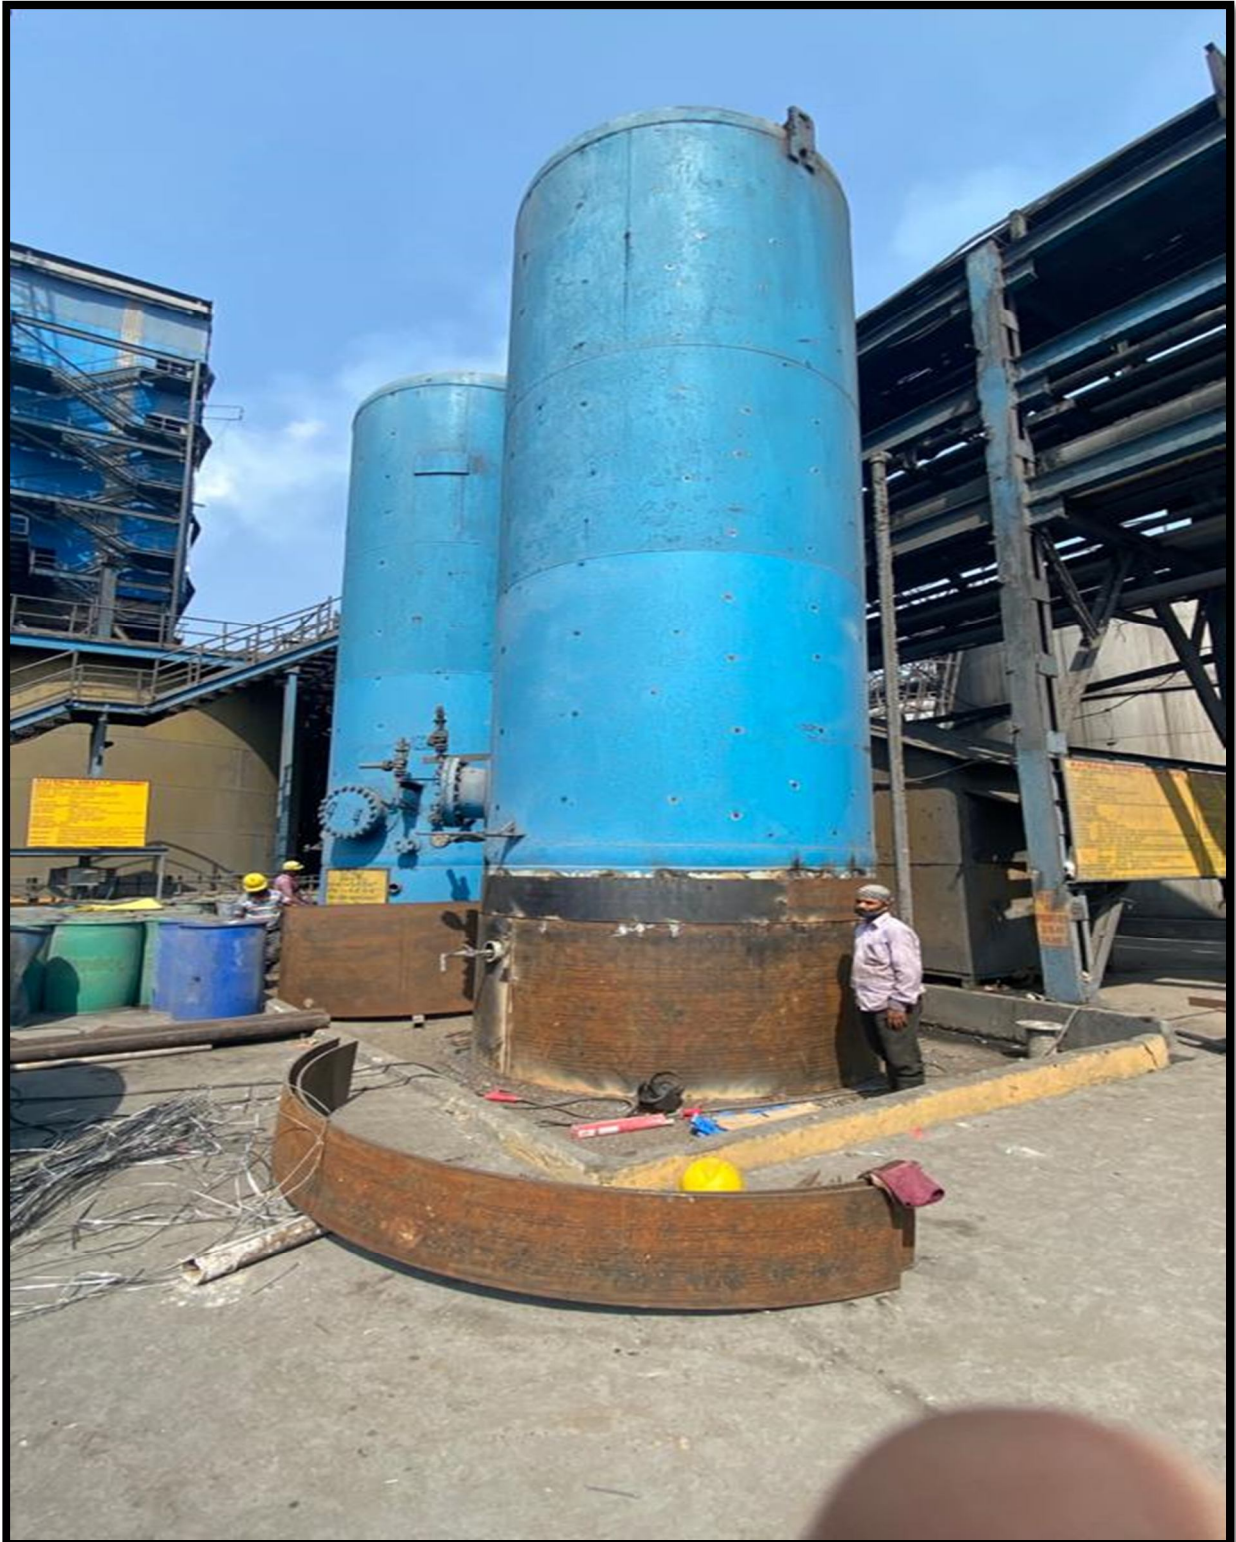
Air Receiver Tank Strengthening

- Air receiver tank base civil foundation done, pipe line modification and painting with hydro test done.

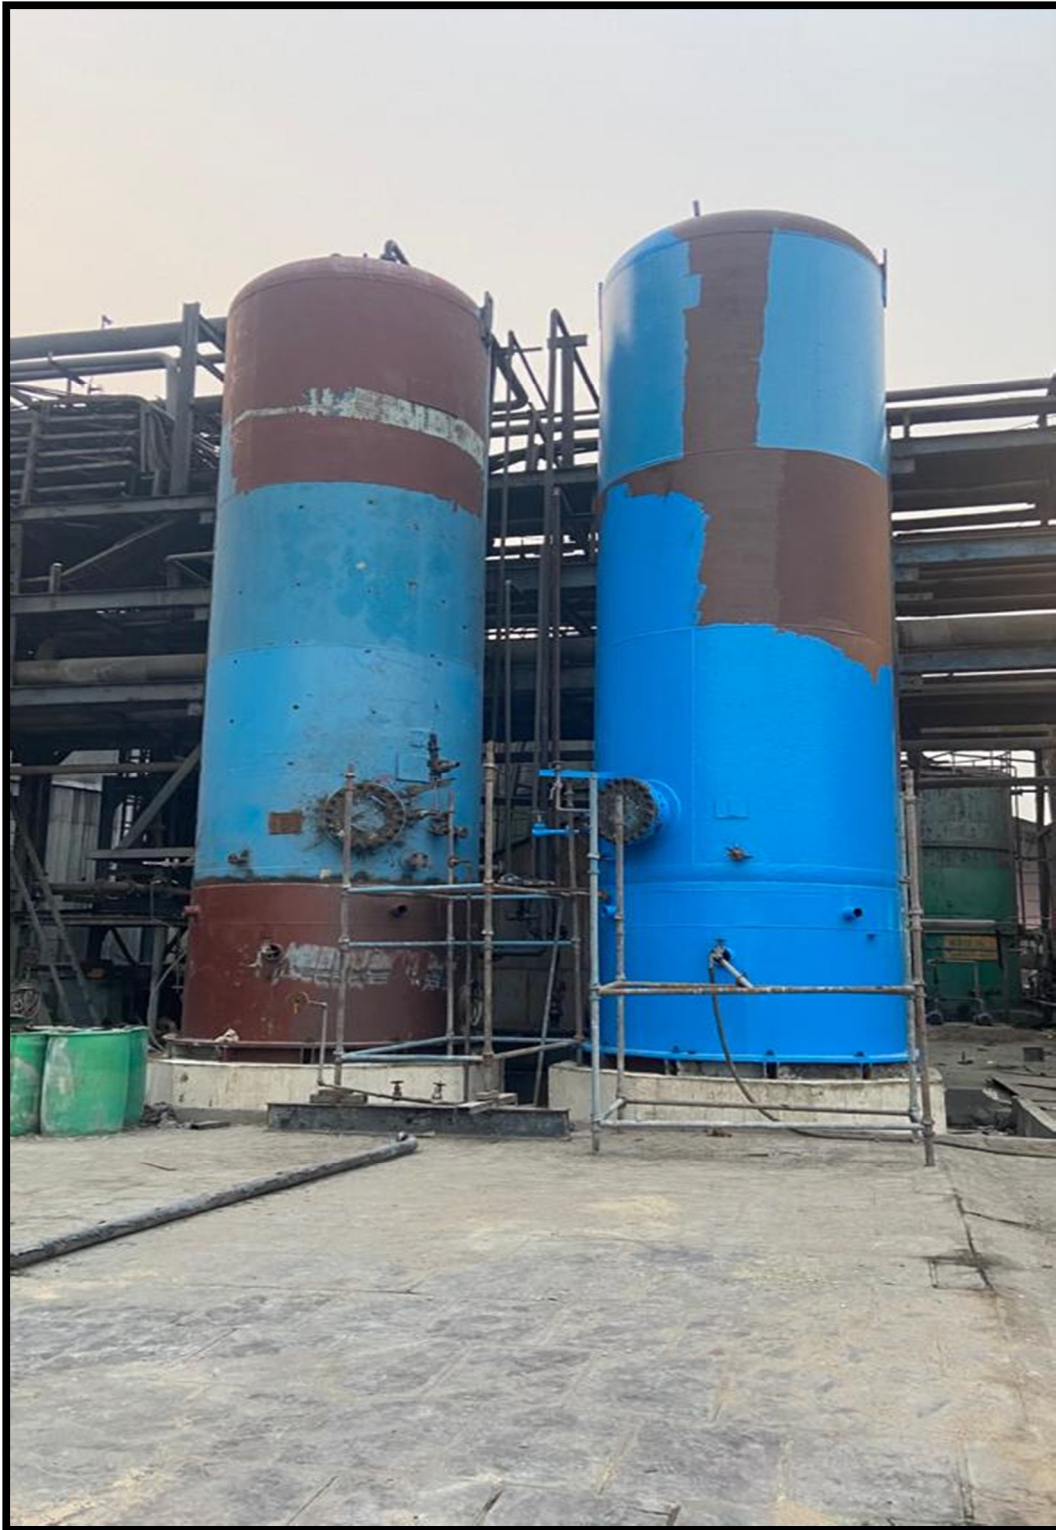
Air Receiver Tank Civil Foundation with Tank

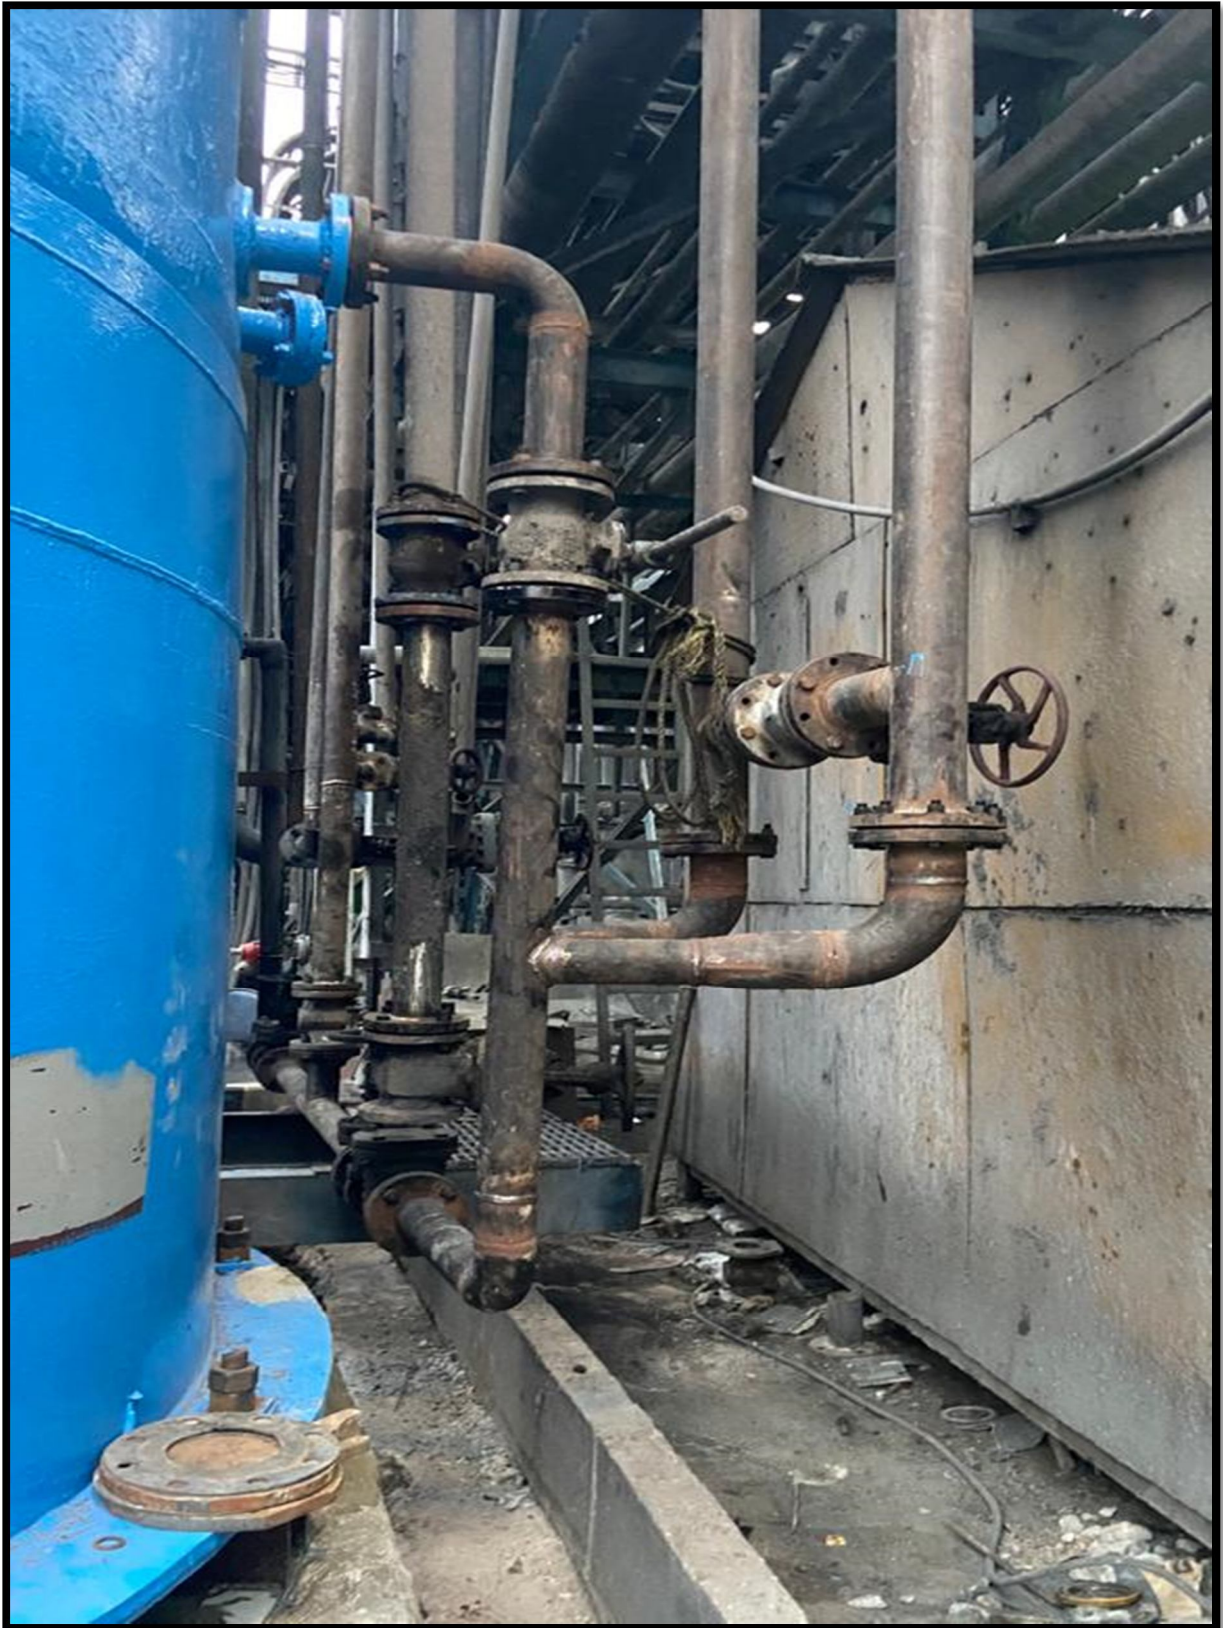
Air Receiver Tank Pipe Line Modification

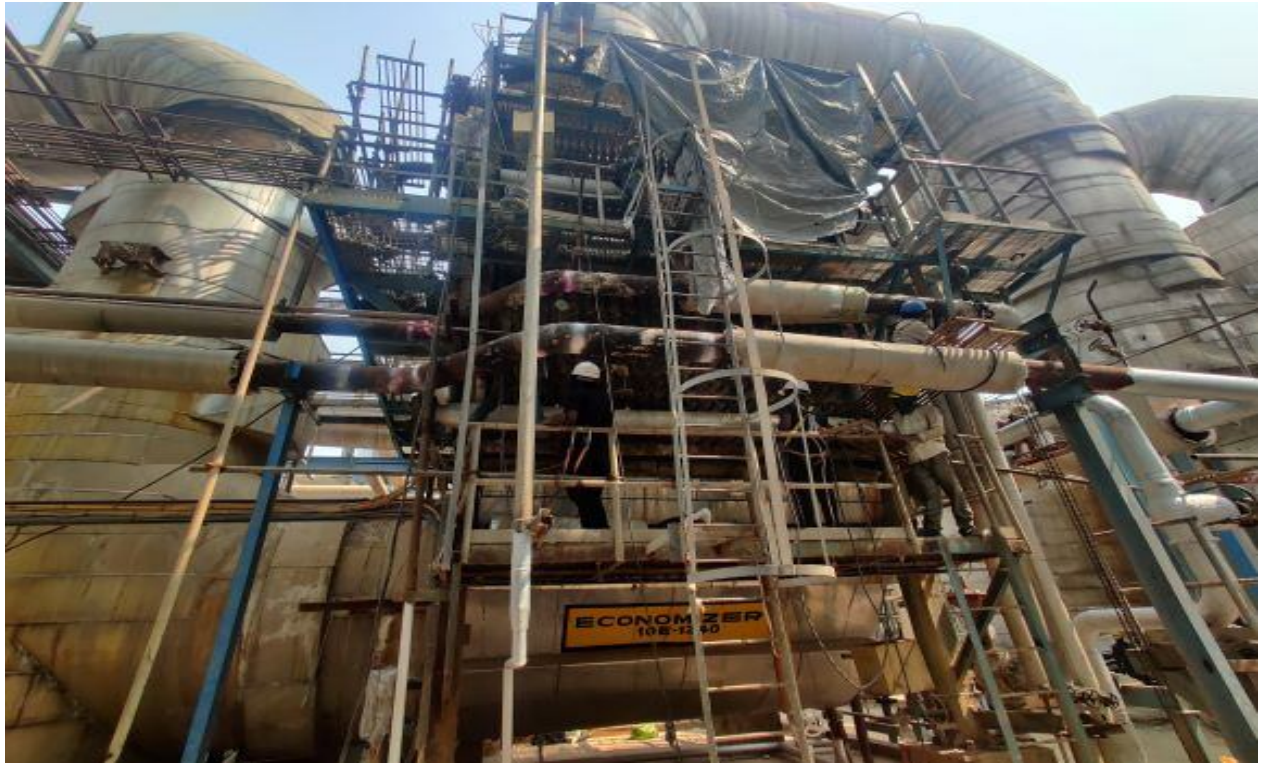
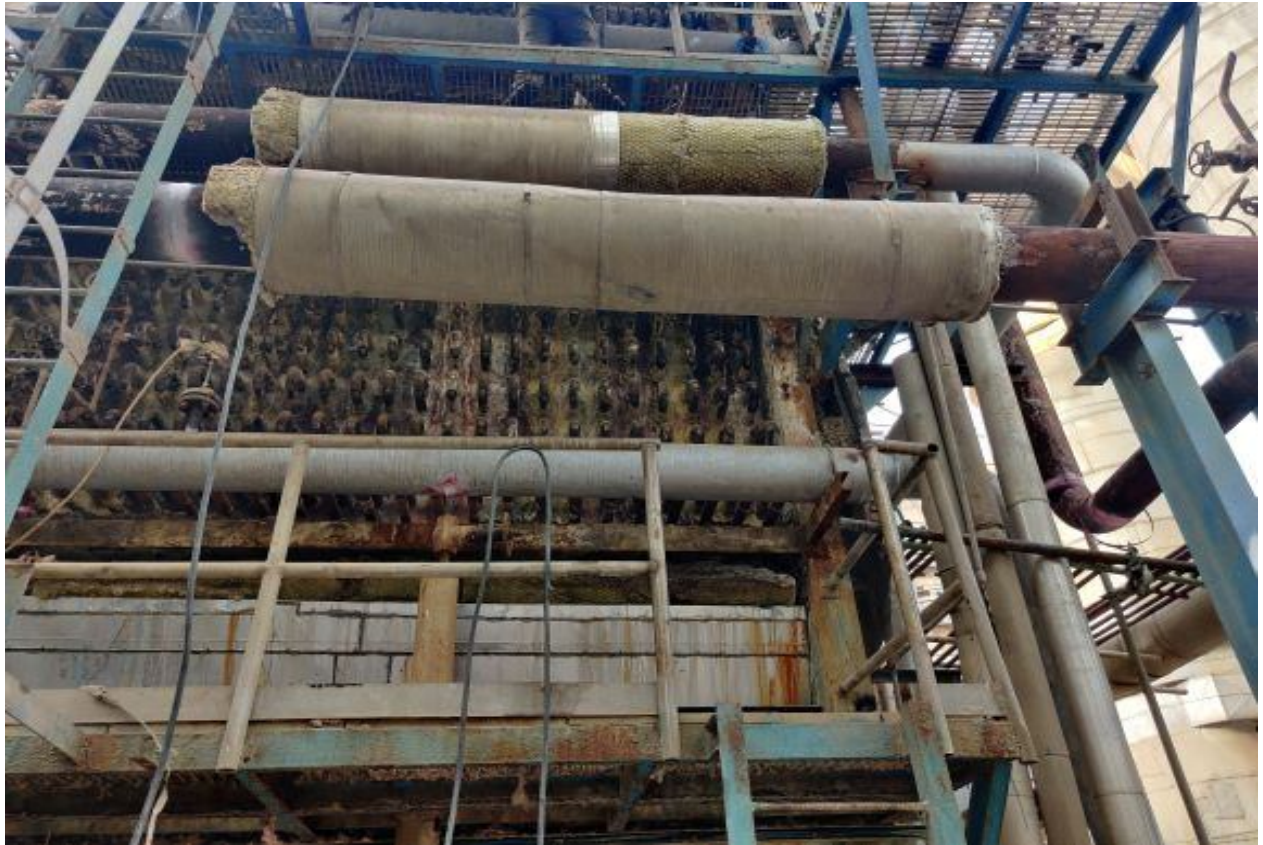
ECONOMISER WATER SIDE BEND AND HEADERS INSPECTION AND THICKNESS MEASURED

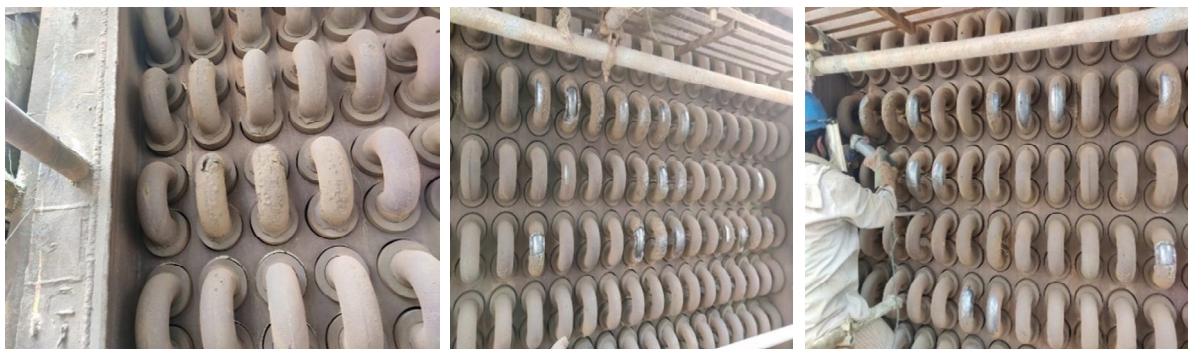
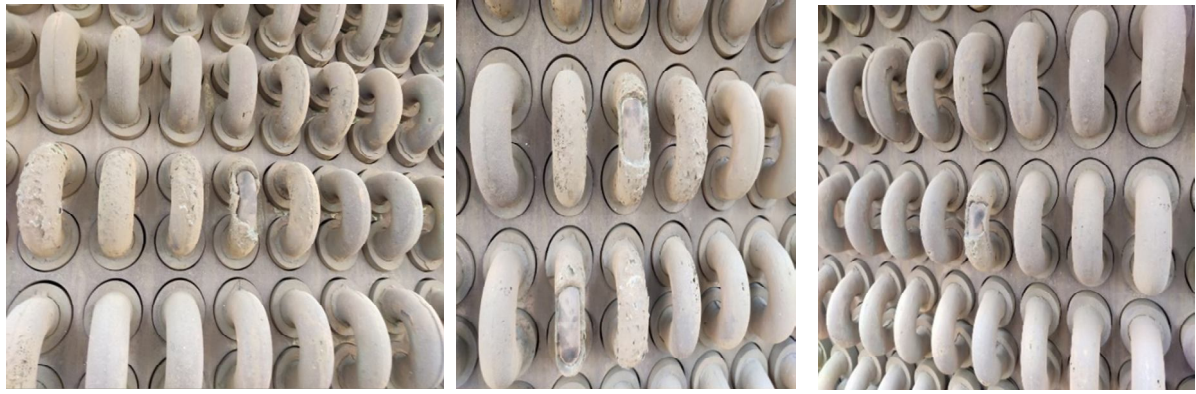
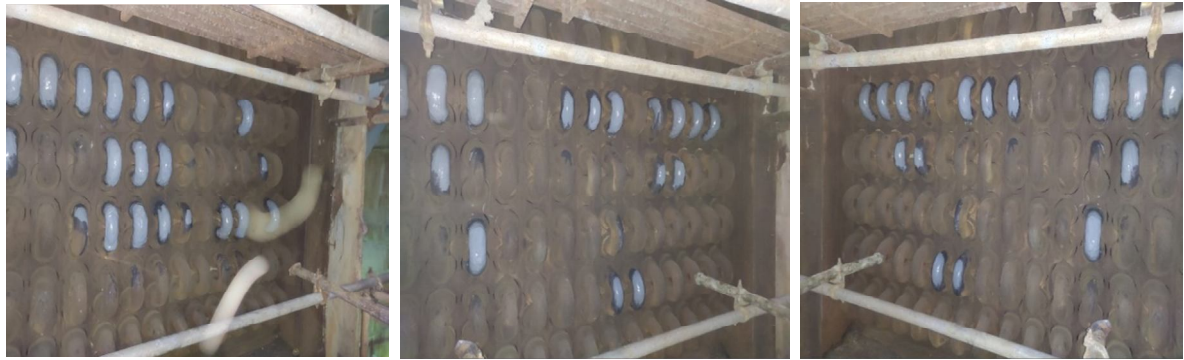
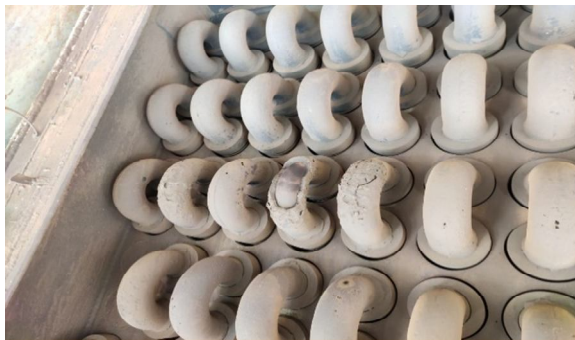
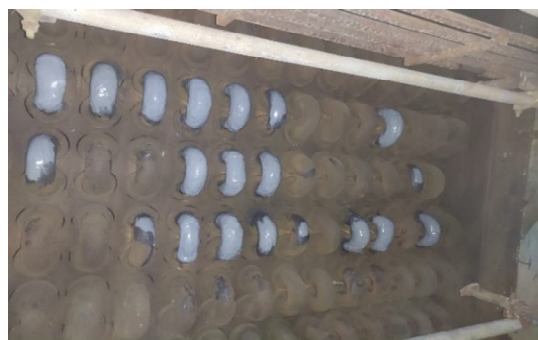
ECONOMIZER BOTTOM BANK

Rear side of Economizer Return bends found eroded which are applied with Titanium Putty

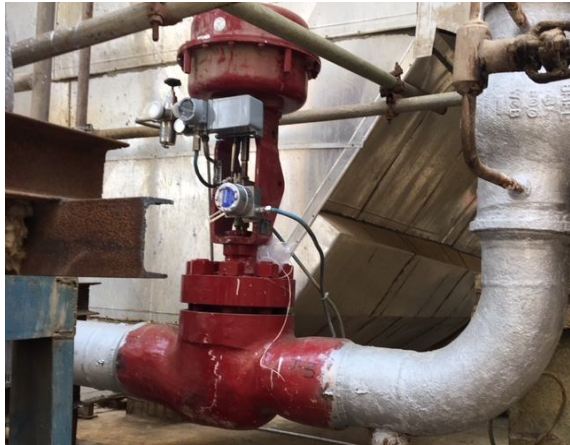
LCV 1301 Installation

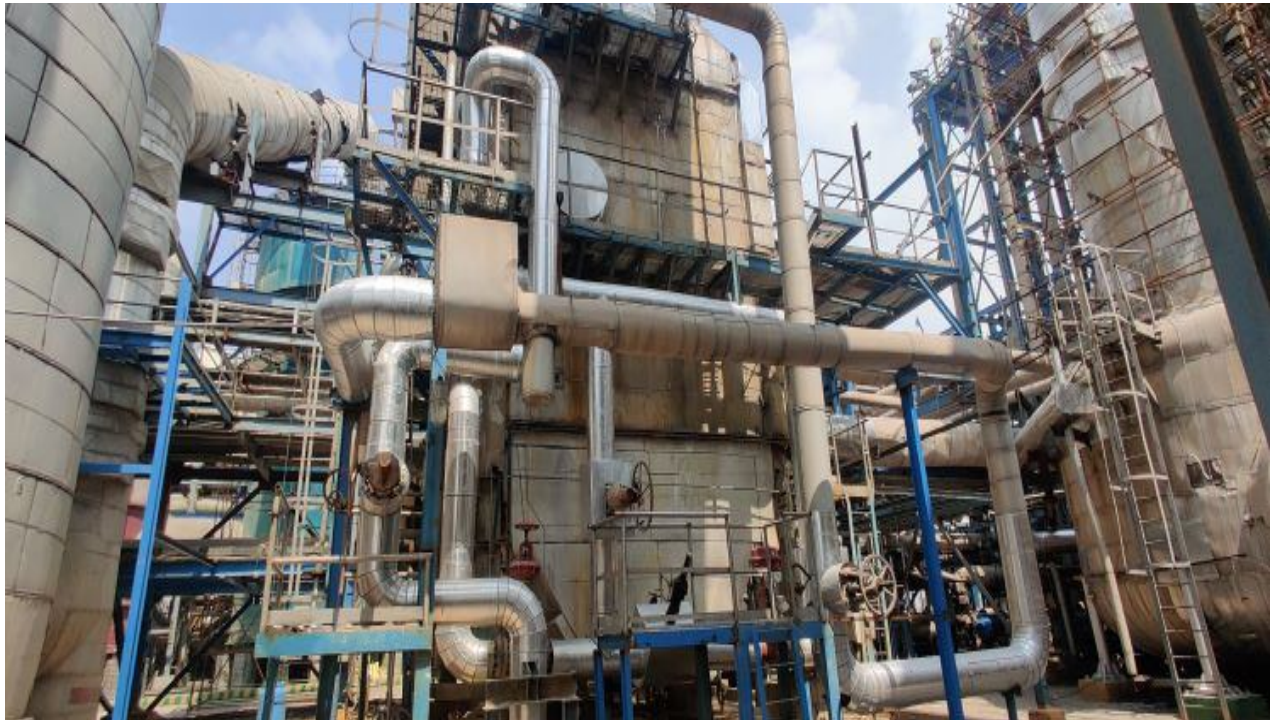
AFTER MODIFICATION

Economiser out let line elbow replaced which was leaked

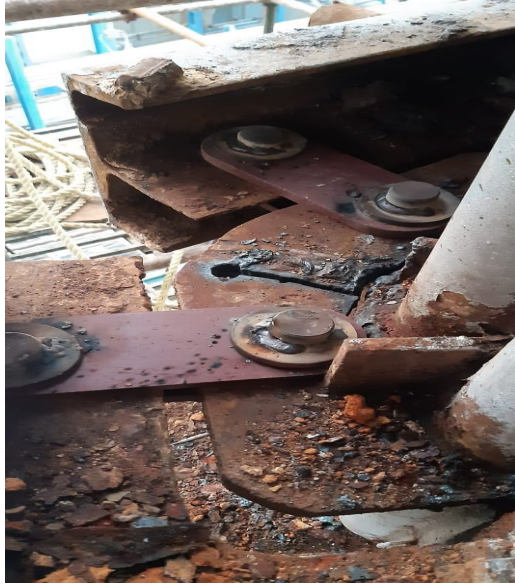
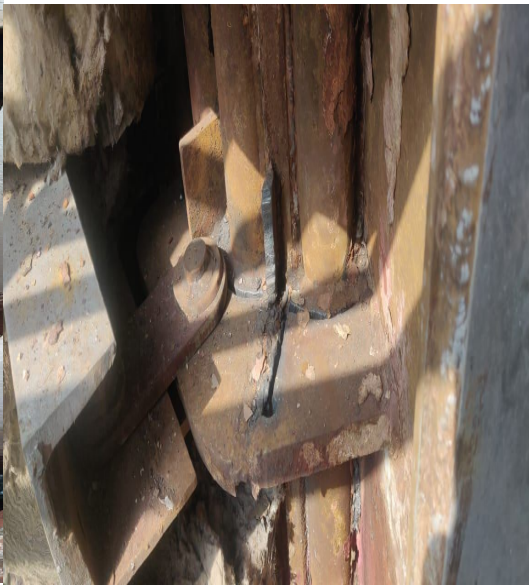
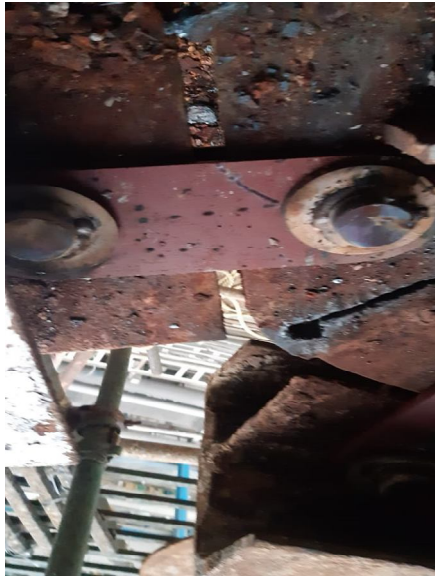
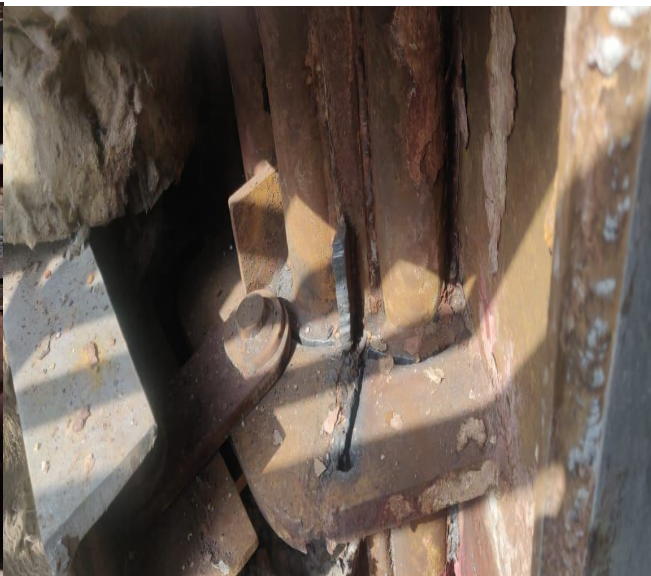
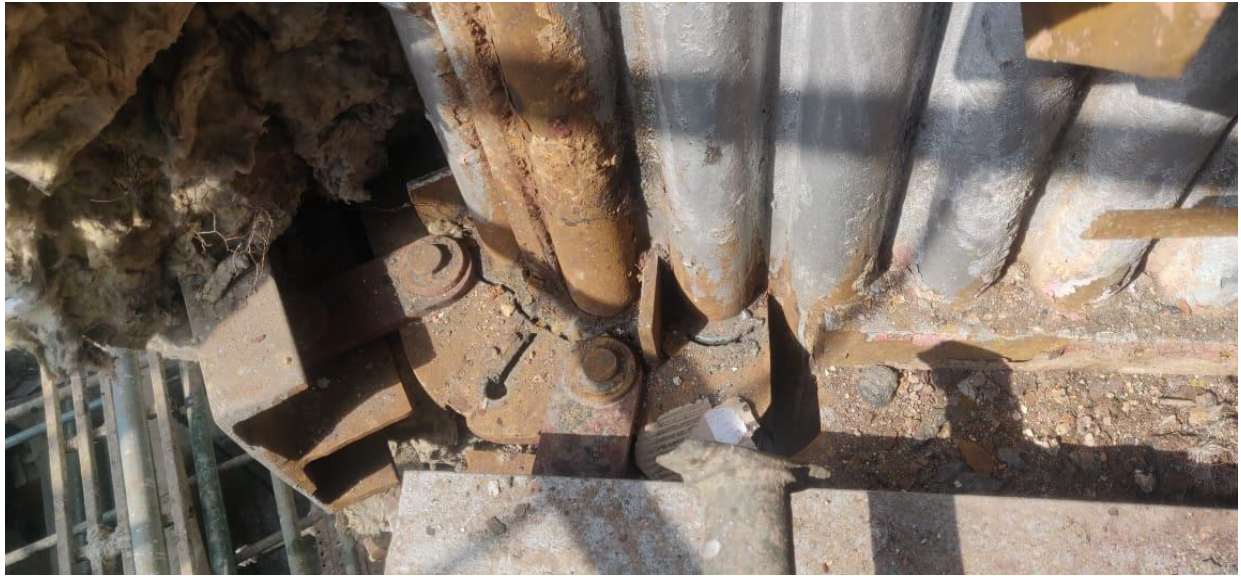
- a) To avoid membrane tubes failures and restriction of thermal expansion at Buck stay, corner plates of buck stay are modified as follows as suggest by M/s Thermal systems (Hyd.) Pvt Ltd

Various pictures of Buck stay corner plate modified at various elevations

There are total 58 No of corner plates installed where 42 nos out of 42 nos above radiation zone (i.e. above El +7.4 m) are modified- as per following drawing.

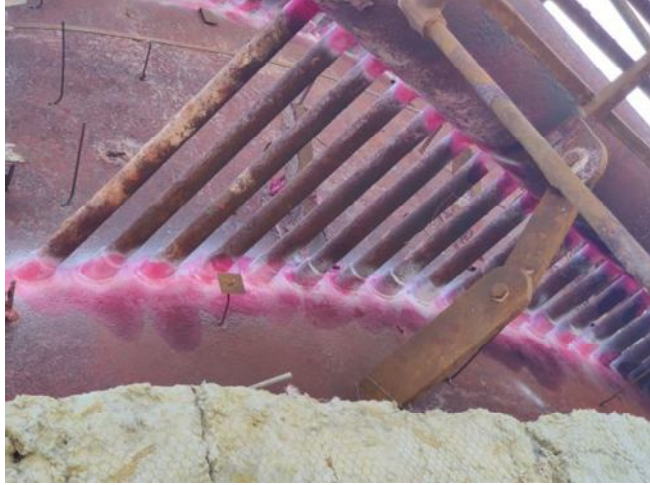
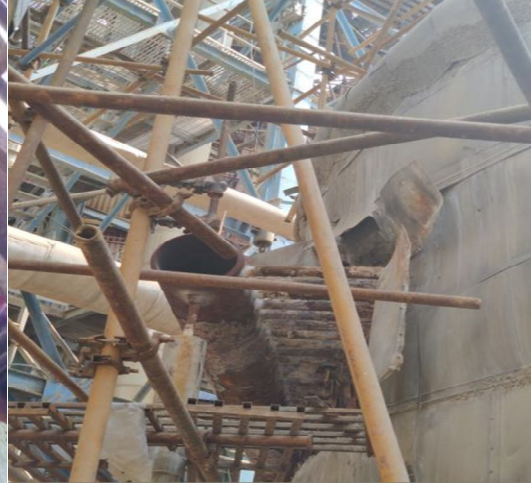
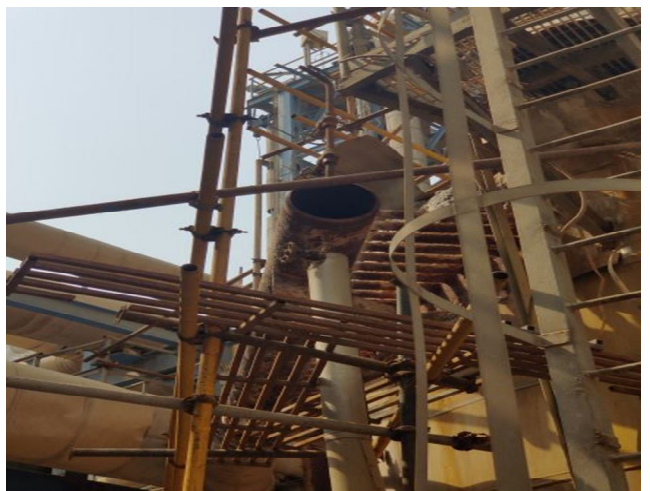
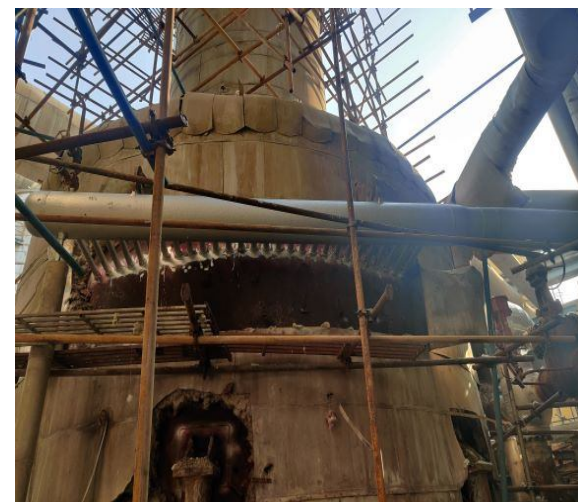
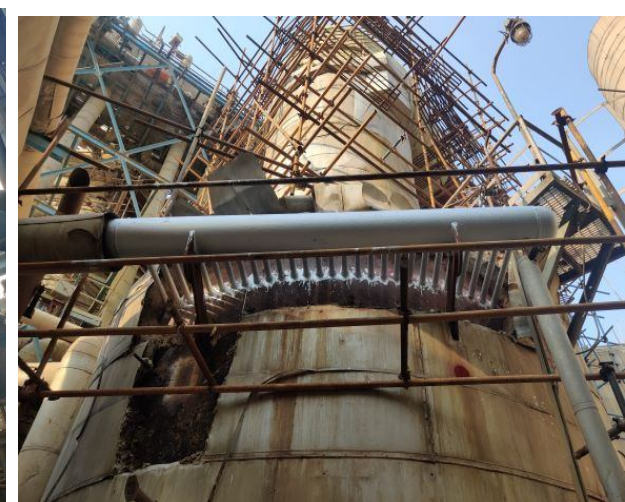
INLET HEADER AND OUT LET HEADER STUB END TUBES INSPECTION

END caps of both headers of Super Heater 1 cutted for fiberoptic inspection as a part of RLA study of boiler

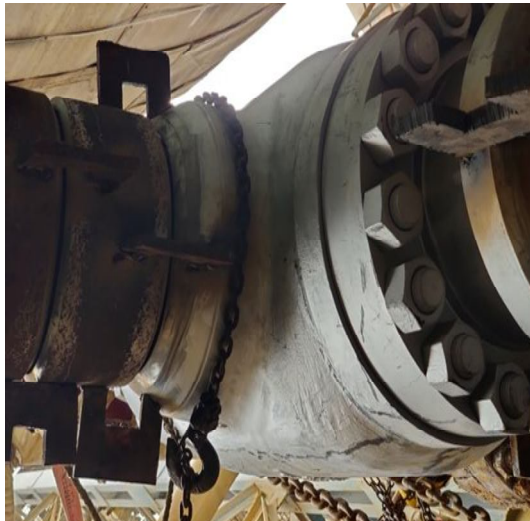
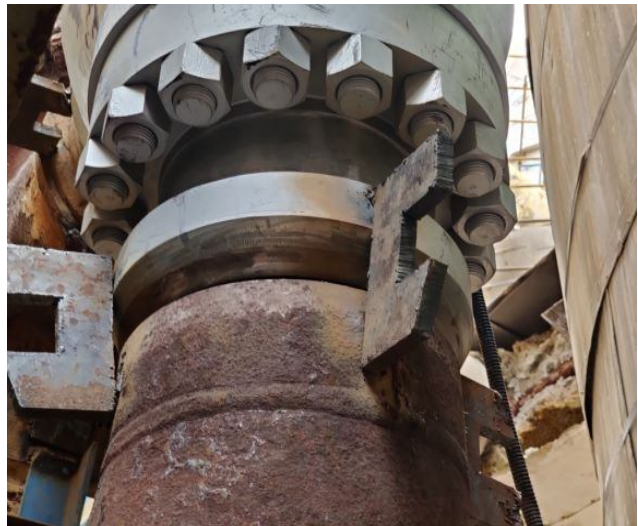
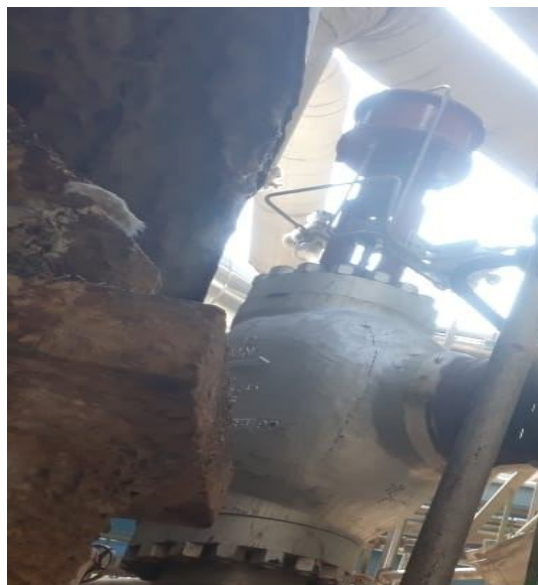
3 way valve replaced at SH- 1 inlet pipe line

**Valve Size - 12", 600 # -MOC ASTM A217 GR WC6 – Make - Baker Hughes
Qty – 01 no**

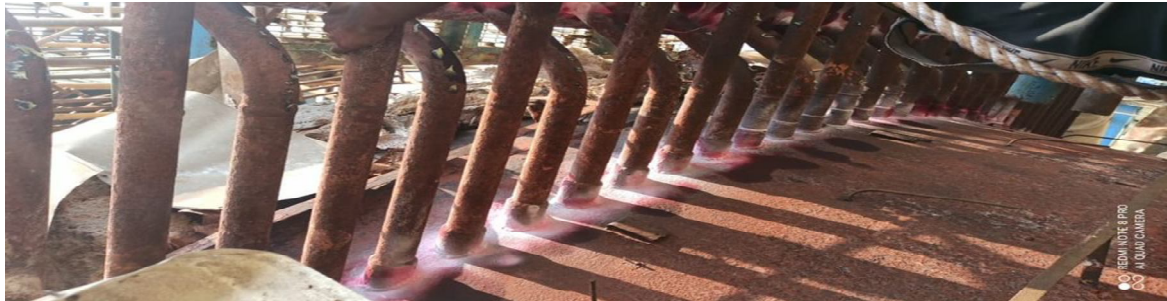
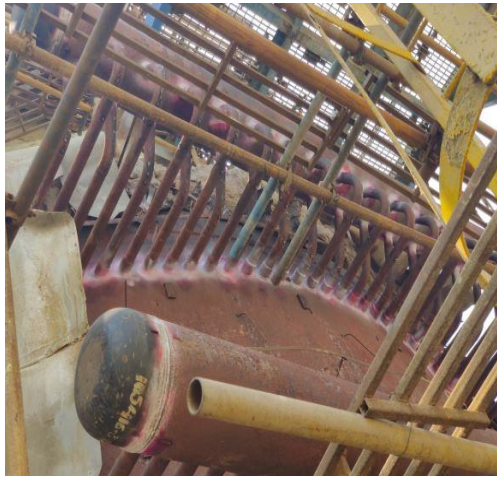
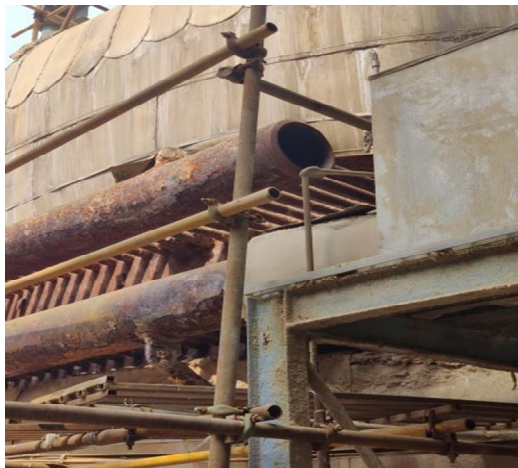
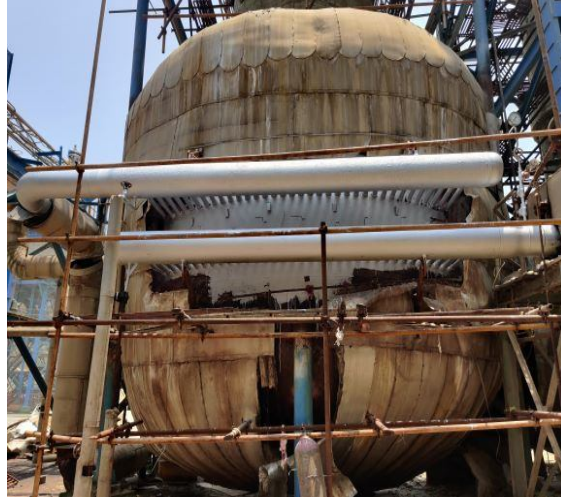
INLET HEADER & OUTLET HEADER STUB END TUBES INSPECTION

END caps of both headers of Super Heater 2 cutted for fibereotic inspection as a part of RLA study of boiler

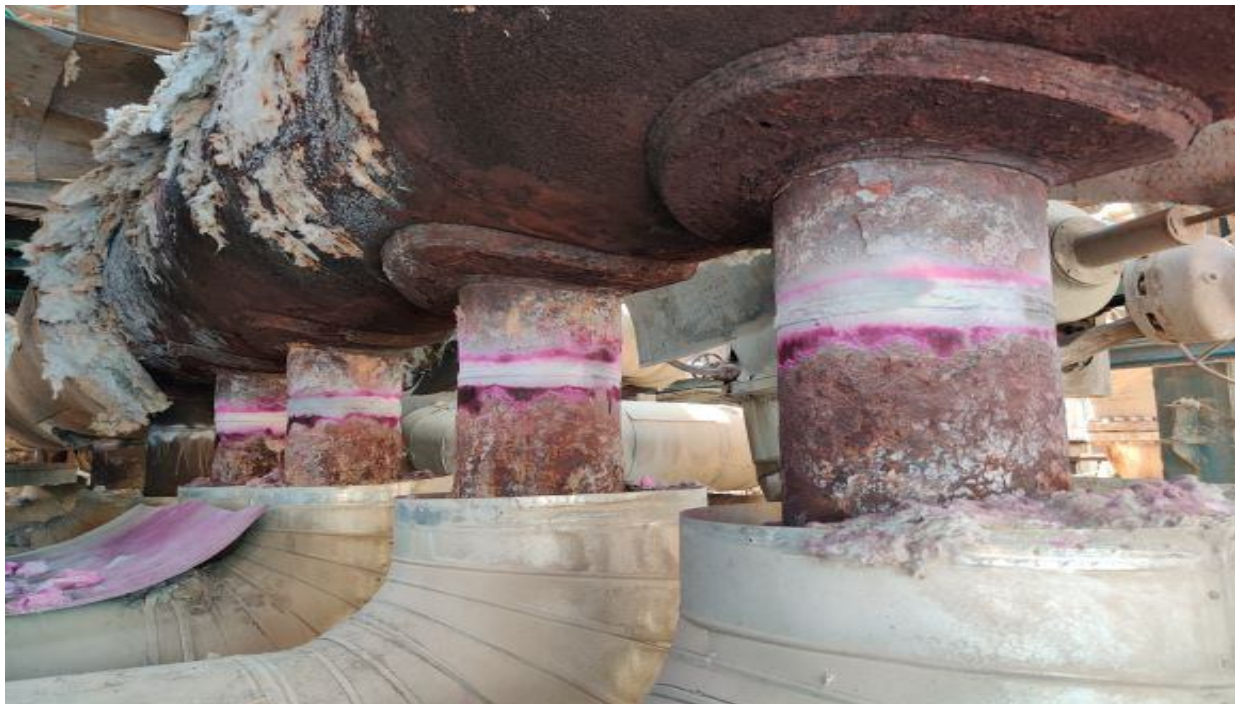
Distribution pipe lines from distribution header joints DP tested

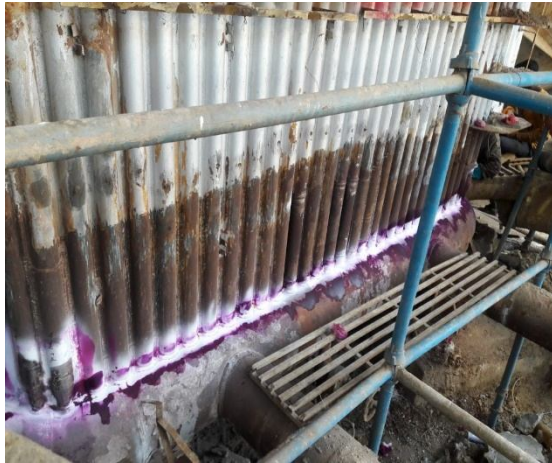
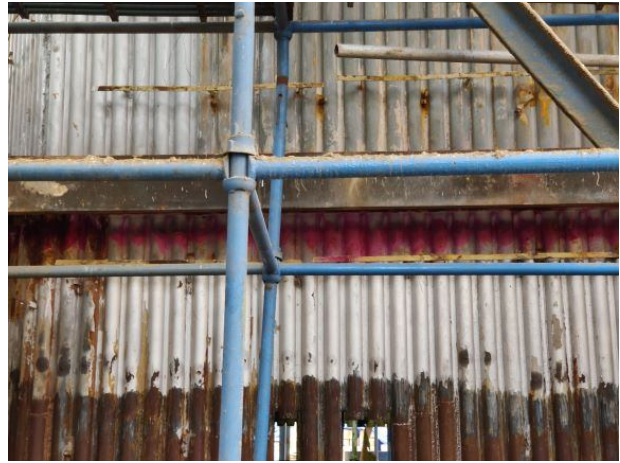
All the stub end joints of distribution pipes 12 nos. at Distribution header and Bottom header are checked with DP test and MP test
