ATR REPORT-2021

**INDIAN FARMERS FERTILISERS CO OPERATIVE LTD.
PARADEEP UNIT**

ATR REPORT: 2021

DAP PLANT

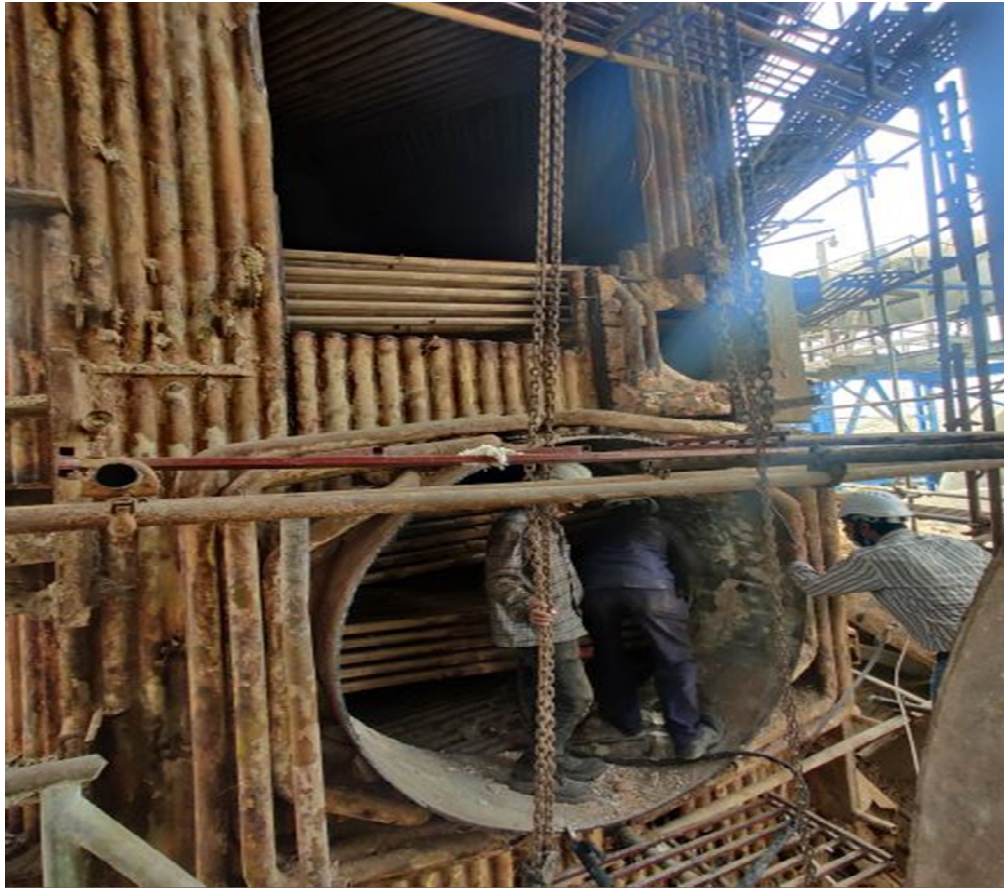
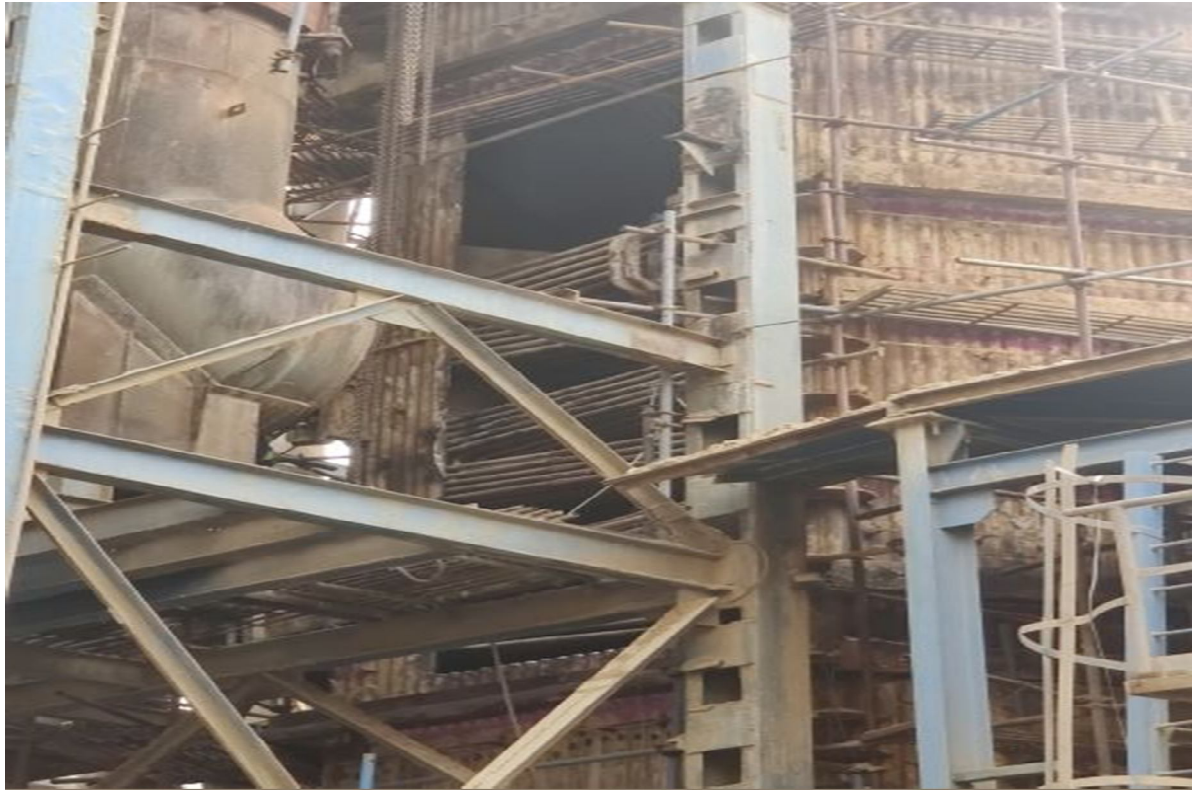
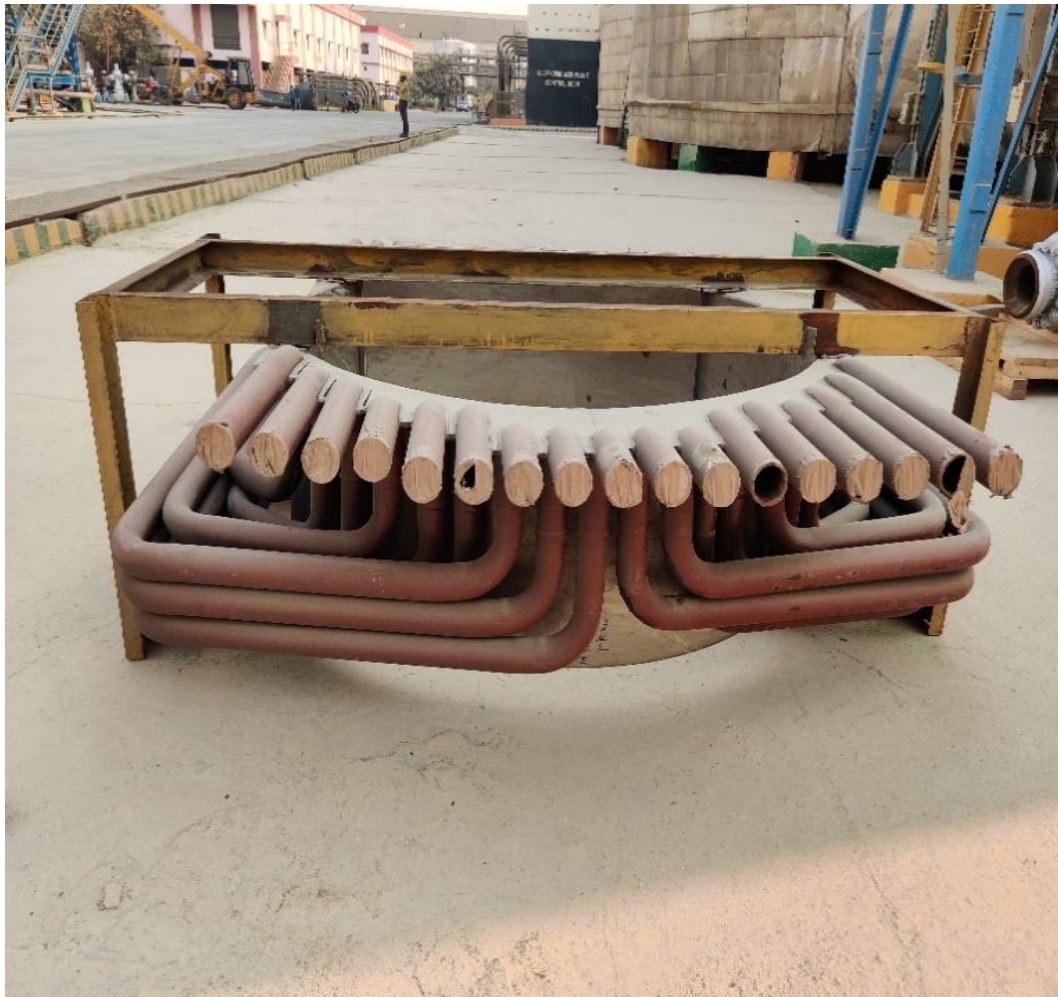
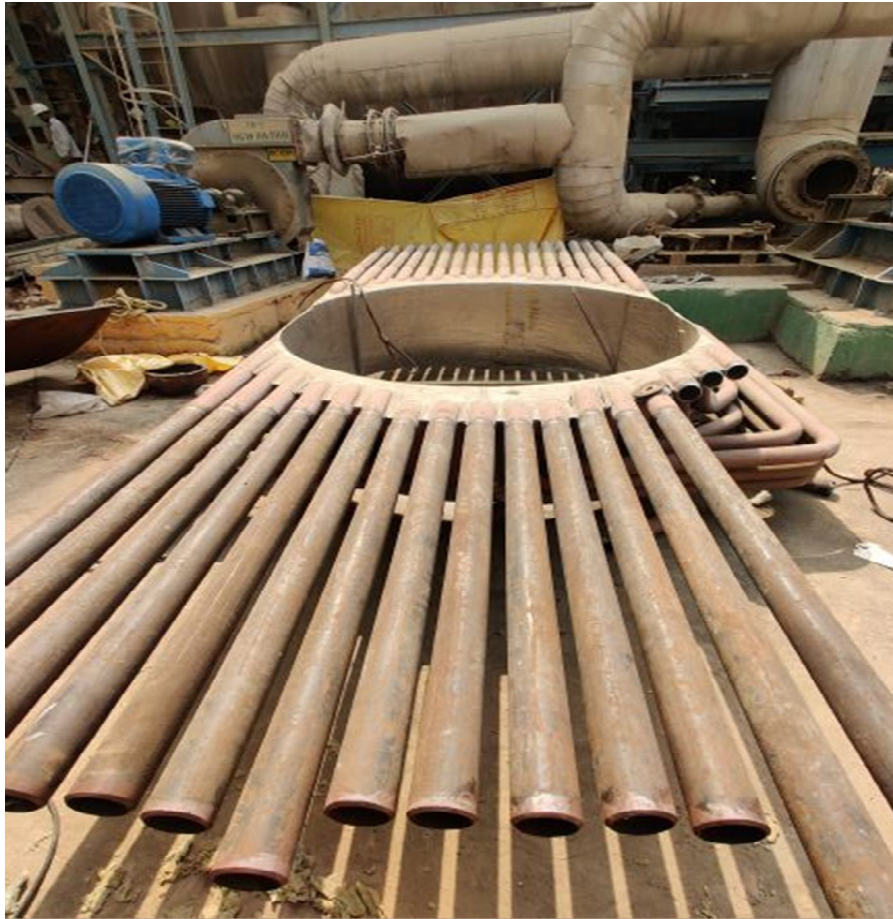
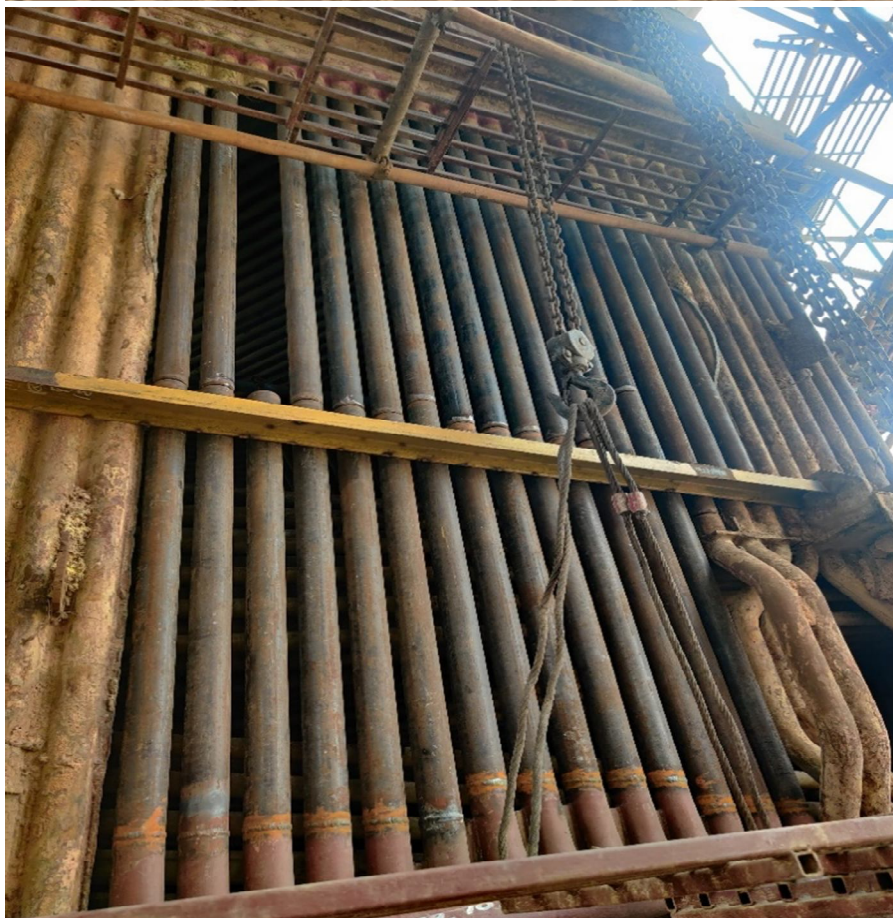
Existing Boiler bypass Nozzle bend tubes badly eroded and thickness reduced at bend portion. This by pass nozzle replaced with new assembly .Old by pass nozzle replaced with straight membrane tubes.

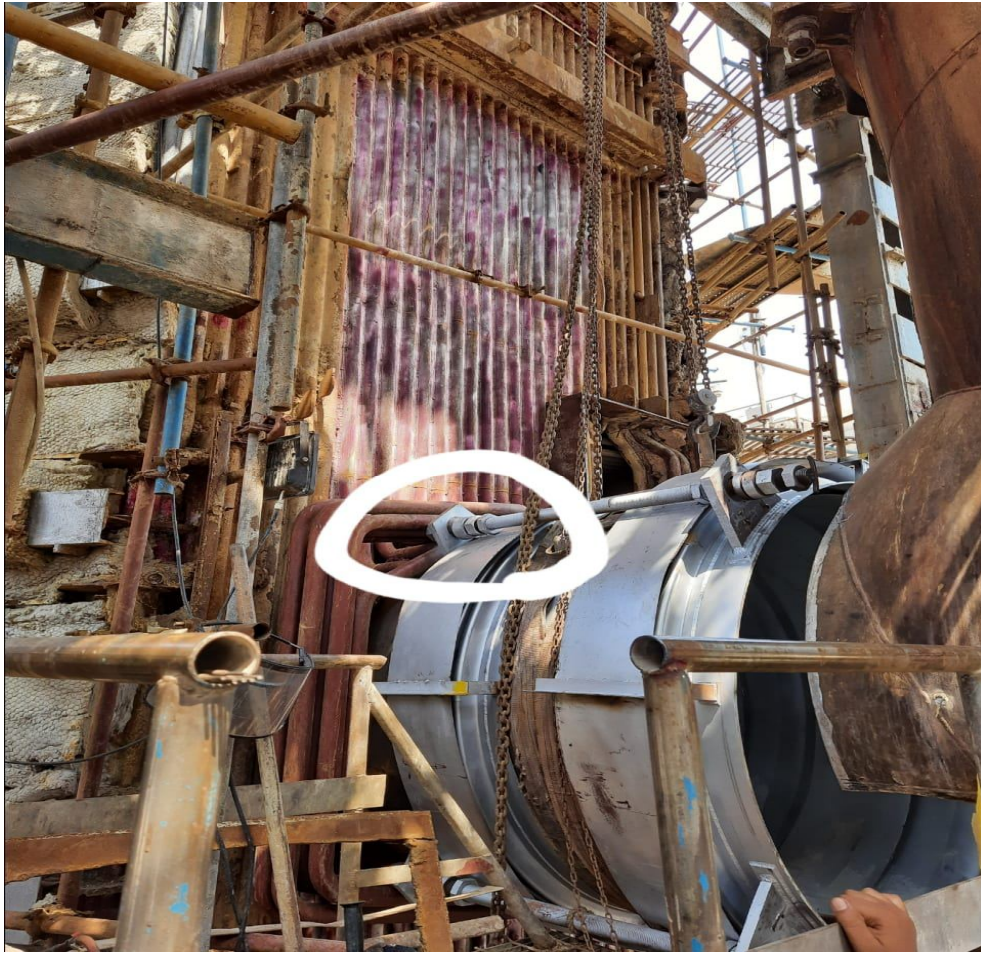
Replacement of Expansion Bellow at Boiler Bypass duct – 1800 NB

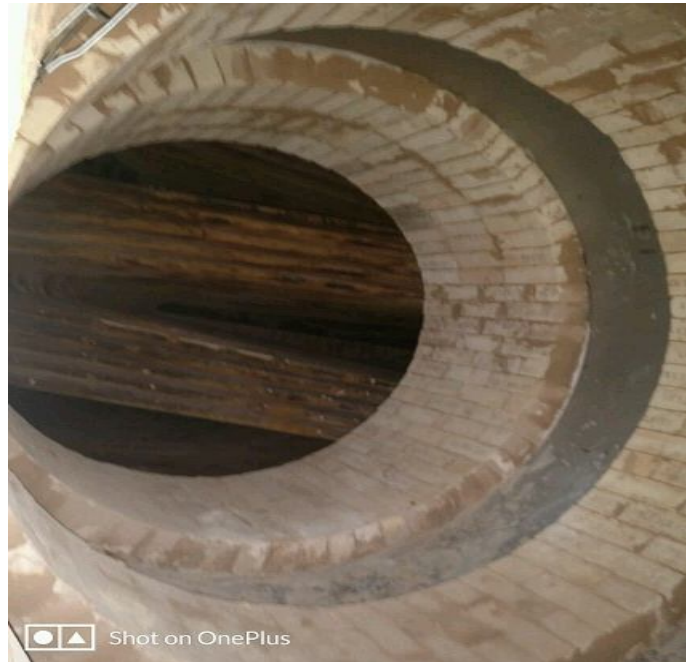
After installation and welding of bypass bellow ,in side brick lining work done

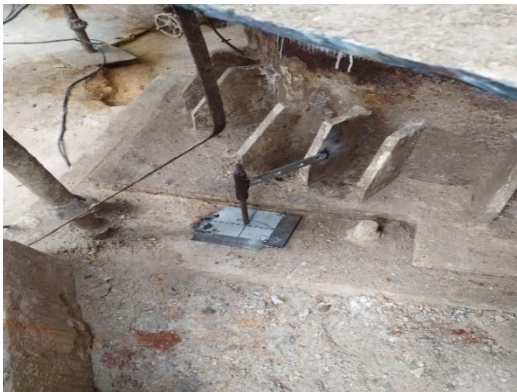
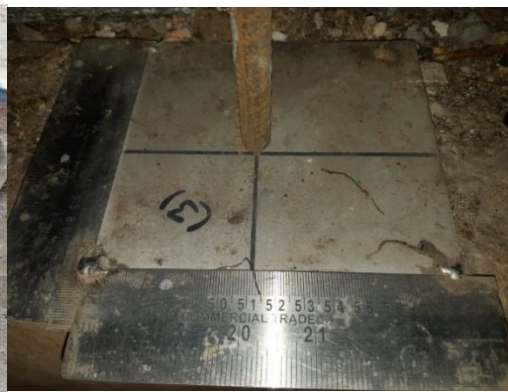
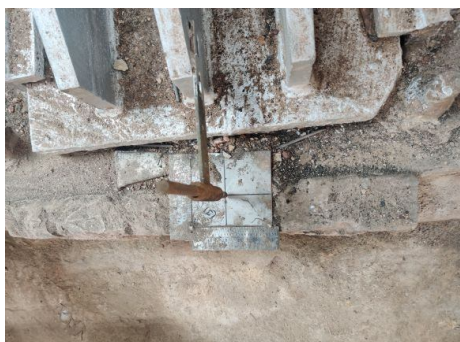
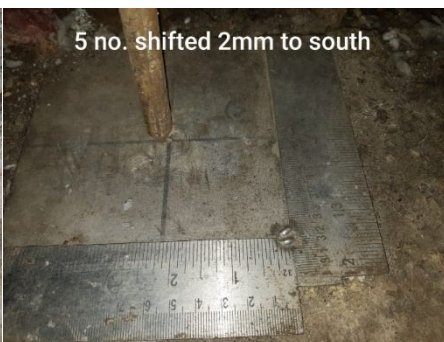
To measure the thermal expansion of Boiler, 05 nos. of thermal expansion measurement provided at Bottom header pedestal supports and one no. at steam drum.

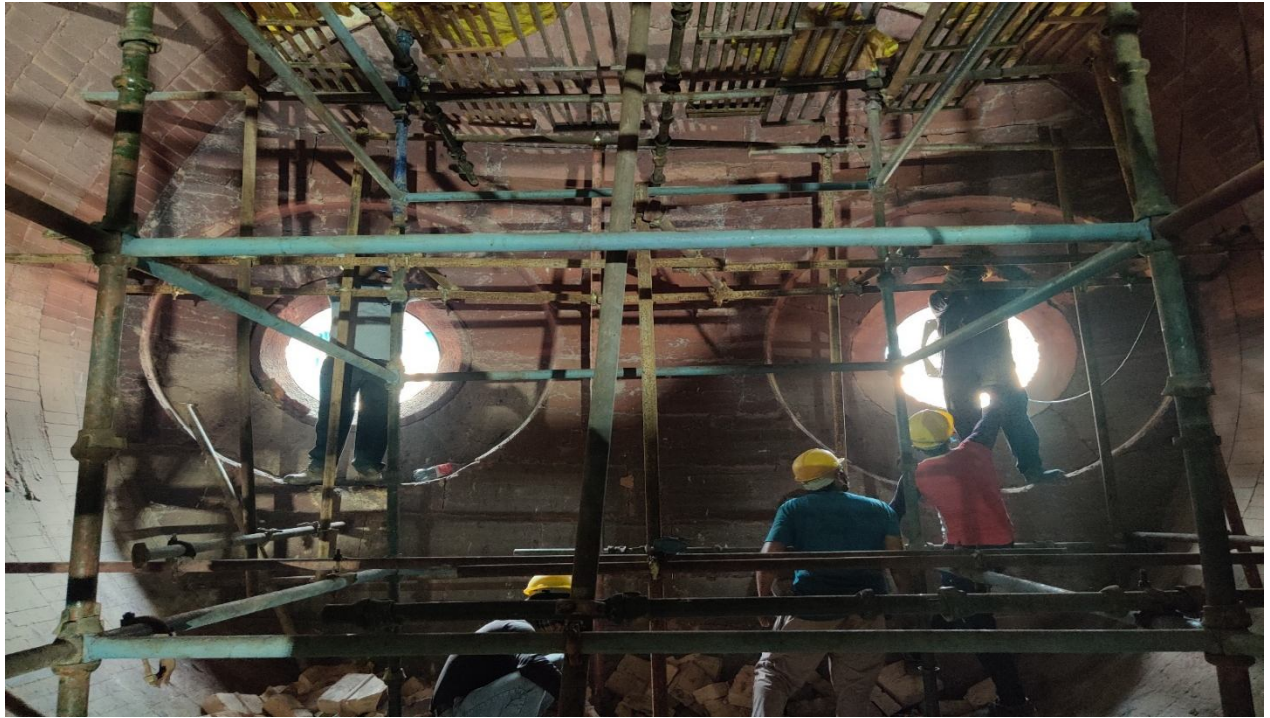
Furnace dished head side brick lining found loosened samme removed and replaced

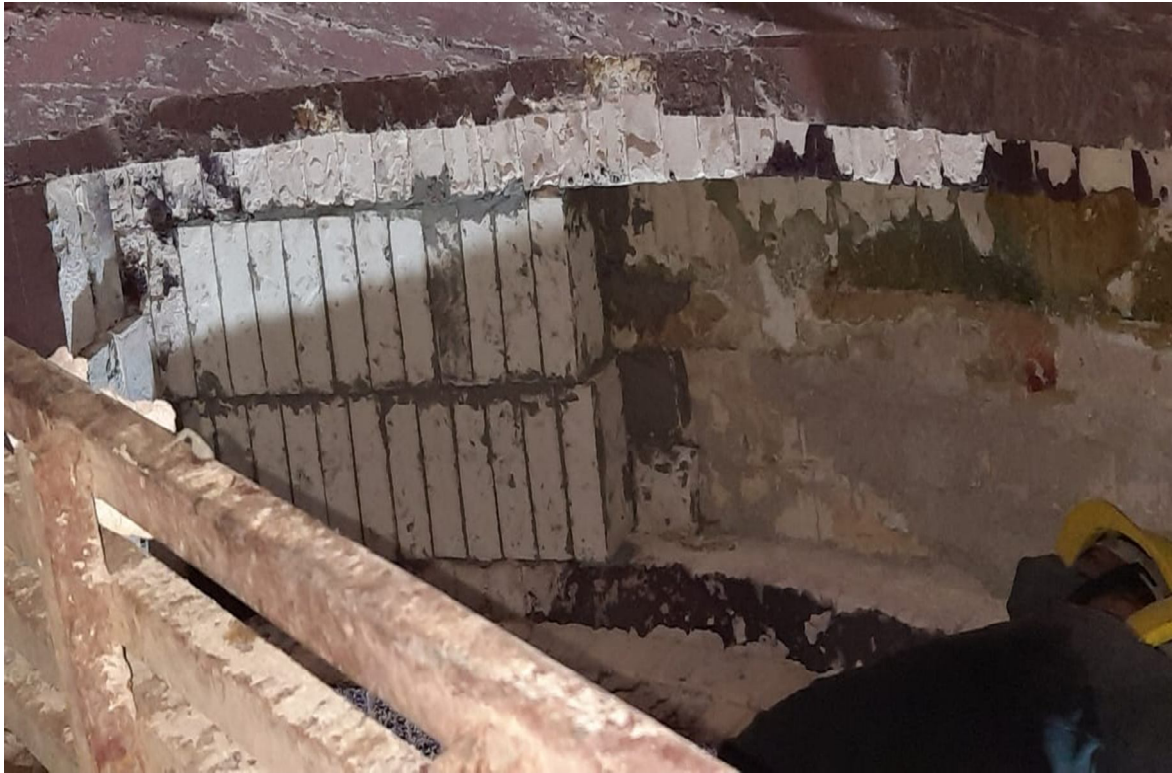
Brick lining work of furnace to dished head area

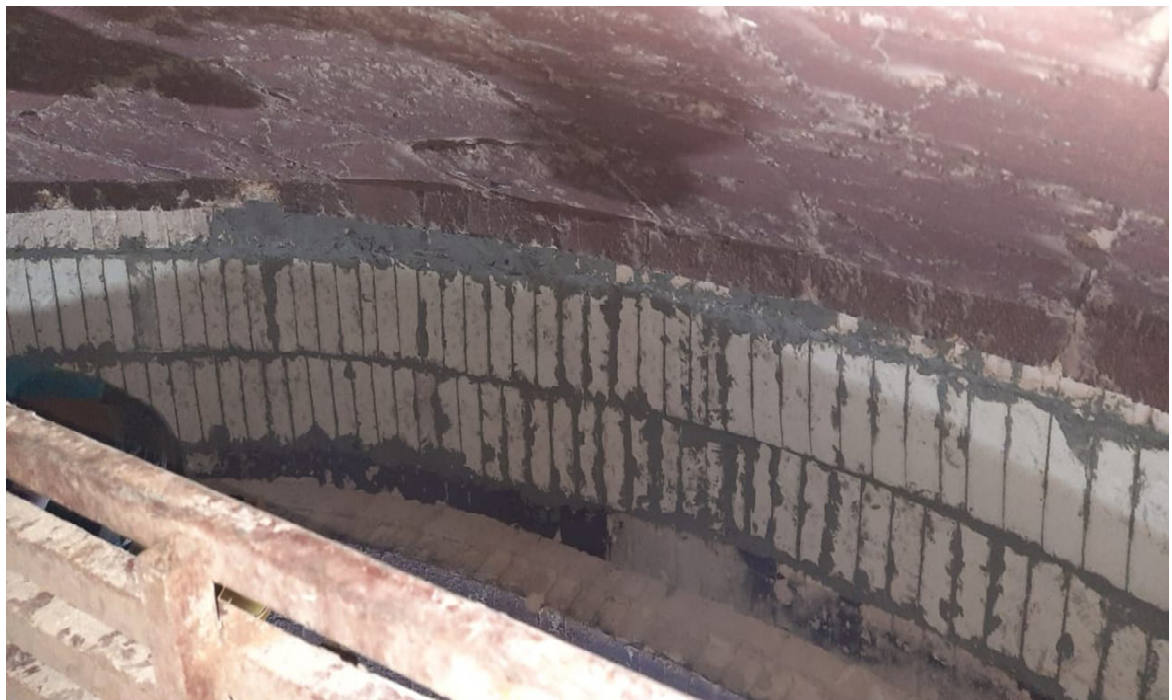
Furnace to Boiler neck portion badly damaged where top portion thickness observed 4.00 mm and bottom of shell observed 9.0 mm against 14.0 mm. damaged shell portion replaced with new one

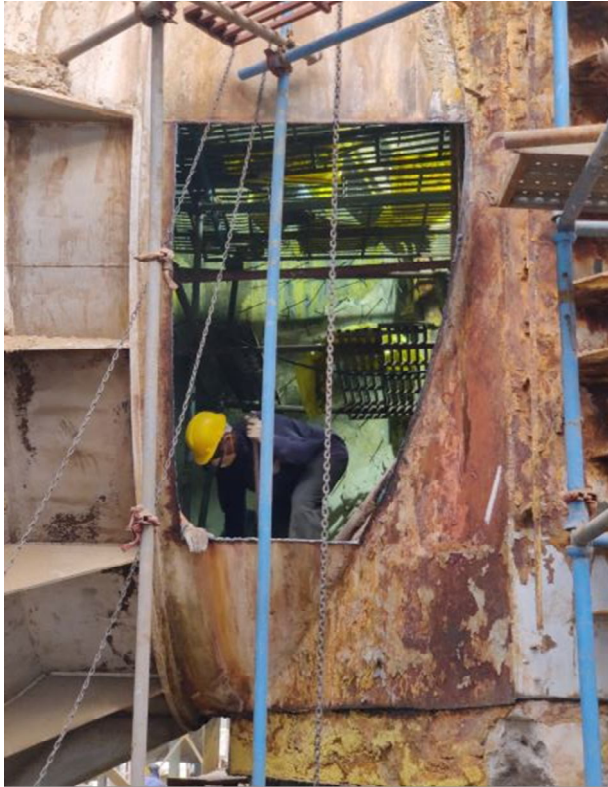
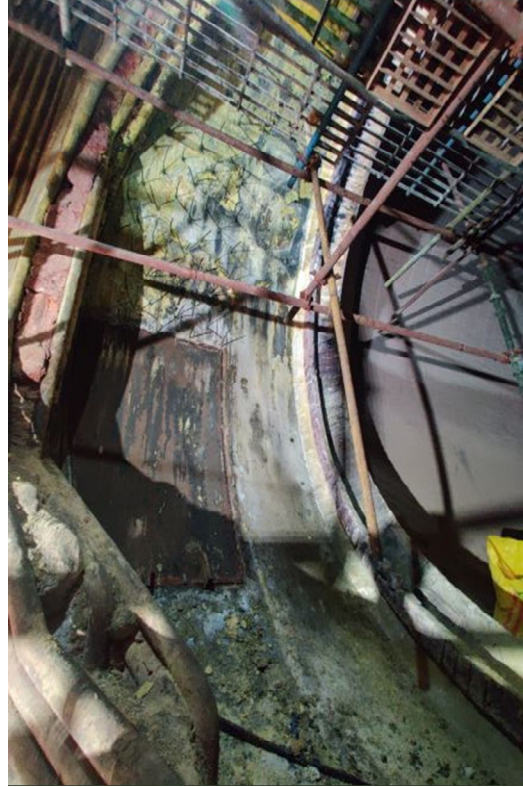
Damaged Shell Plate removed at boiler neck portion due to less thickness

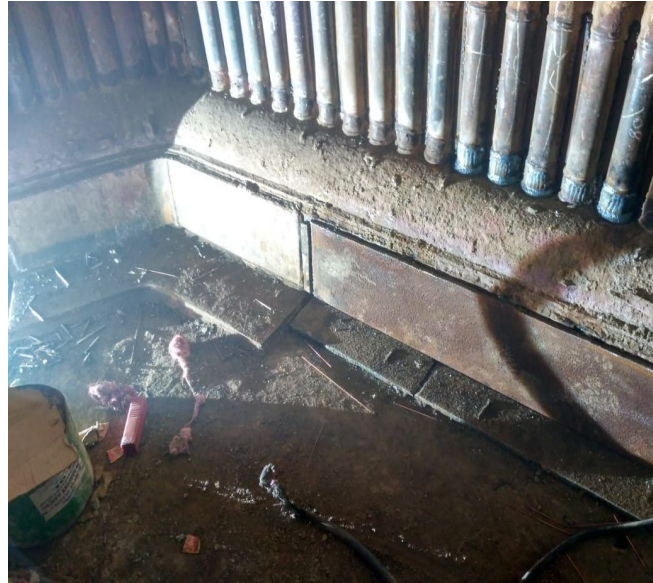
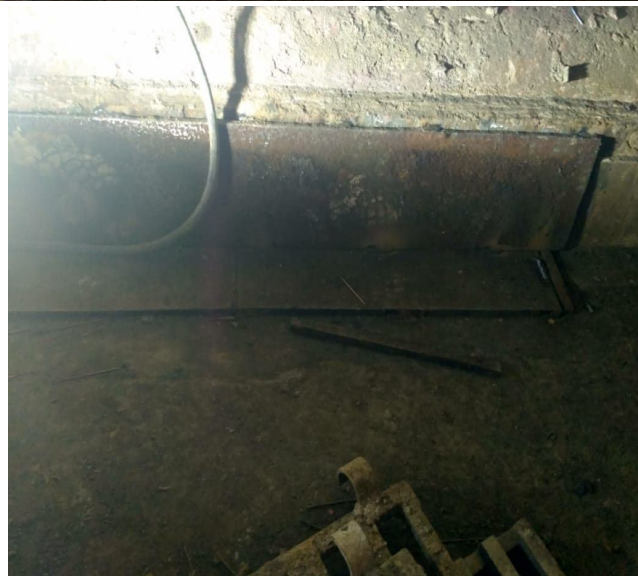
All membrane tubes thickness measured which are not replaced , Around 56 nos found less than 3.5 mm thickness, These membrane tubes are buttering welding done and DP tested

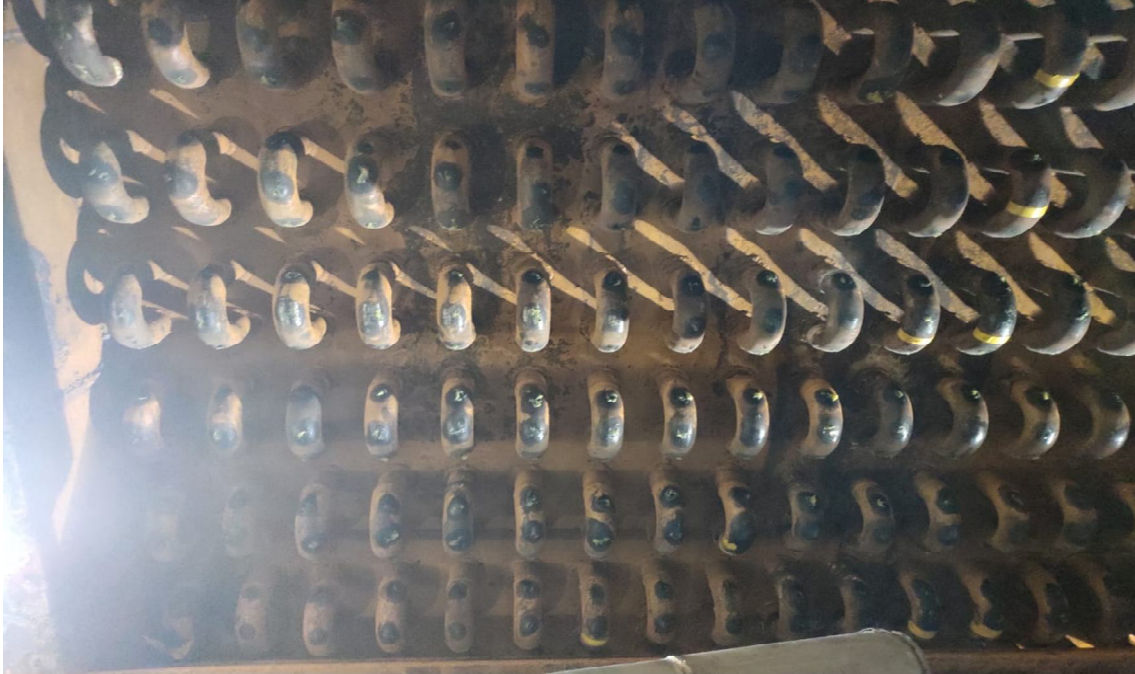
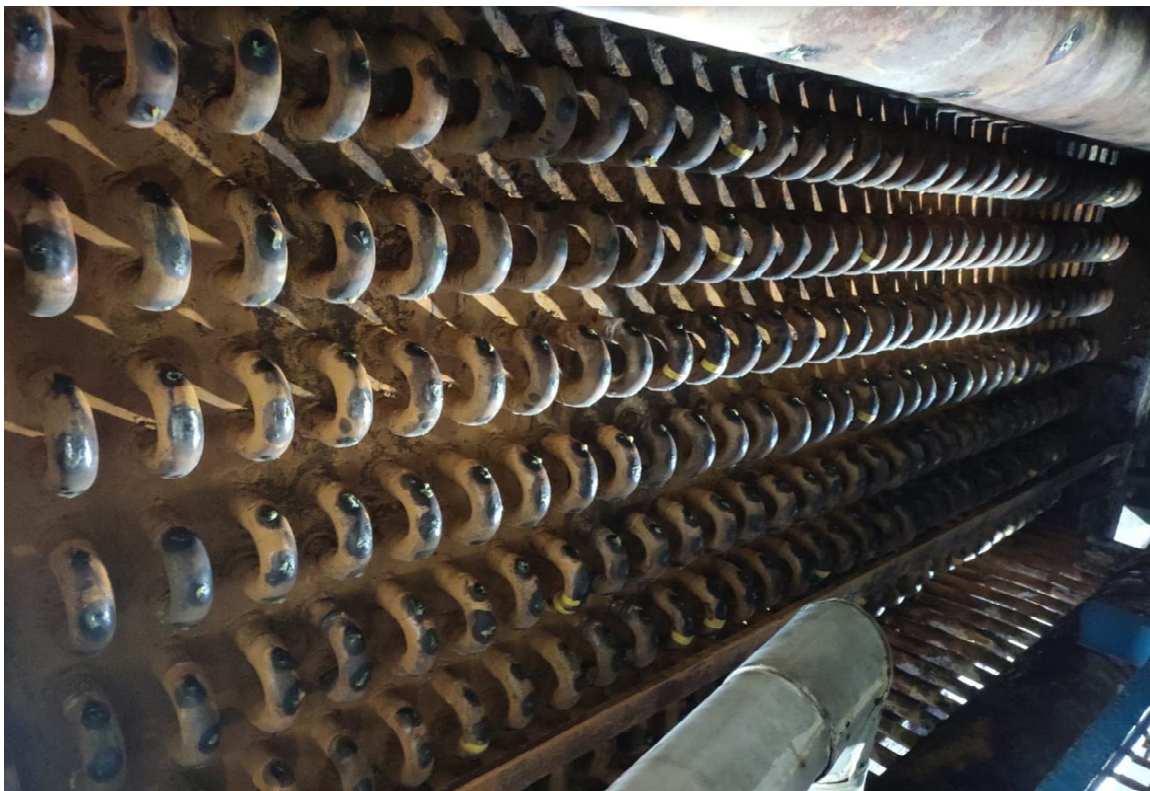
ECONOMISER WATER SIDE BEND AND HEADERS INSPECTION AND THICKNESS MEASURED

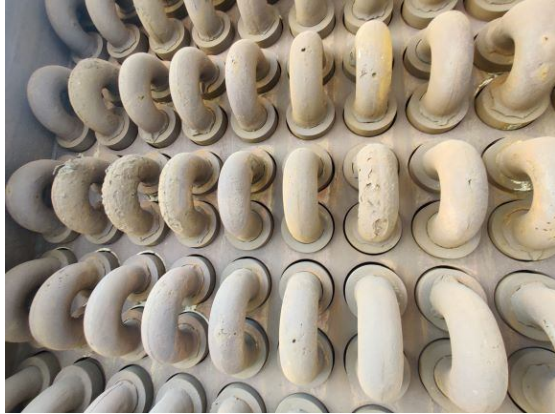
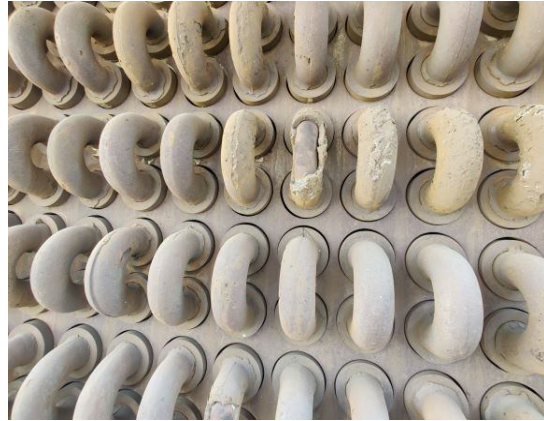
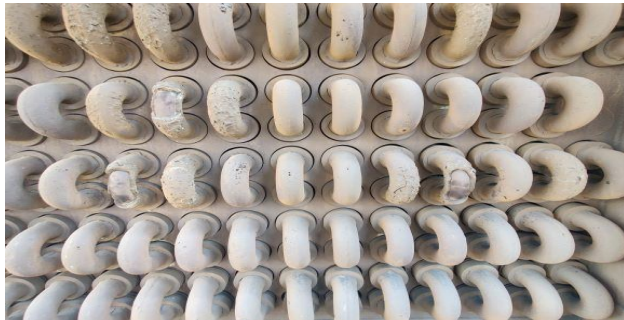
ECONOMIZER BOTTOM BANK

**Rear side of Economizer
Return bends found
eroded which are
applied with Titanium
Putty**

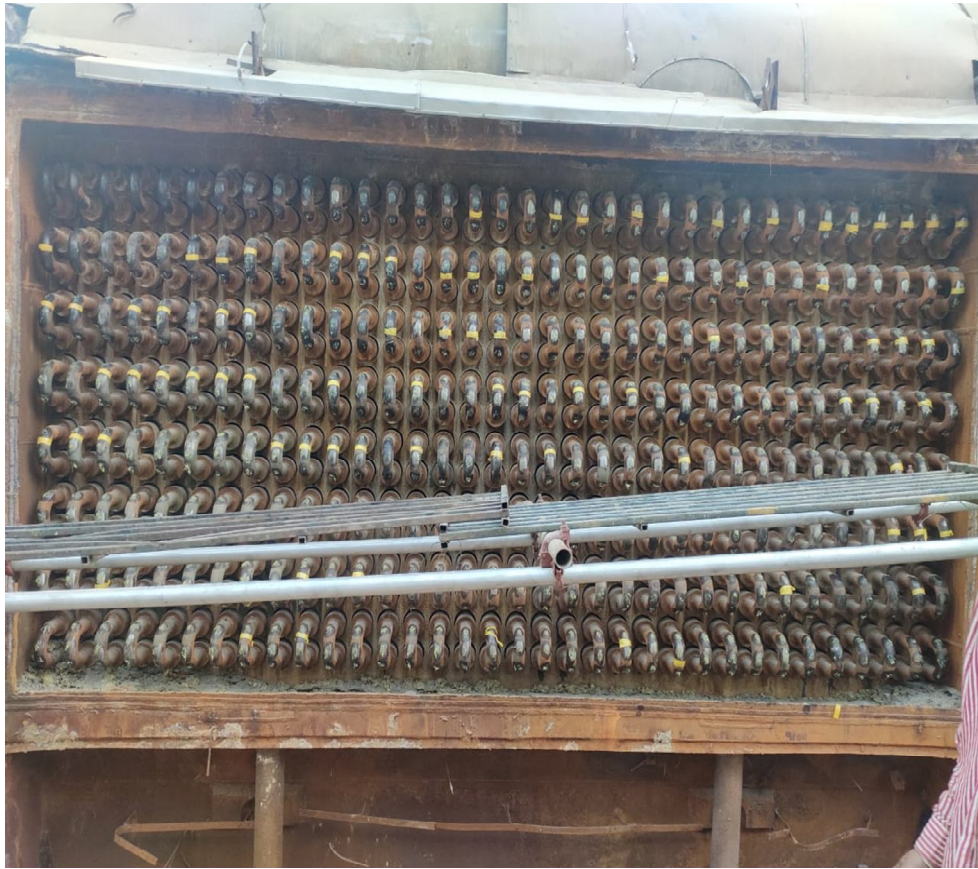
ECONOMIZER TOP BANK

Economiser U-bends in top bank and bottom front and rear side are inspected, marked bends found eroded and reduced in thickness by more than 30%. These bends are found thickness less than 3.6 mm where design thickness of U bends is 5.1 mm.

Economiser Top bank U bends replaced

Front side – 24 nos Rear side – 89 nos

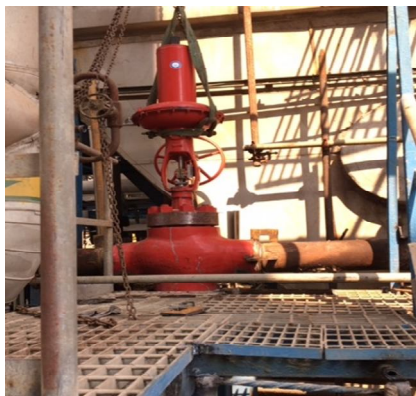
BEFORE MODIFICATION

BFW pipe line inlet to Economiser modified and Level control valve and Isolation valve replaced.

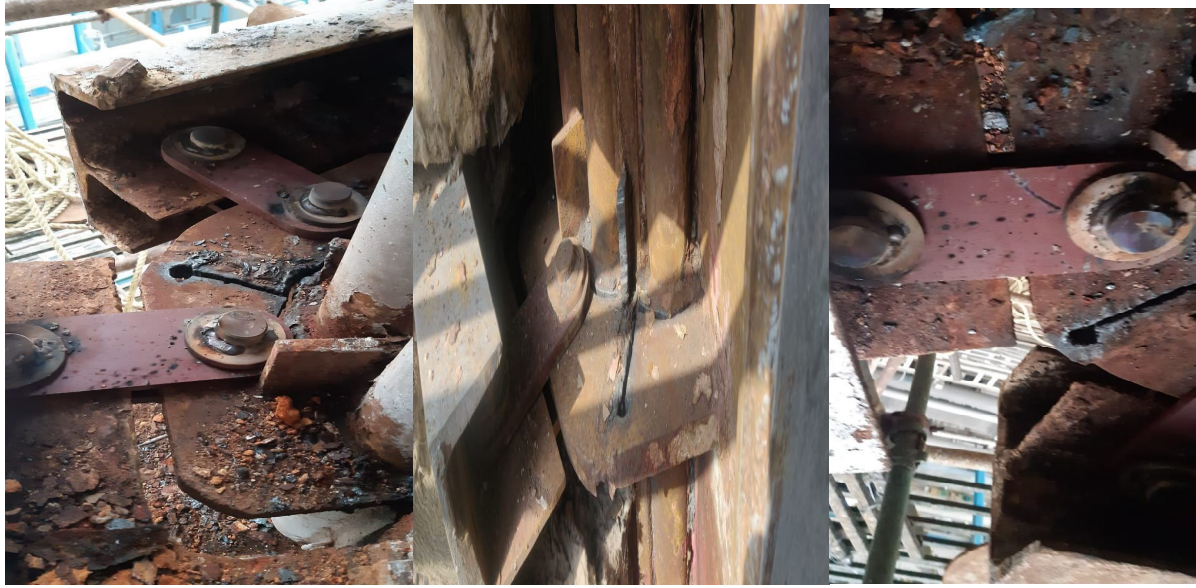
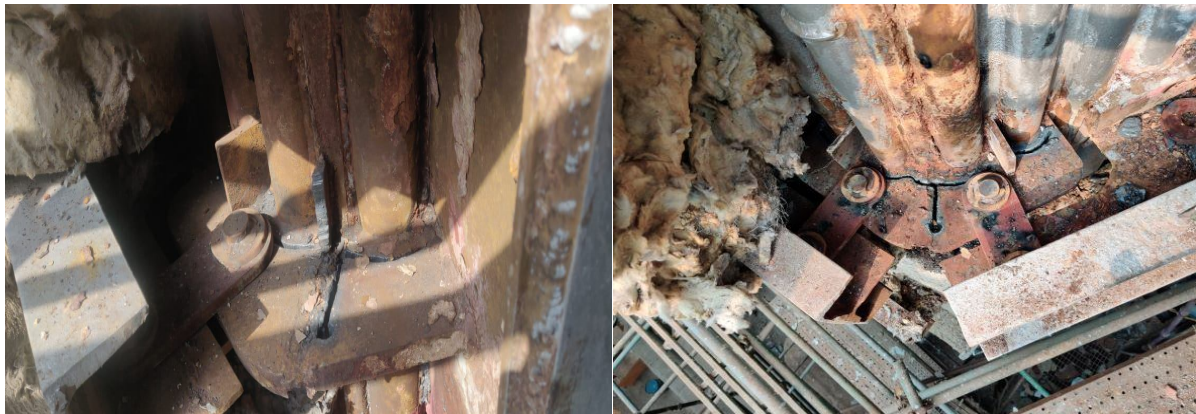
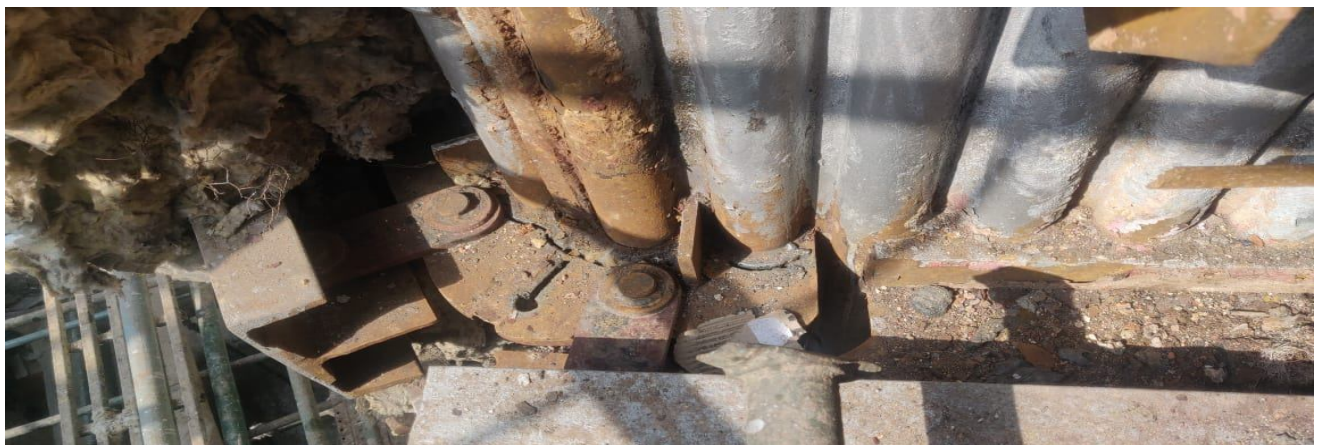
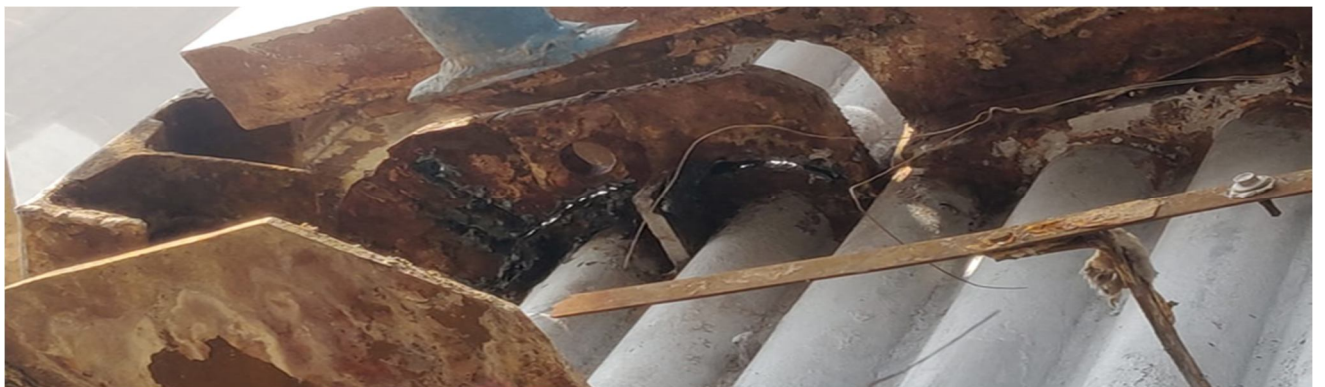
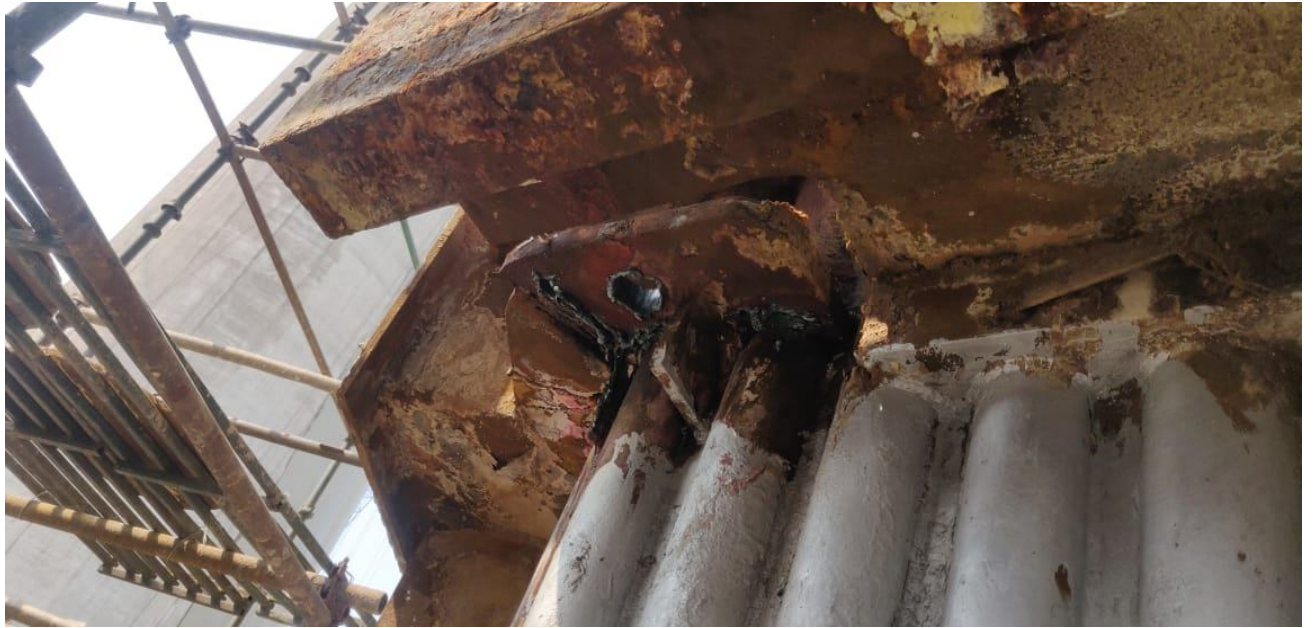
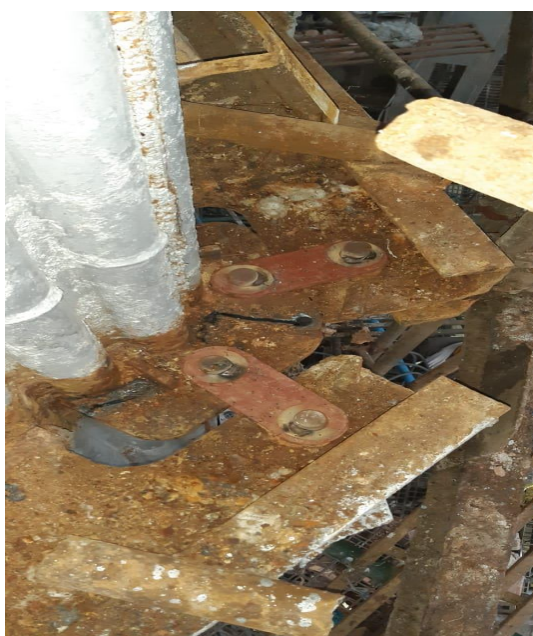
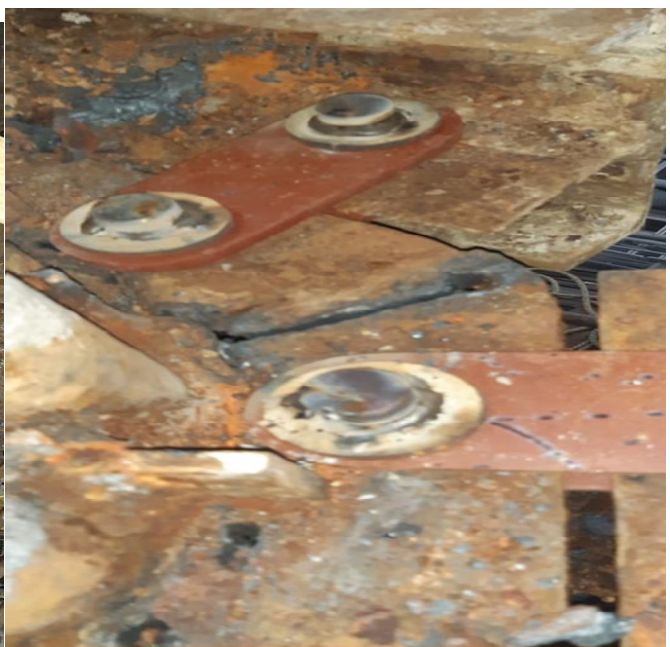
- b) To avoid membrane tubes failures and restriction of thermal expansion at Buck stay, corner plates of buck stay are modified as follows as suggest by M/s Thermal systems (Hyd.) Pvt Ltd

Various pictures of Buck stay corner plate modified at various elevations

There are total 58 No of corner plates installed where 38 nos out of 42 nos above radiation zone (i.e. above El +7.4 m) are modified- as per following drawing.

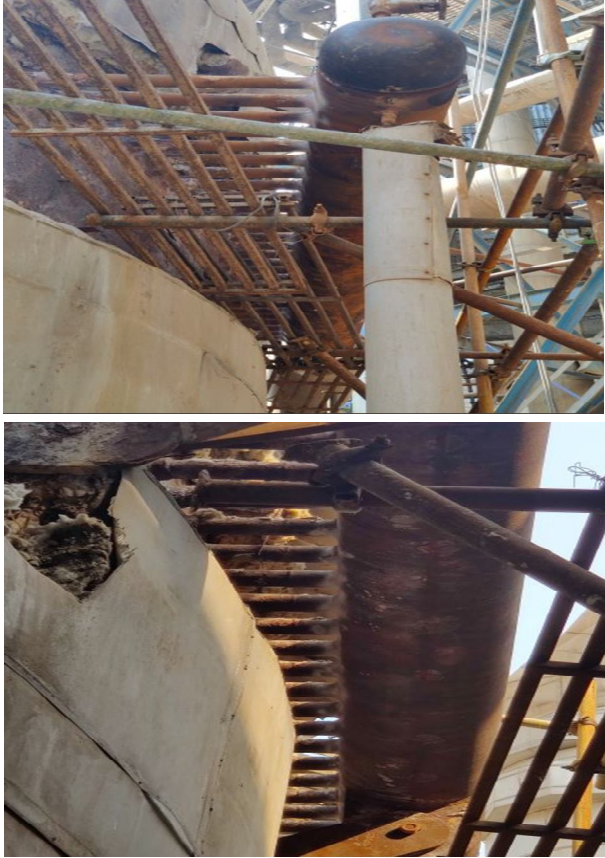
INLET HEADER AND OUT LET HEADER STUB END TUBES INSPECTION

END caps of both headers of Super Heater 1 cutted for fiberoptic inspection as a part of RLA study of boiler

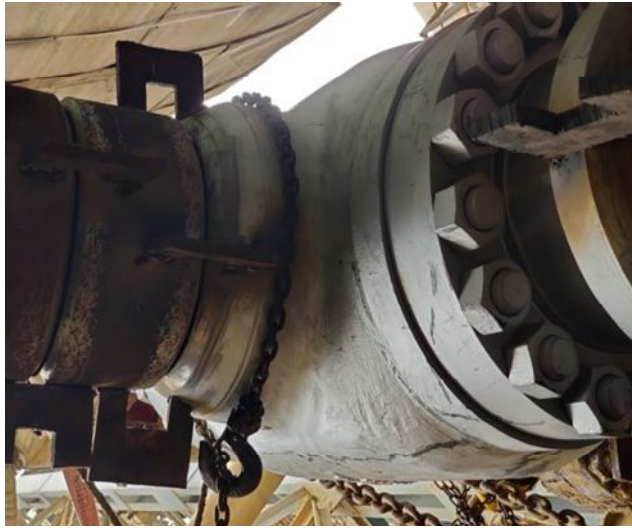
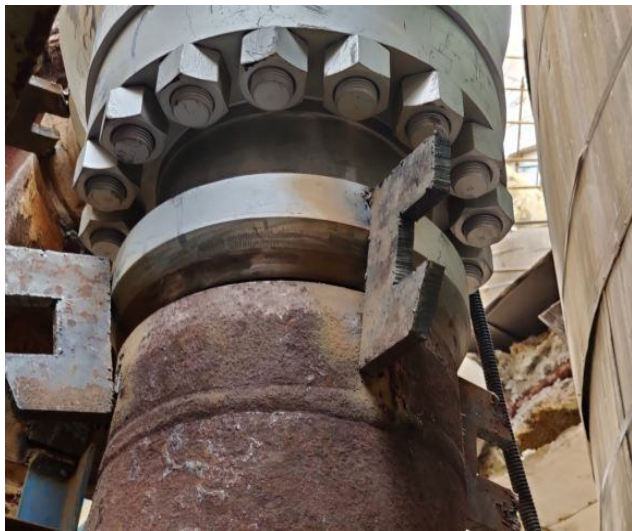
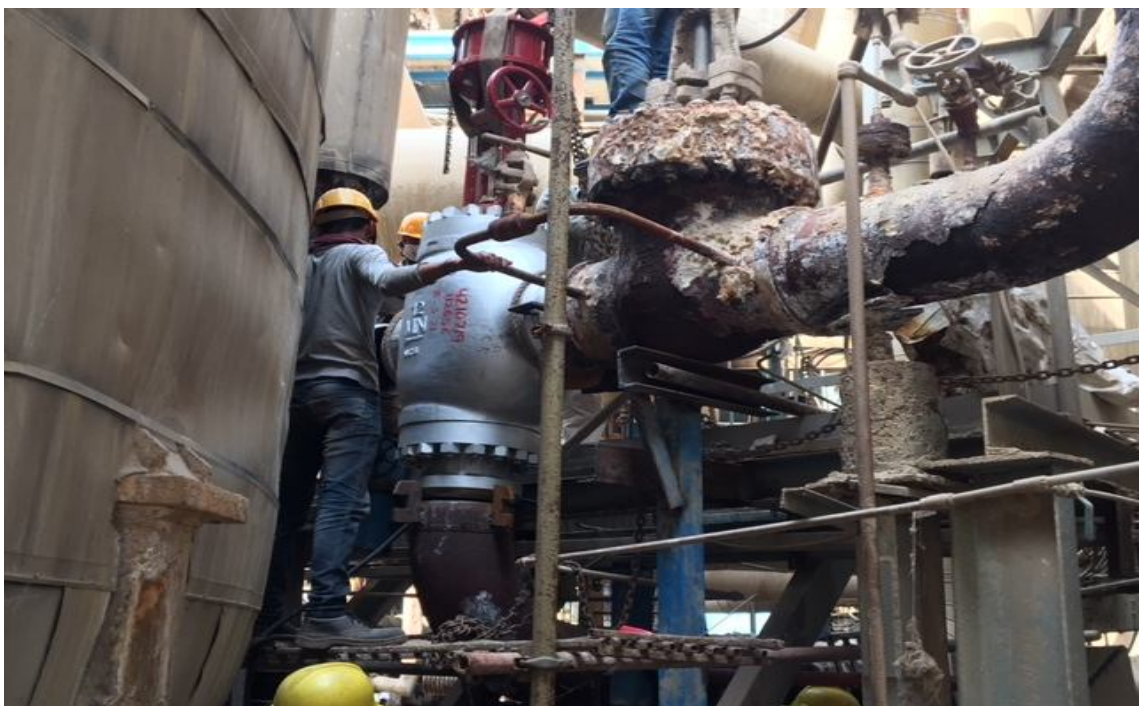
3 way valve replaced at SH- 1 inlet pipe line

**Valve Size - 12", 600 # -MOC ASTM A217 GR WC6 – Make - Baker Hughes
Qty – 01 no**

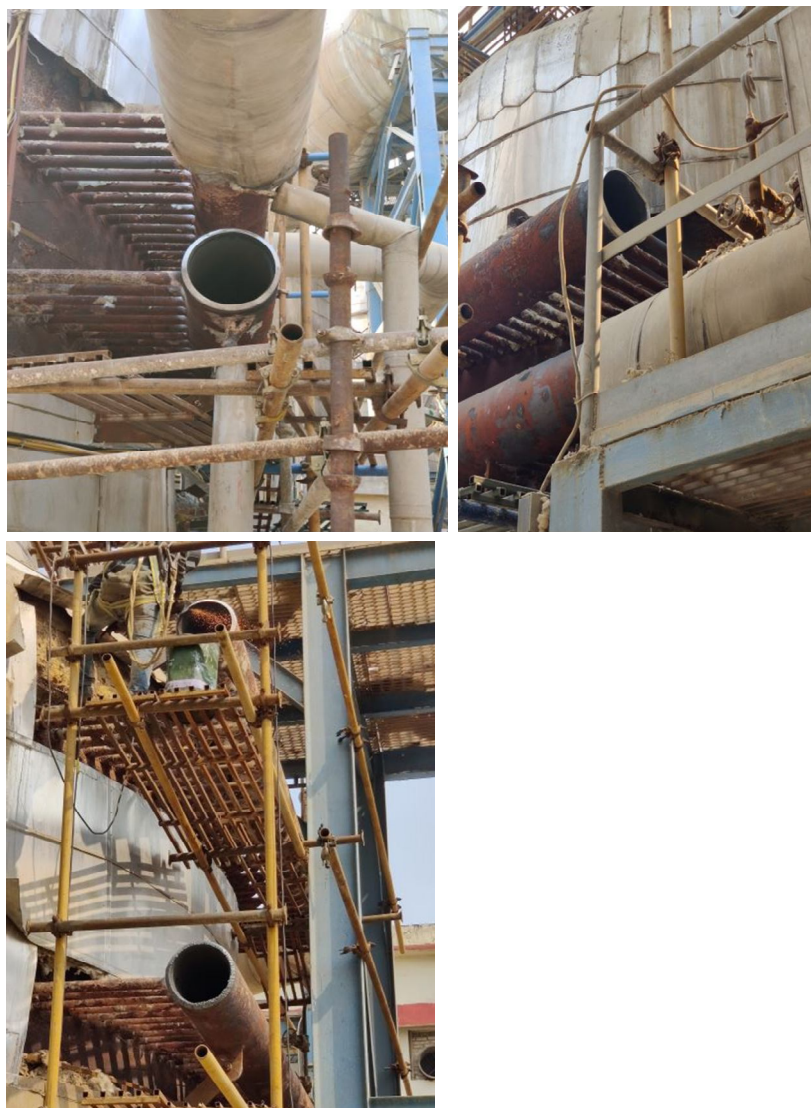
INLET HEADER & OUTLET HEADER STUB END TUBES INSPECTION

**END caps of both headers of Super Heater 2 cutted for
fibereotic inspection as a part of RLA study of boiler**

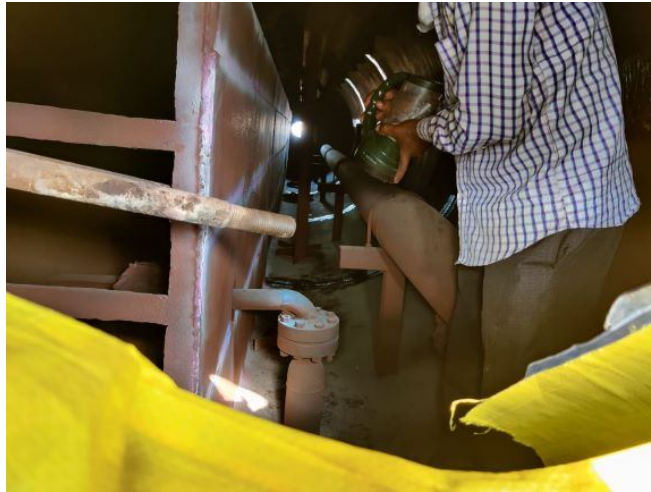
- b) Steam drum internals checked and found in order. L-seam and C-seam joints with dished head DP test checked found ok.

STEAM DRUM INSIDE AFTER COMPLETE CLEANING
