ATR REPORT-2021

**INDIAN FARMERS FERTILISERS CO OPERATIVE LTD.
PARADEEP UNIT**

ATR REPORT: 2021

DAP PLANT

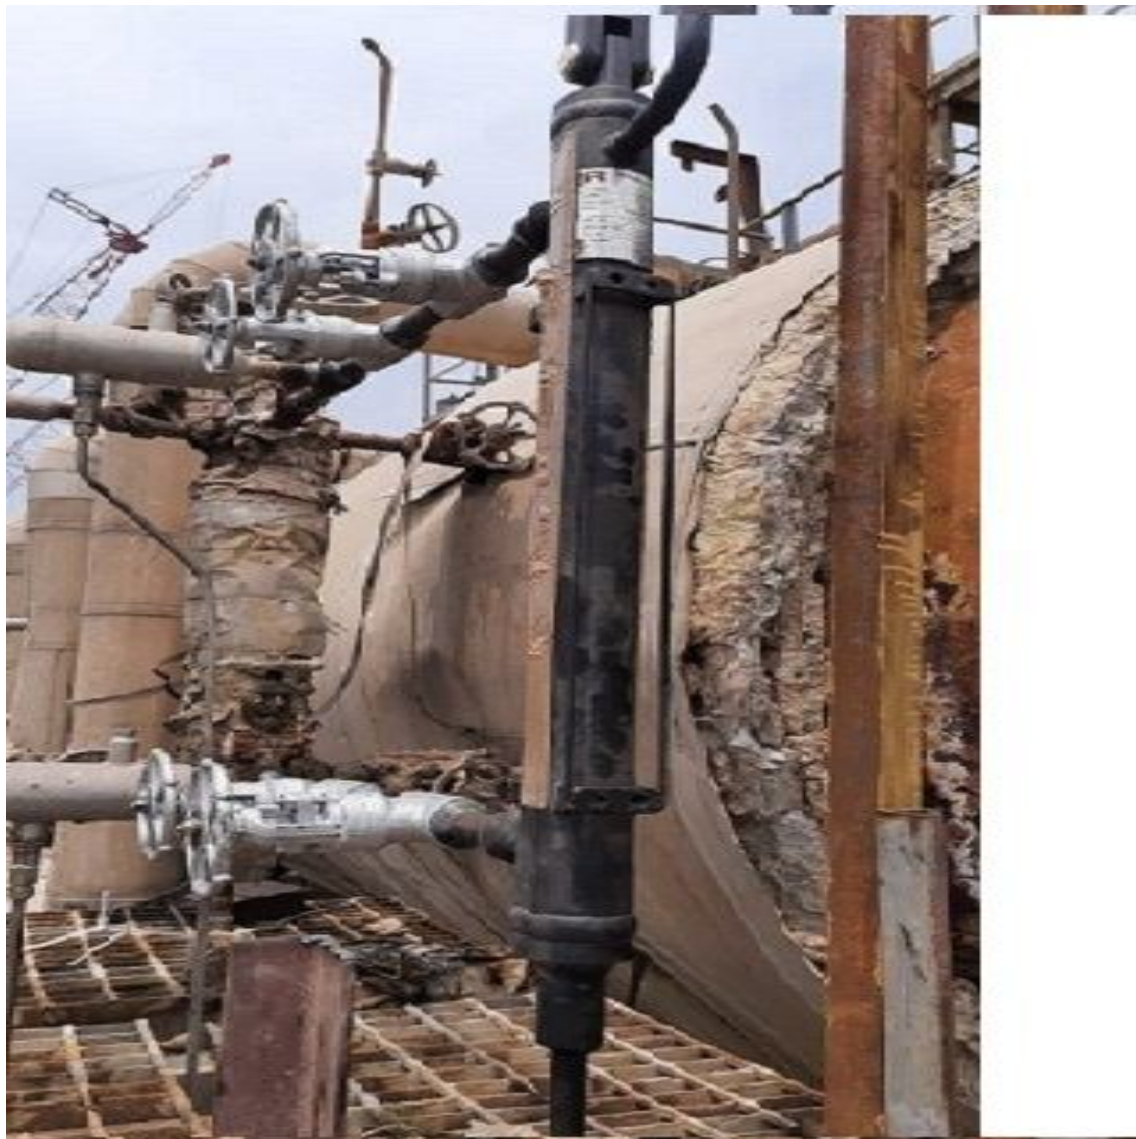
DISTRIBUTION HEADER INSPECTION HOLES OPENED AND INSPECTED

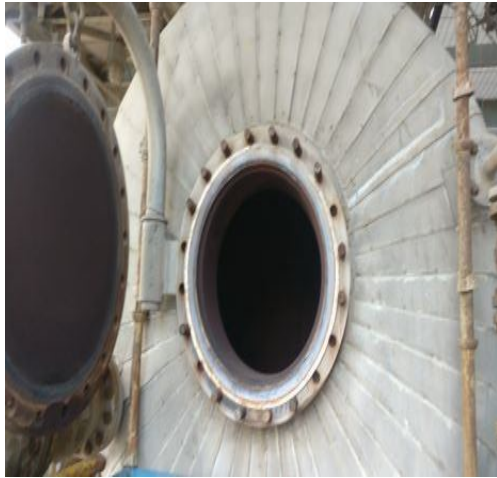
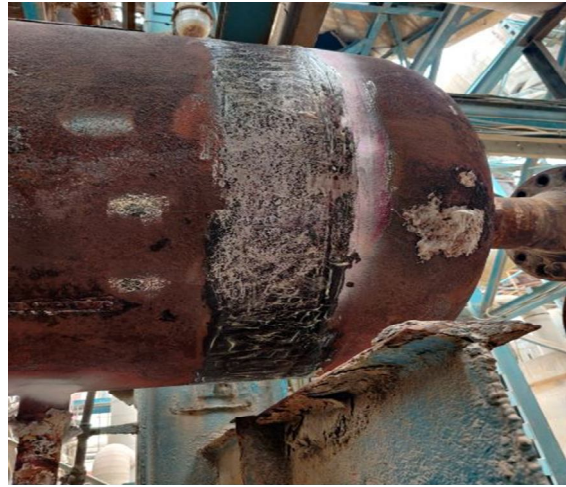
Distribution pipe lines from distribution header joints DP tested

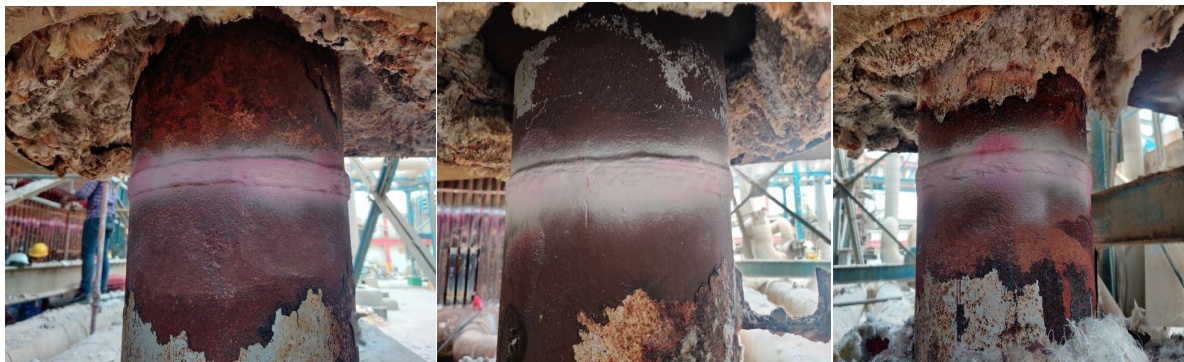
All the stub end joints of distribution pipes 12 nos. at Distribution header and Bottom header are checked with DP test and MP test

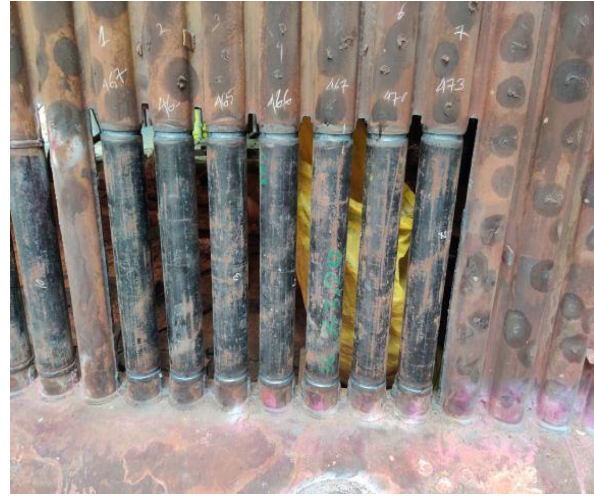
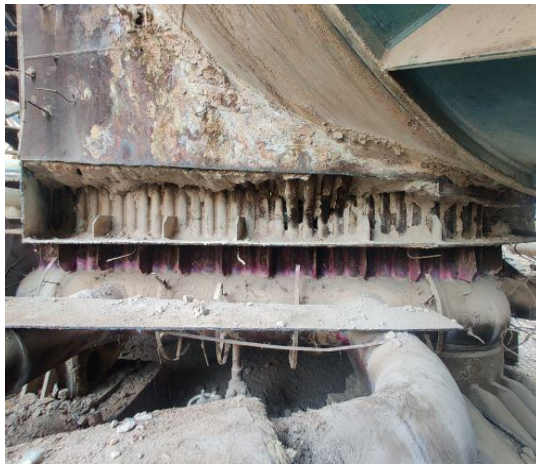
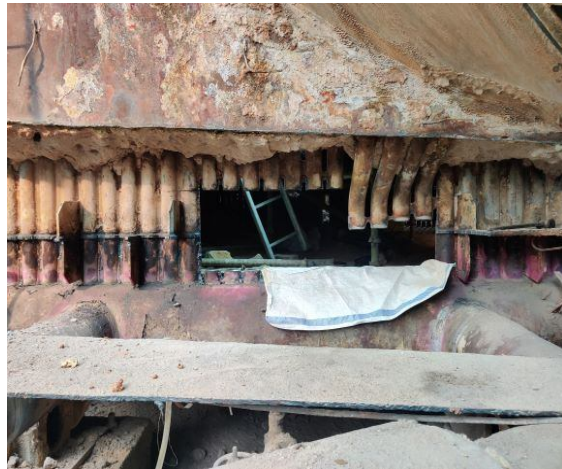
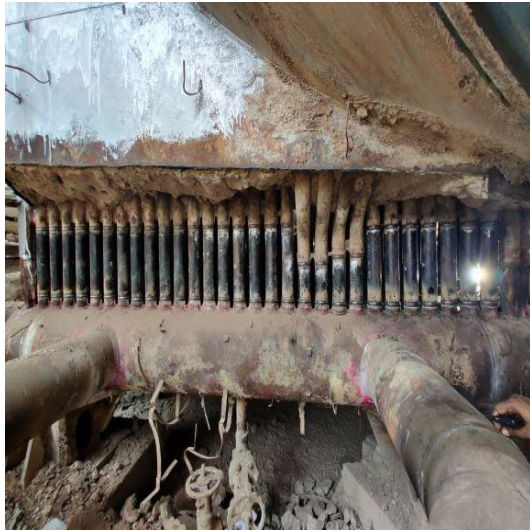
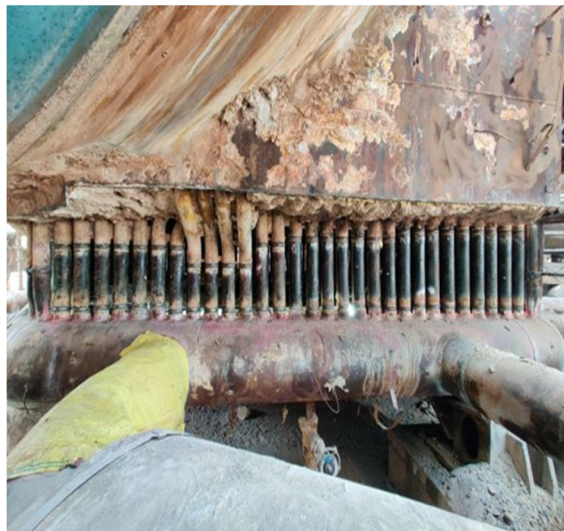
EVAPORATOR WATER WALL PANELS & FLAG COILS

- a) Around 300 mm. length of 96 membrane tubes out of total 186 tubes above bottom header are found eroded badly.
96 nos. membrane tubes measuring from bottom header 400-500 mm are cut and withdrawn and new membrane tubes are fitted back in position and welded

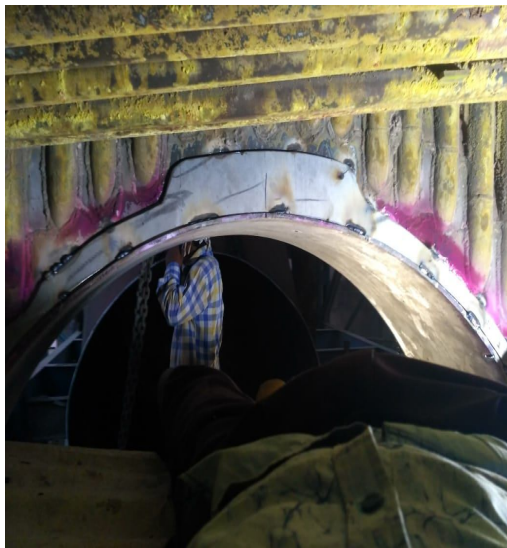
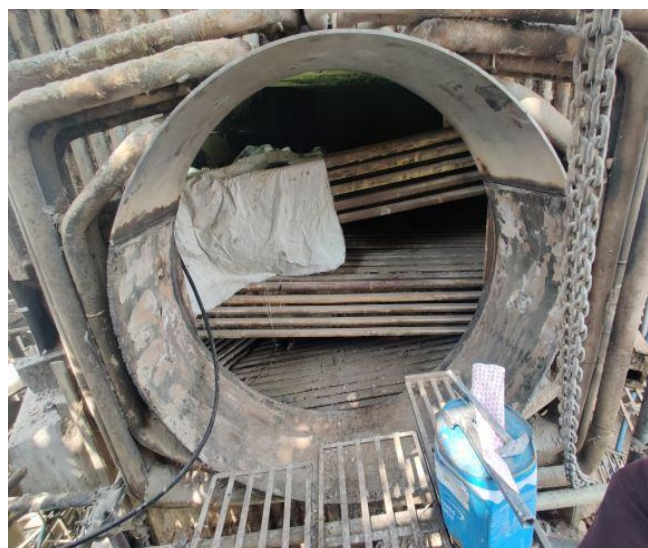
Boiler bypass nozzle top portion badly damaged which is replaced with new one.

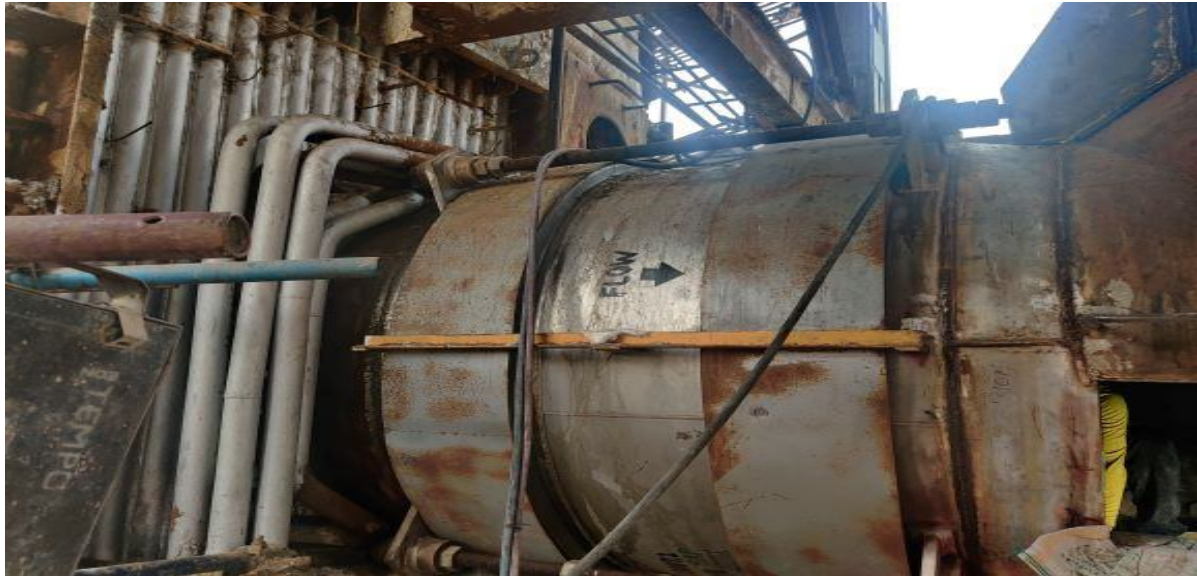
Replacement of Expansion Bellow at Boiler Bypass duct – 1800 NB

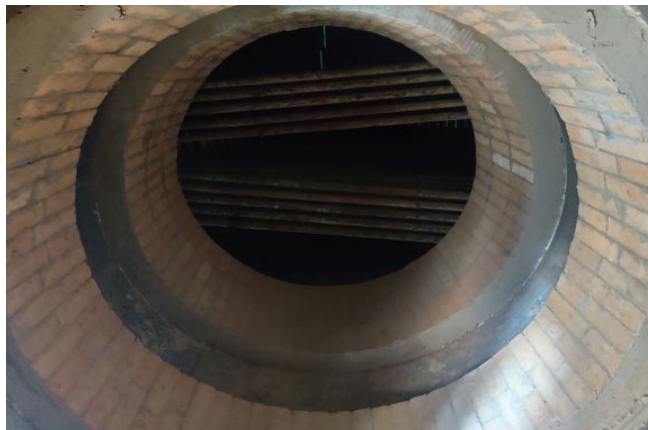
Brick lining of inside of bypass duct

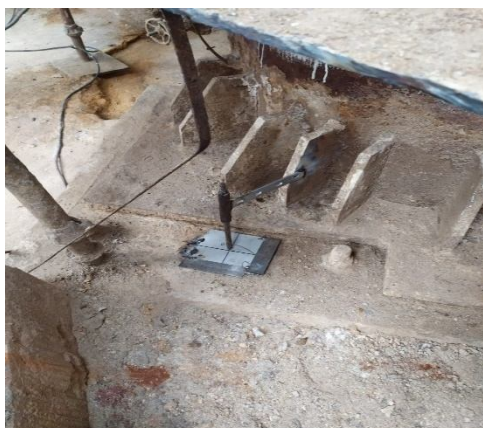
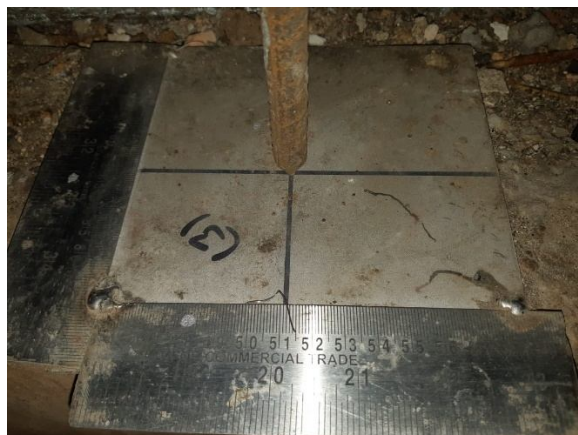
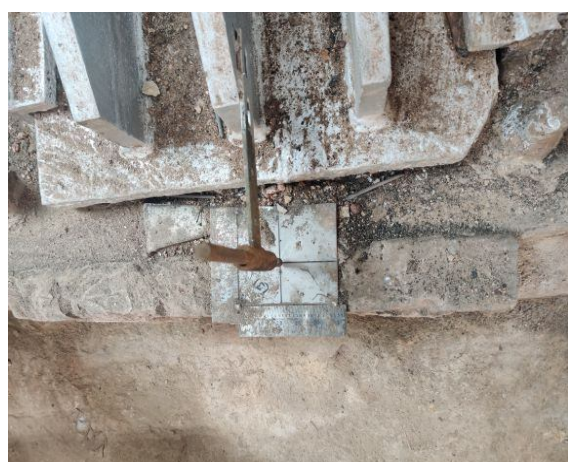
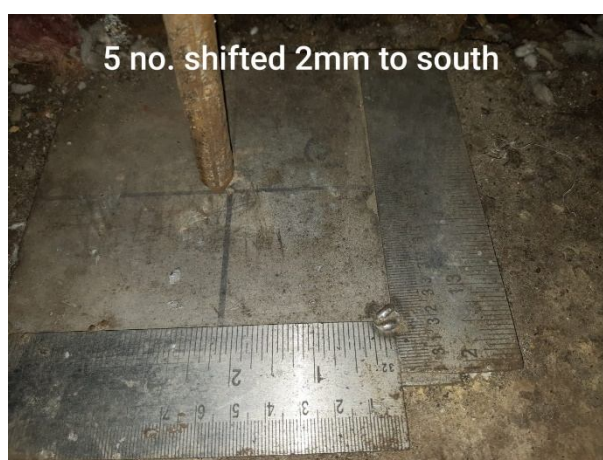
To measure the thermal expansion of Boiler, 05 nos. of thermal expansion measurement provided at Bottom header pedestal supports and one no. at steam drum.

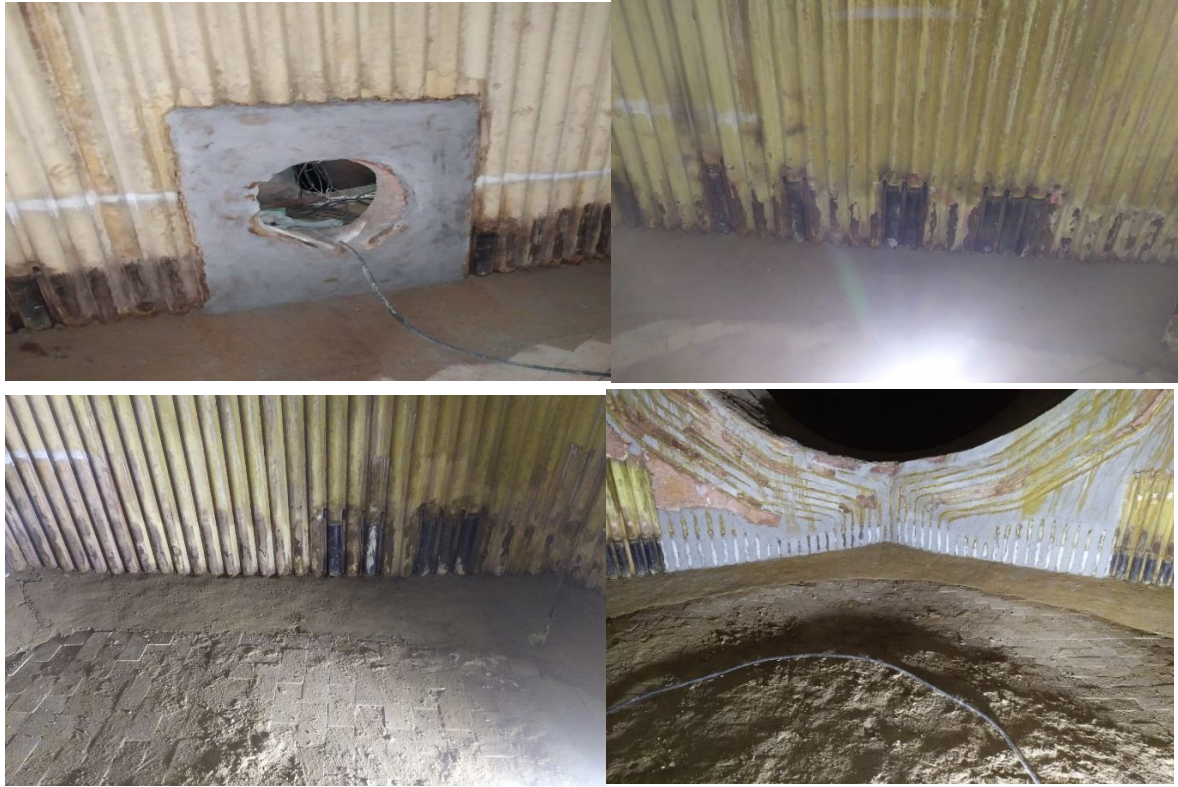
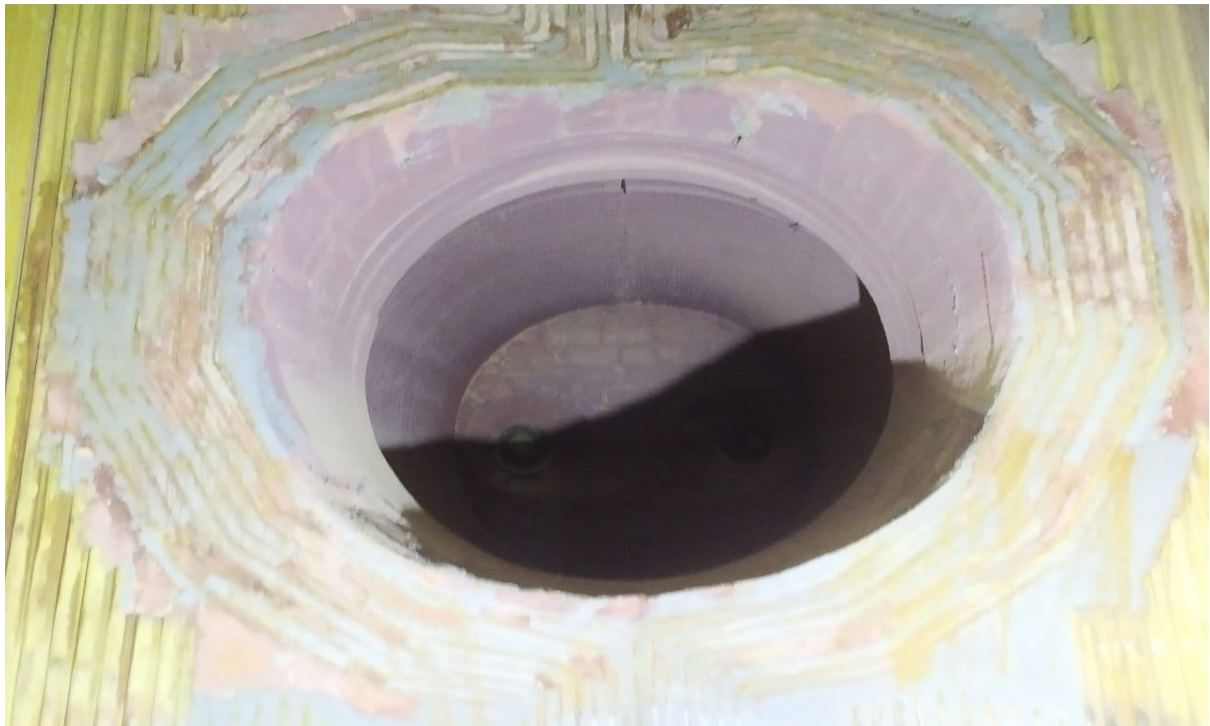
Boiler Bottom header refractory castable removed and header checked and bottom plate joints

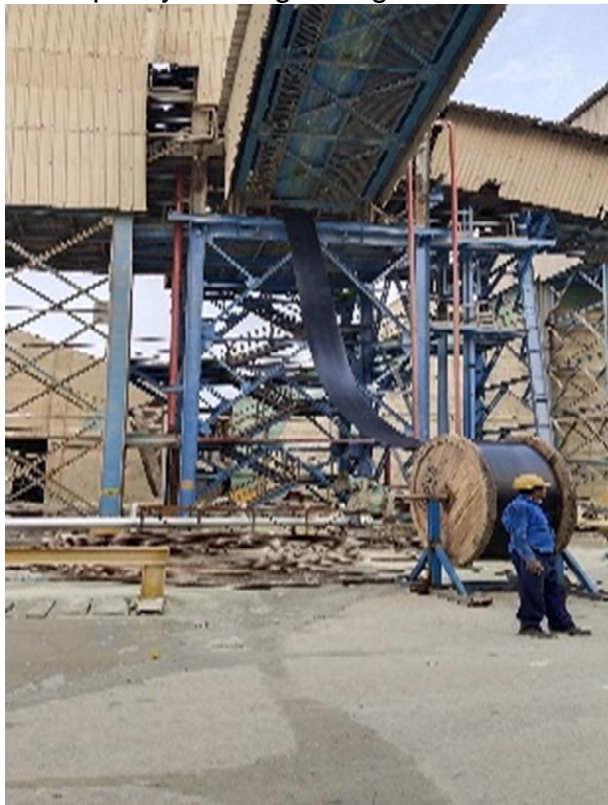
C.CONVEYOR 103

1. All pulley bearing checked & greasing done with Omega 73.
2. Damaged carrying idlers are replaced by HPPE idlers with their frames.
3. Gear box checked, oil flushing done and new oil Mesh 320 replaced.
4. Primary scrapper installed.
5. Belt replacement done with new belt.
- 6.Tail pulley bearing changed with new sleeves.

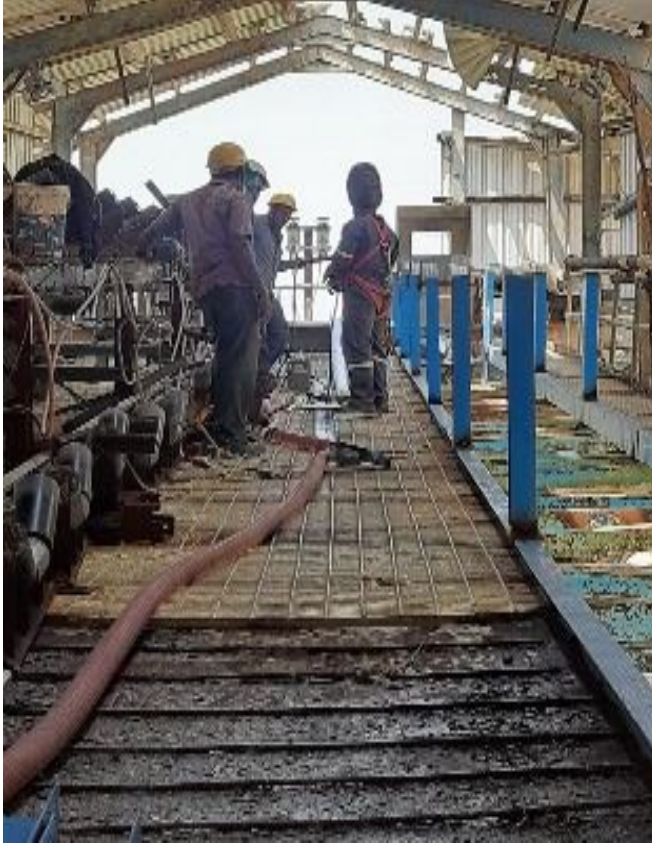
D.CONVEYOR 104 A

1. Conveyor belt removed, conveyor structure replacement done completely.
2. Deck plate new fitting done, Gear box removed and overhauling done.

3. Complete alignment done. Head pulley lagging done and bearing changed.
4. New conveyor belt replacement done and hot vulcanization done.
5. Snub pulley bearing changed.
6. Primary scrapper blades replaced.
7. Main support beam near head pulley strengthening done.

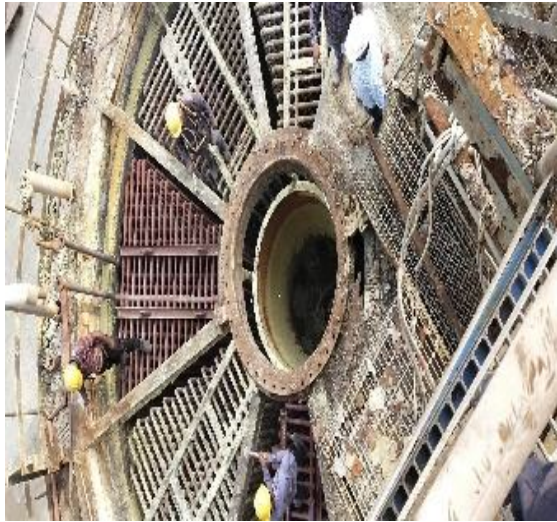
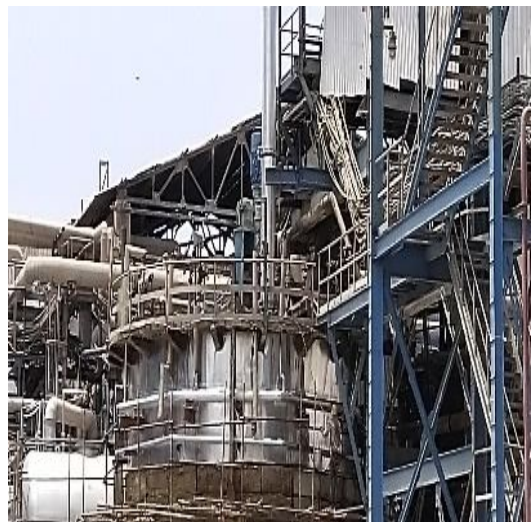
MELTER 131

1. All roof plates, associated structure, chimney and agitator removed from position.
2. Five nos coil removed from position from base for easy cleaning.
3. Conical portion neck area and flange cleaning done and welding done after thickness measurement.
4. All coils steam trap cleaning done.
5. 01 no new coil replaced and other five nos coil positioning done after cleaning and hydro testing.
6. Complete shell, conical portion, chimney, associated pipe line blasting and HR painting done.
7. All coils, chimney, agitator, roof plates positioning done.
8. Hydro testing of shell done and found ok.
9. Melter overflow nozzle, overflow pipe and filling pipe repairing done and positioning done.
10. Agitator gear box oil flushing done and greasing done.

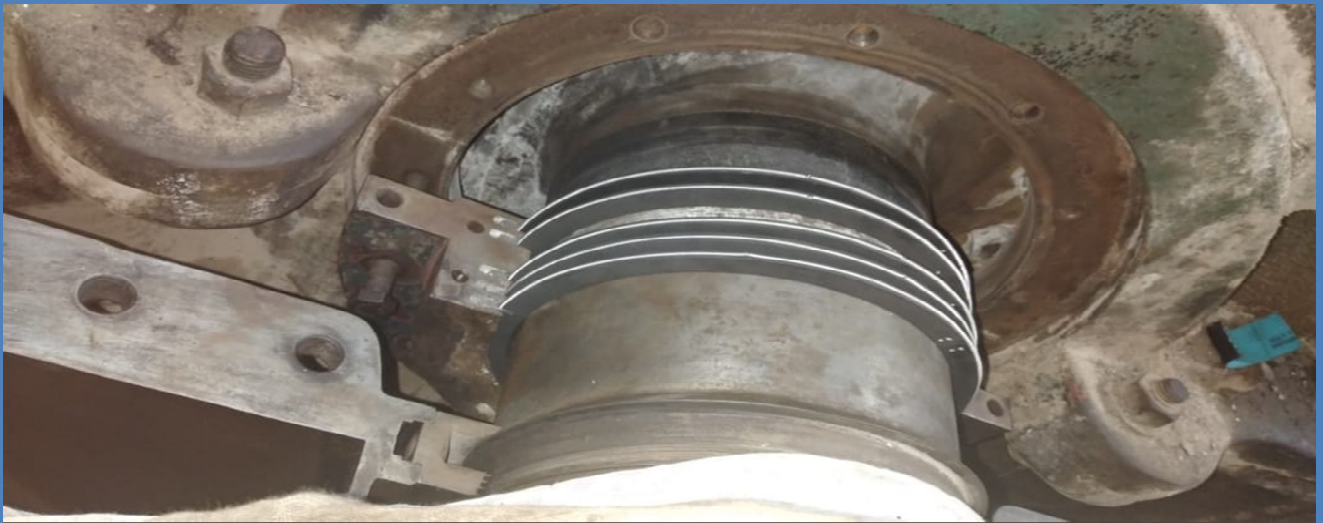
TURBINE MECHANICAL SEAL CARBON RING
DAMAGE.

BROKEN CARBON RING CHANGE
WITH NEW.

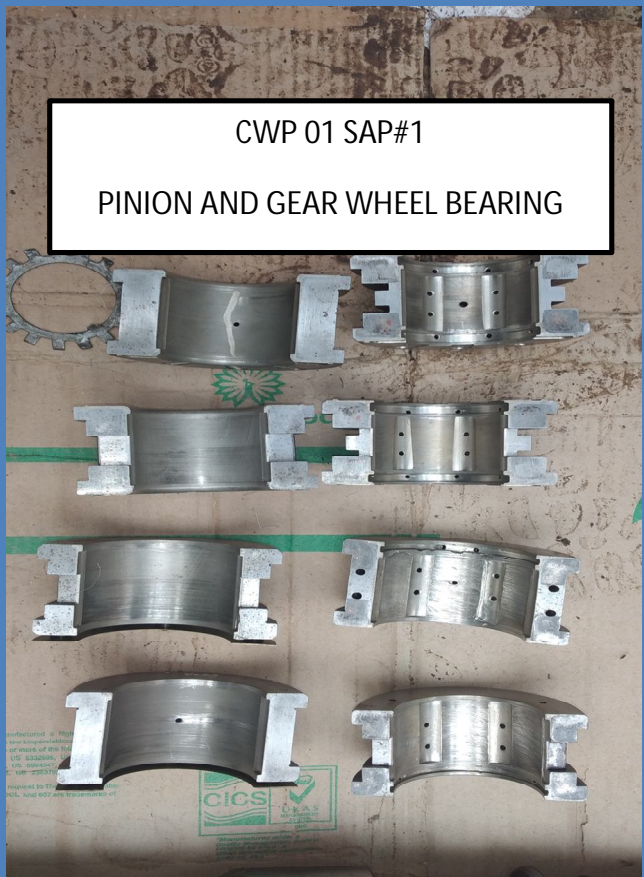
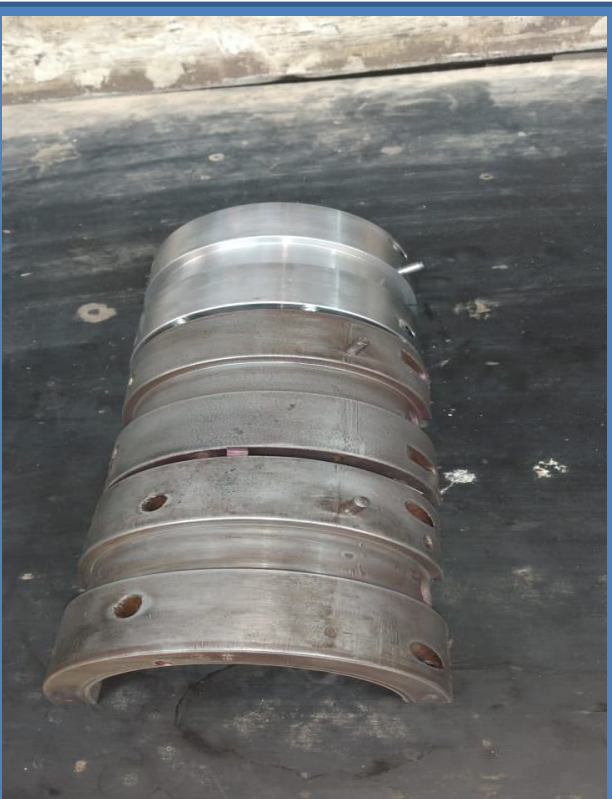
CWP 01 SAP#1
PINION AND GEAR WHEEL BEARING

GEAR BOX PINION (DE) SIDE BEARING CHANGE DUE TO HIGH CLEARANCE AND IN NEW BEARING ANTIROTATION PIN FOUND IN WRONG POSITION AS PER OLD BEARING

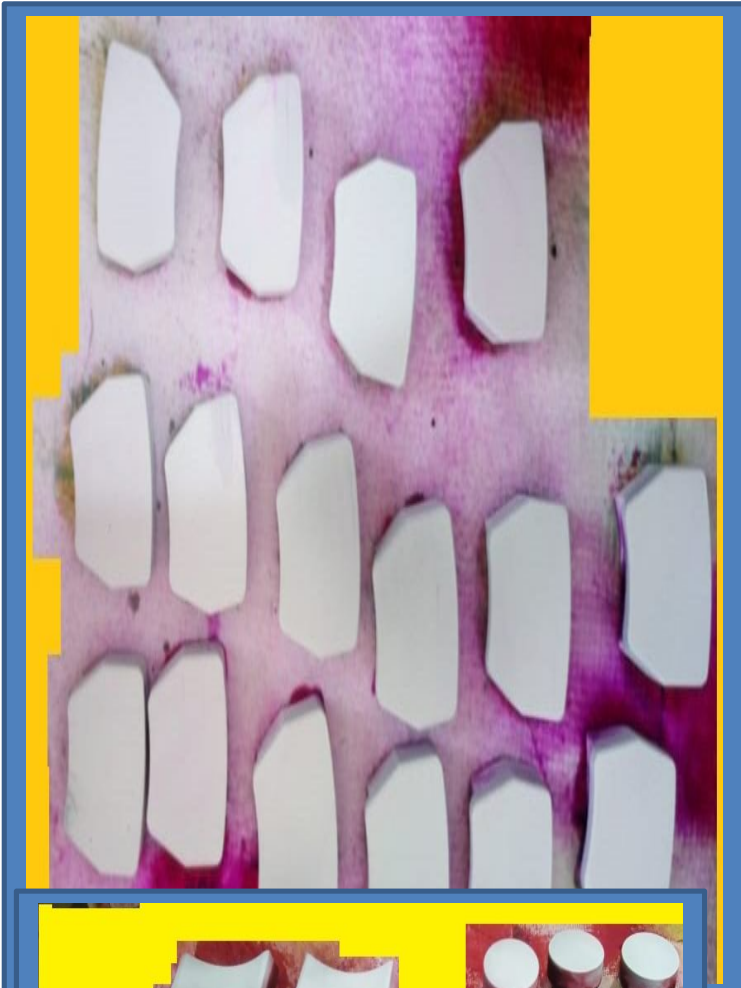
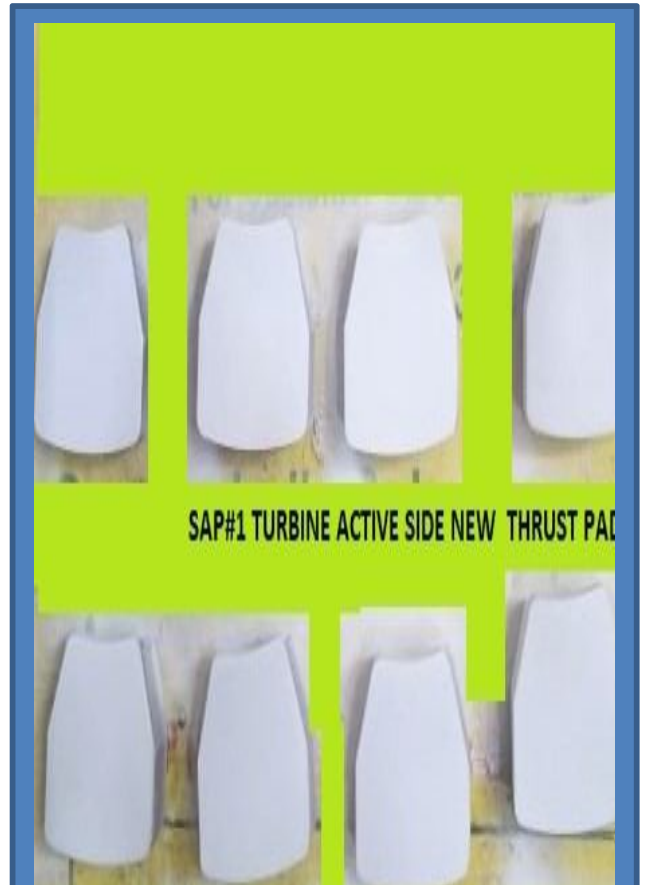
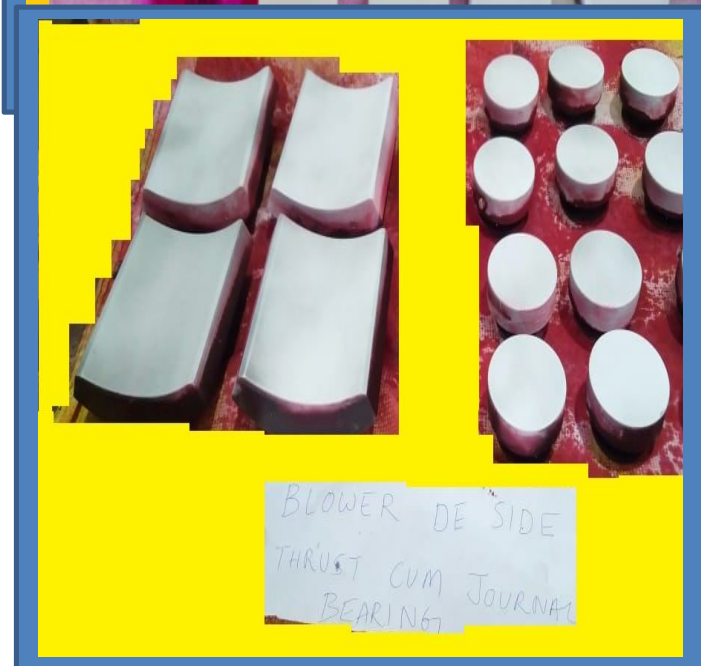
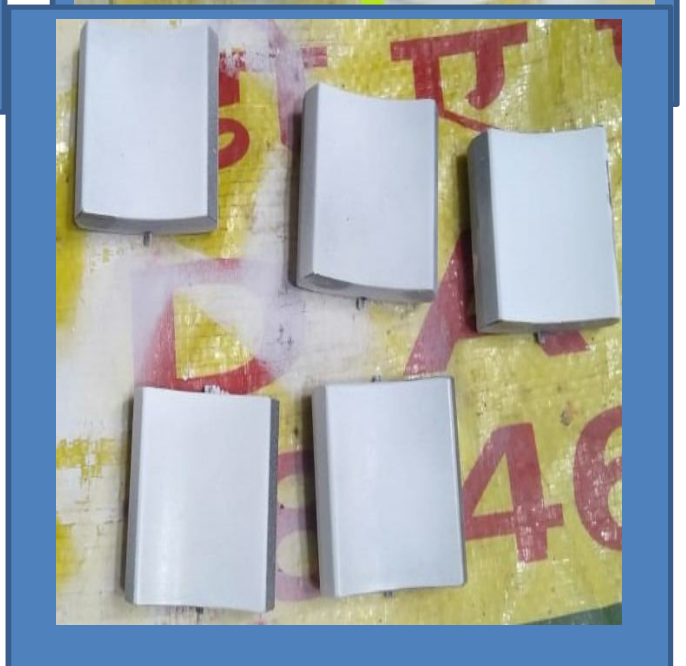
SAP#1 BLOWR BEARING (DE AND NDE SIDE)

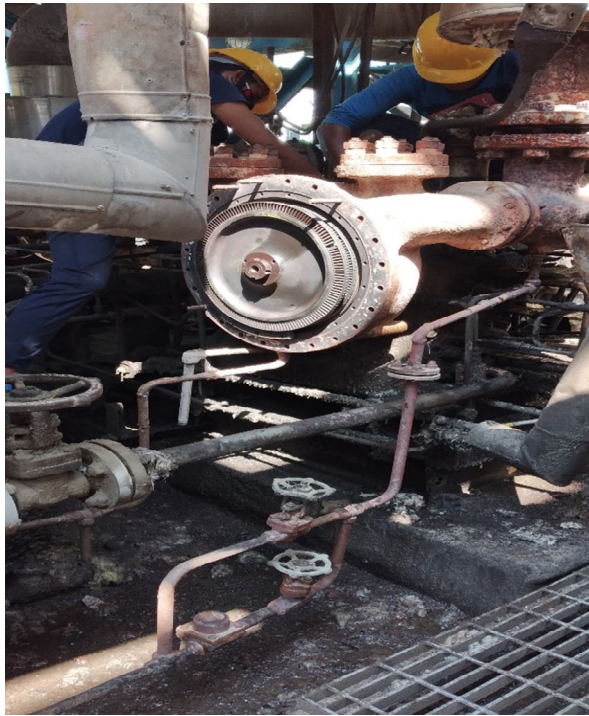
CWP TURBINE ROTOR DISMANTLE

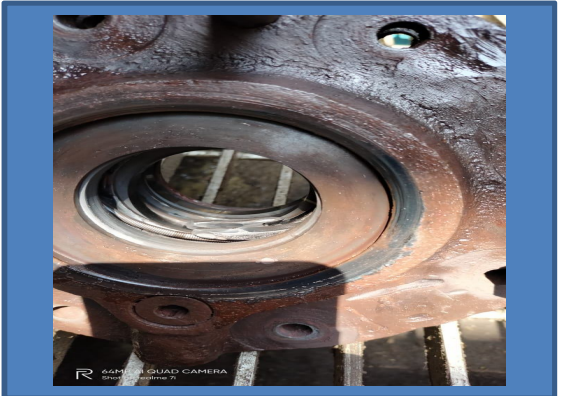
CWP 01(SAP2) AND CWP 04 ,01 (SAP1)

TURBINE MECHANICAL SEAL CARBON RING
DAMAGE.

MECHANICAL SEAL CARBON RING FOUND DAMAGE

BROKEN CARBON RING CHANGE
WITH NEW.

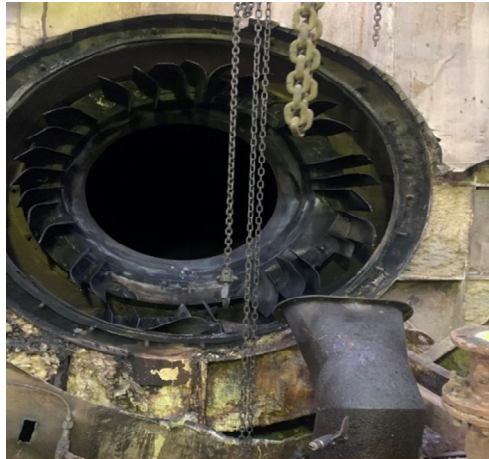
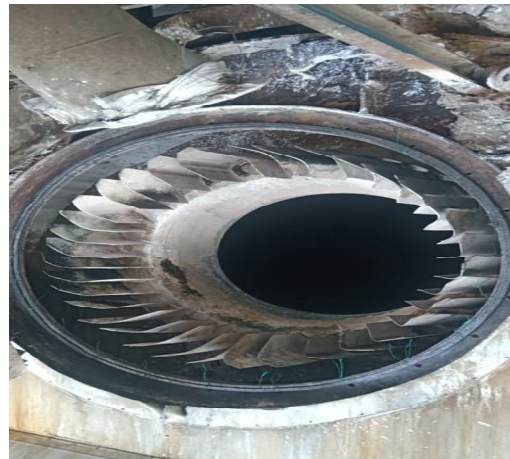
- ✓ Both Sulphur Burner removed and Balancing done with new rotary cup.
- ✓ Bearing and Seal replaced with new one.
- ✓ Wind box opened and found the air resister vanes are in damaged and broken condition.
- ✓ All damaged vanes replaced with new vanes made of SS 304 and ,
- ✓ All seal rope replaced with new one and matching face lapped to proper contact with burner sealing face.

Fig 2.1(a) damaged vane of air resister fig 2.1(b) after vane replacement

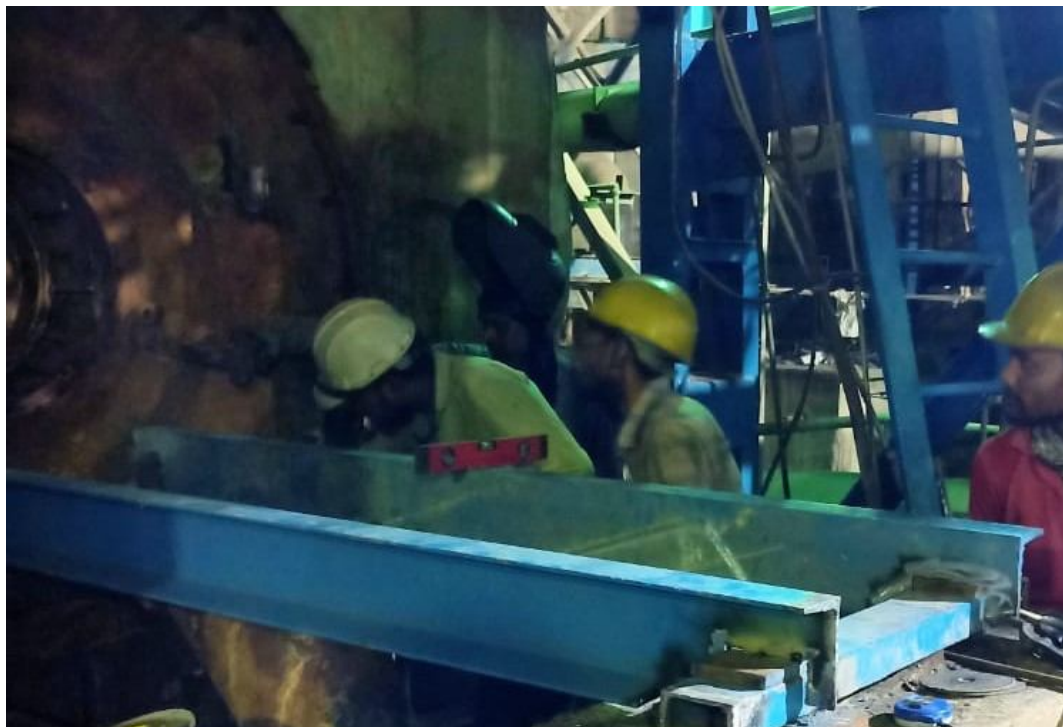
Fig 2.1(c) burner rail after replacement

- ✓ Burner Base rail replaced with new strengthen beam from 75 to 120 Chanel to enhance the burner support strength.

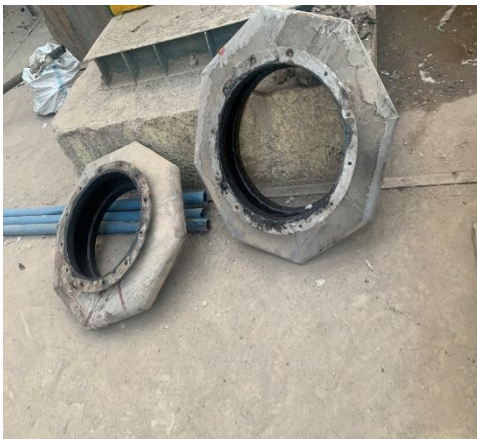
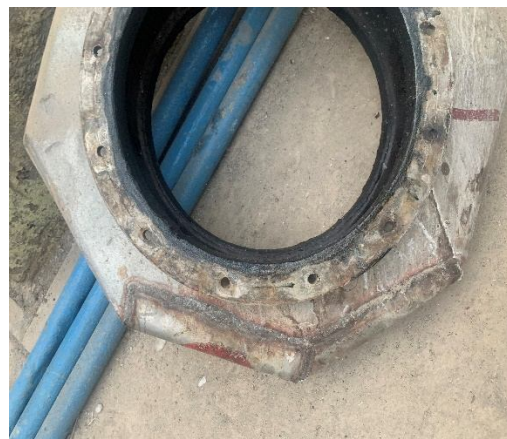
Fig 2.2(a) Damaged suction and discharge below of PA fan

- ✓ Both PA fan overhauling done fan rotor removed balancing checked, Bearing with sleeve replaced with new bearing and sleeve.
- ✓ Both PA fan Suction and discharge duct expansion bellow replaced with new bellow.

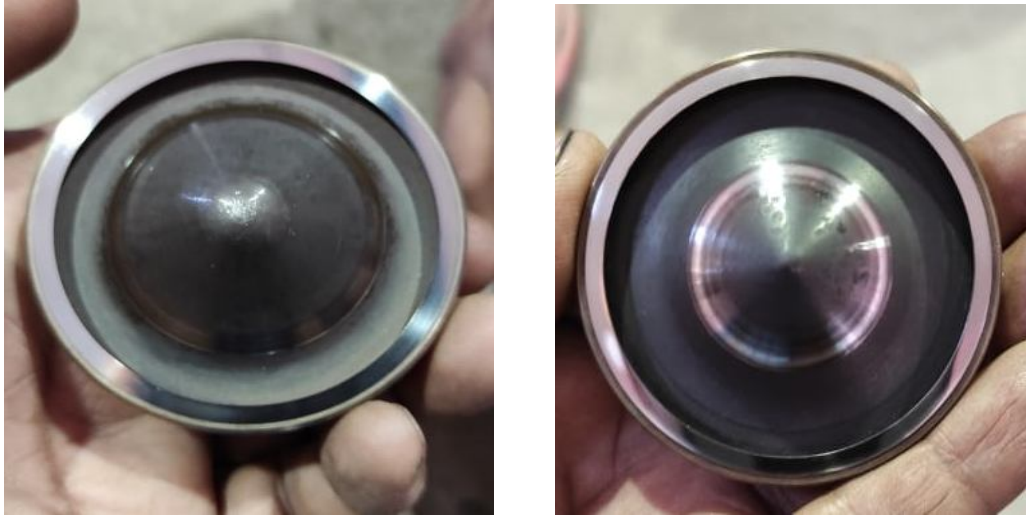
Fig2.3(a) disc insert after lapping

- ✓ Boiler Drum Both Safety Valve removed and lapping/ Servicing done and tested on test bench for set pressure 74 Kg/Cm2 and 75Kg/cm2.
- ✓ Economizer Safety valve Lapping Servicing done and tested on test bench.
- ✓ Super heater Safety valve is replaced with new one and tested on test bench.
- ✓ CBD tank safety valve removed Lapping /Servicing done and tested in in test bench.
- ✓ Startup vent isolation valve which has passing removed and lapping & testing done.
- ✓ Super heater -1 control valve isolation valve ring gasket removed and Valve disc lapping done for proper sealing.
- ✓ Export steam line valve which has jamming problem spindle removed servicing done and installed with smooth operation.
- ✓ BCW pump 1 steam exhaust line isolation valve which has heavy passing removed lapping of disc done and servicing done for smooth operation.

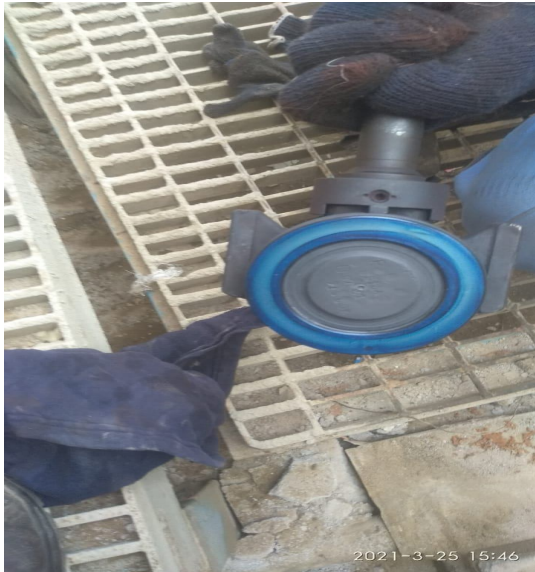
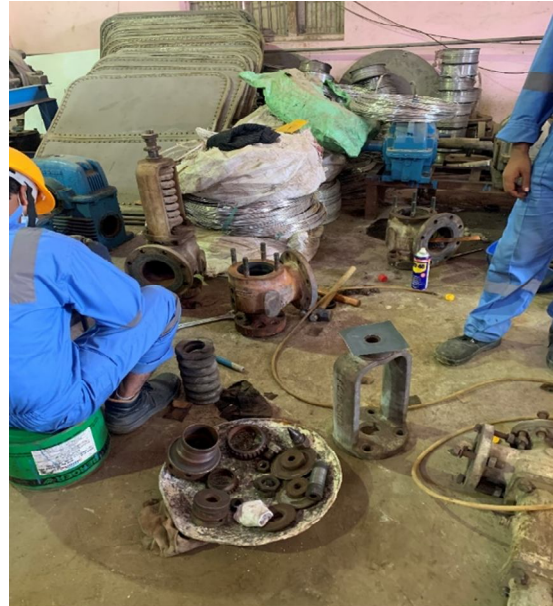
Fig 2.3(c) Lapping / Servicing Job

- ✓ LP deaerator All three safety valve removed and lapping servicing done.

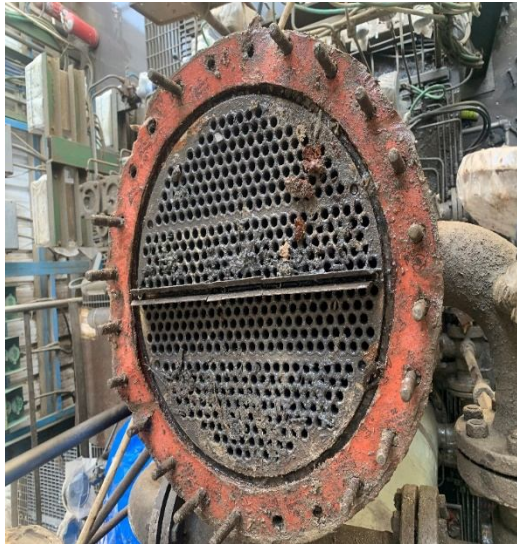
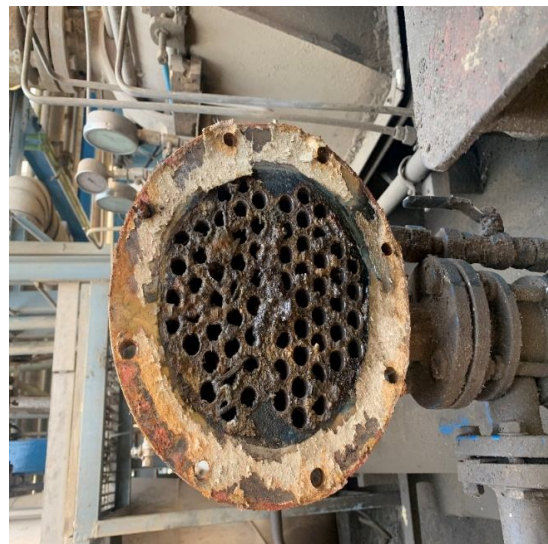
Fig 2.4.1(a) lube oil cooler before cleaning

- ✓ Turbine Both Lube oil cooler cleaned with hydro jetting at pressure 150 kg/cm²
- ✓ Both Cooler of BCW pumps cleaned by hydro jetting machine at pressure 100 kg/cm².
- ✓ Condensate and gland steam cooler of Turbine cleaned by hydro jetting machine at pressure 100 kg/cm².

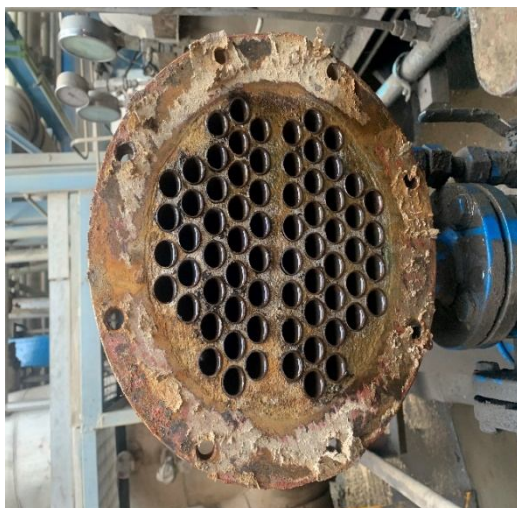
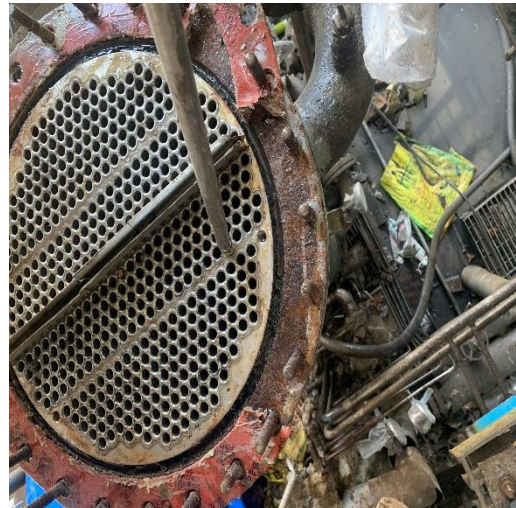
Fig2.4.1 (b) lube oil cooler after cooling

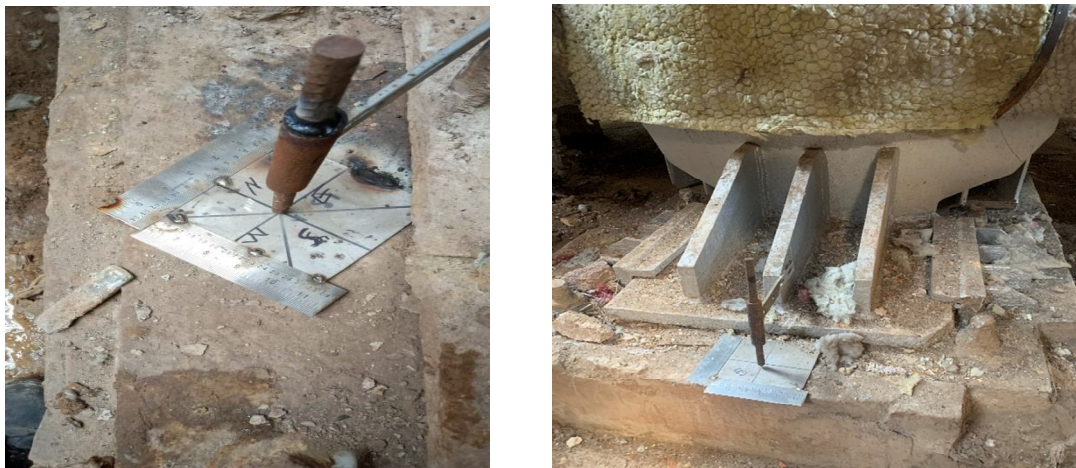
Fig 2.5(a) Arrangement for boiler thermal expansion measurement

- ✓ Arrangement is made to measure the thermal expansion of boiler at its each supports and at steam drum.
- ✓ SH-1 & SH-2 support thermal expansion measurement is done along with boiler and steam drum.

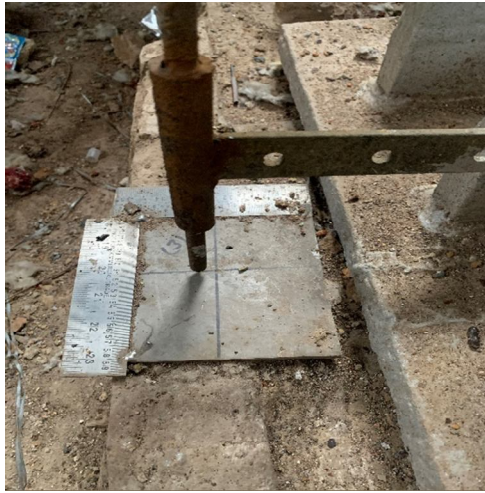
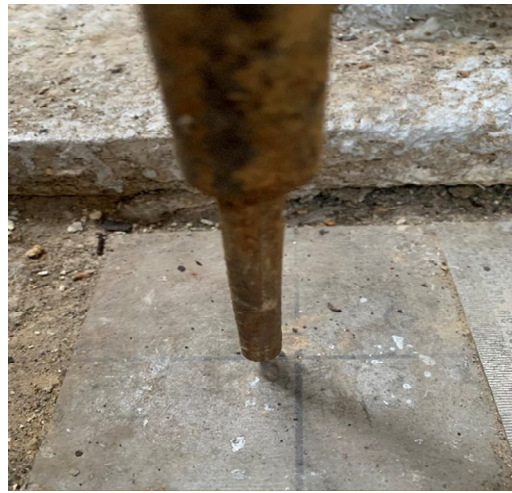
Fig 2.5(b) Samples after thermal expansion of boiler

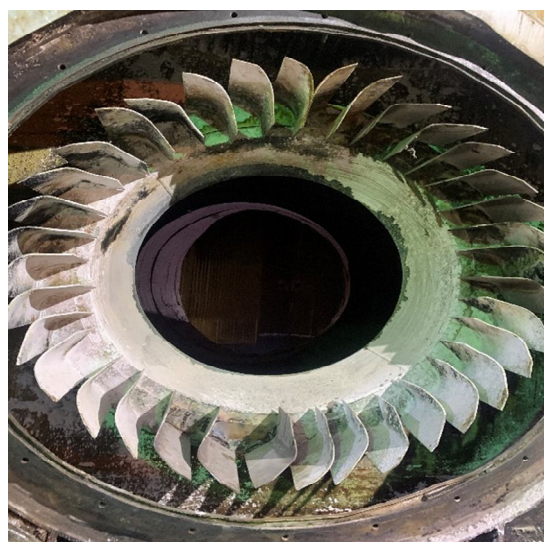
fig 1.1(b) after vane replacement

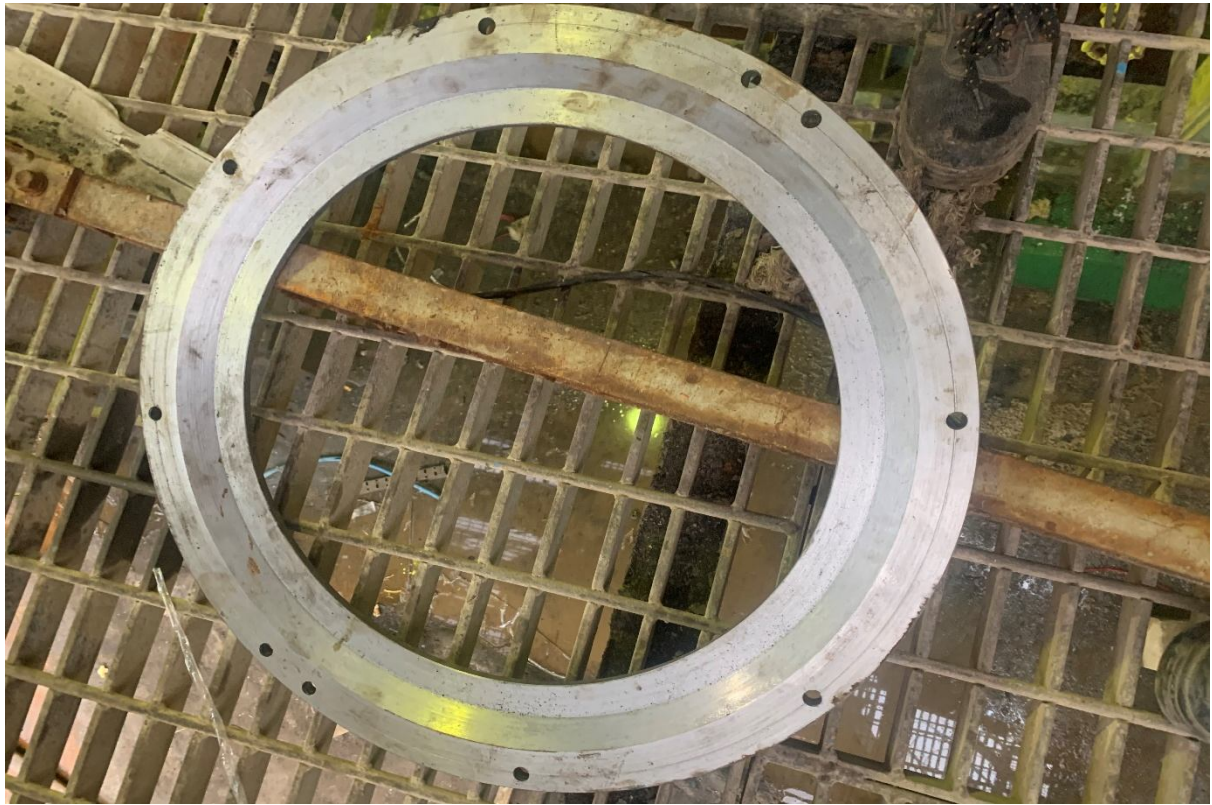
Fig 1.1(c) indigenously developed matching plate

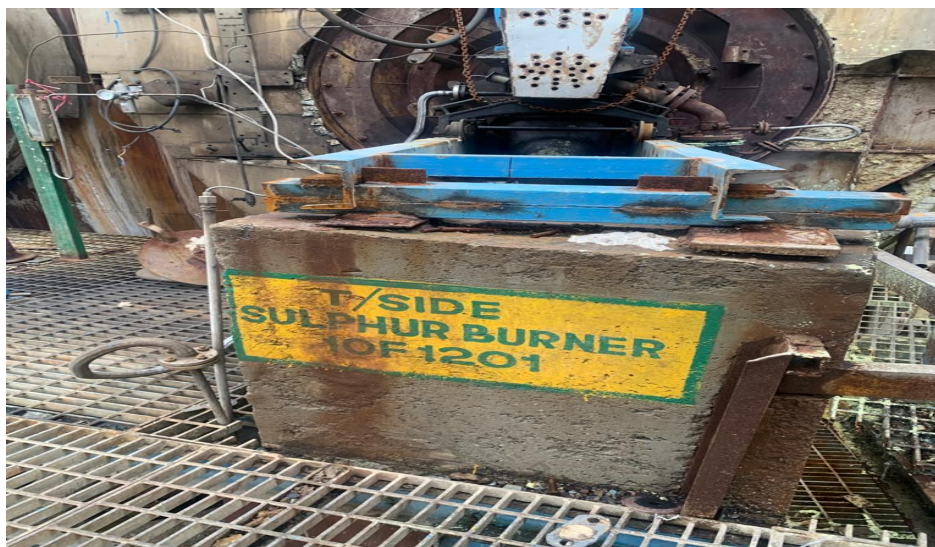
Fig 1.1(d) burner rail after replacement

- ✓ Burner Base rail replaced with new strengthen beam from 75 to 120 Chanel to enhance the burner support strength.
