ATR REPORT-2021

**INDIAN FARMERS FERTILISERS CO OPERATIVE LTD.
PARADEEP UNIT**

ATR REPORT: 2021

DAP PLANT

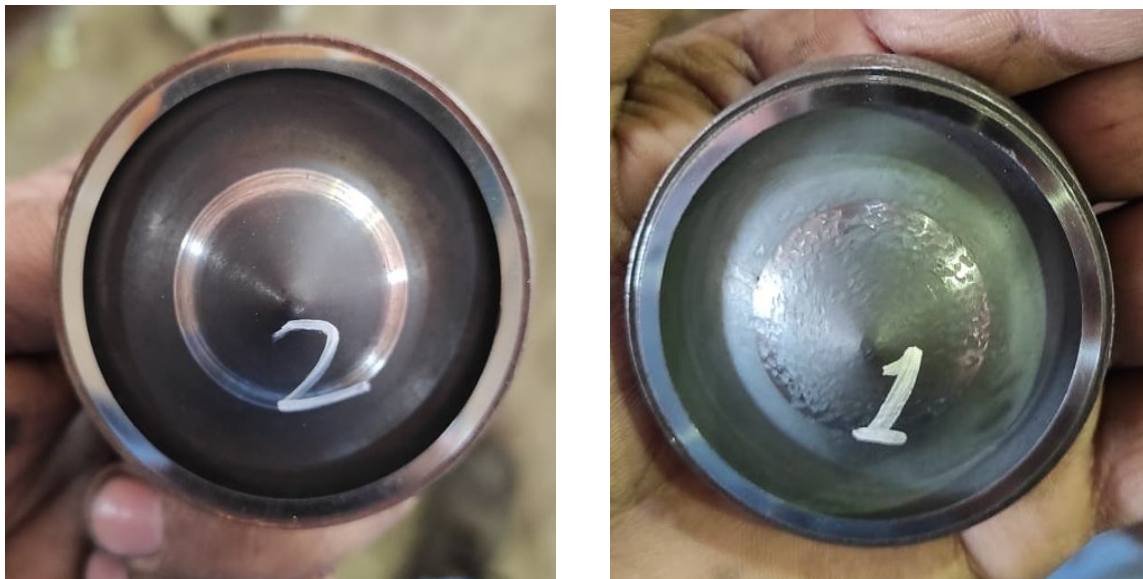
Fig 1.3(b) Steam Drum both Safety valve disc after lapping

- ✓ Boiler Drum Both Safety Valve removed and lapping/ Servicing done and tested on test bench for set pressure 74 Kg/Cm2 and 75Kg/cm2.
- ✓ Economizer Safety valve Lapping Servicing done and tested on test bench.
- ✓ Super heater Safety valve is replaced with new one and tested on test bench.
- ✓ CBD tank safety valve removed Lapping /Servicing done and tested in in test bench.
- ✓ Startup vent isolation valve which has passing removed and lapping & testing done.
- ✓ Super heater -1 control valve isolation valve ring gasket removed and Valve disc lapping done for proper sealing.
- ✓ Export steam line valve which has jamming problem spindle removed servicing done and installed with smooth operation.
- ✓ BCW pump 1 steam exhaust line isolation valve which has heavy passing removed lapping of disc done and servicing done for smooth operation.

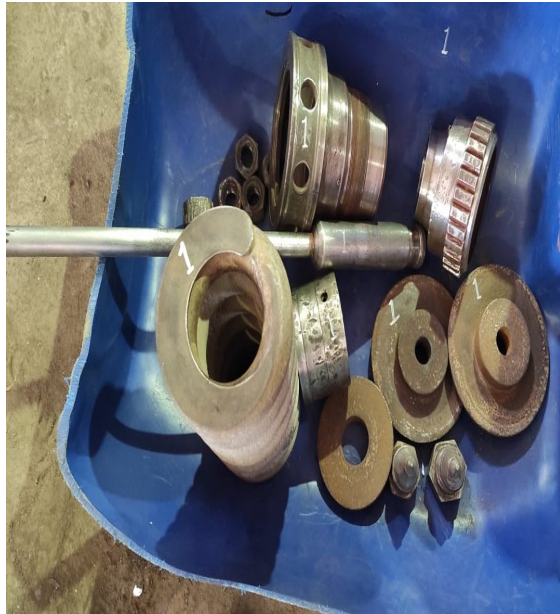
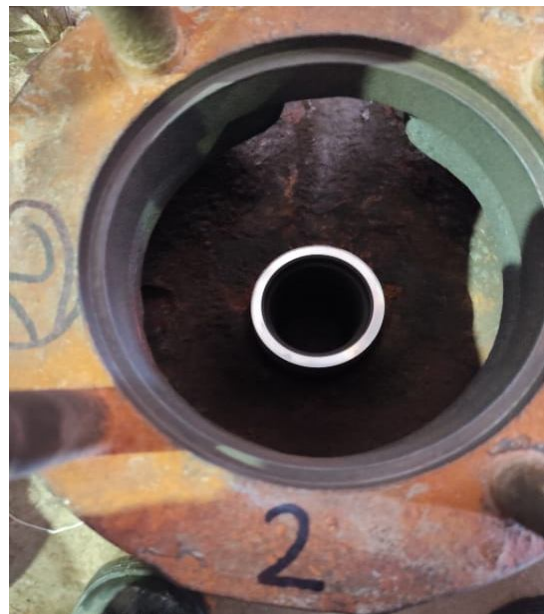
Fig 1.3(c) Servicing Job samples

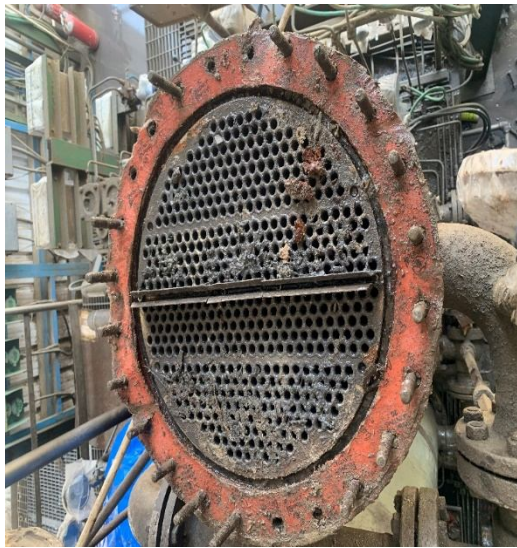
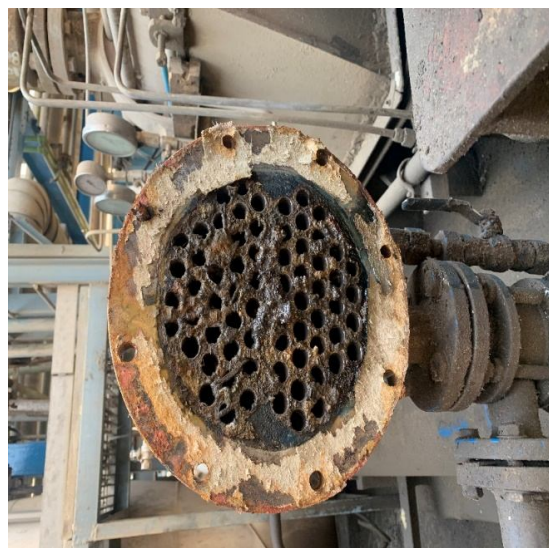
Fig1. 4.1(a) lube oil cooler before cleaning

- ✓ Turbine Both Lube oil cooler cleaned with hydro jetting at pressure 150 kg/cm²
- ✓ Both Cooler of BCW pumps cleaned by hydro jetting machine at pressure 100 kg/cm².
- ✓ Condensate and gland steam cooler of Turbine cleaned by hydro jetting machine at pressure 100 kg/cm².

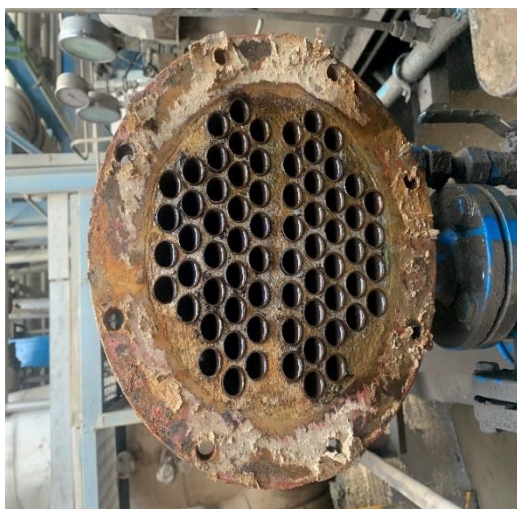
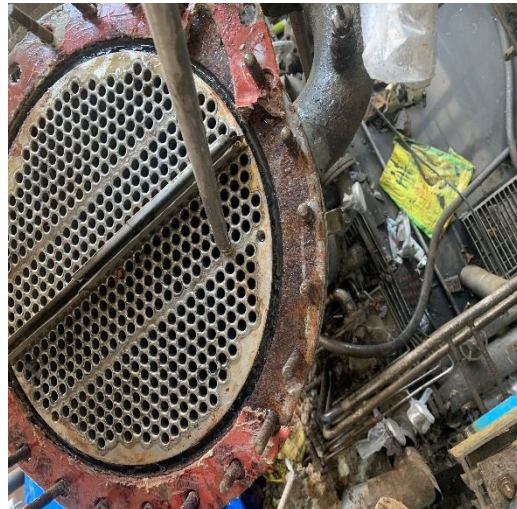
Fig 1.4.1(b) lube oil cooler after cooling

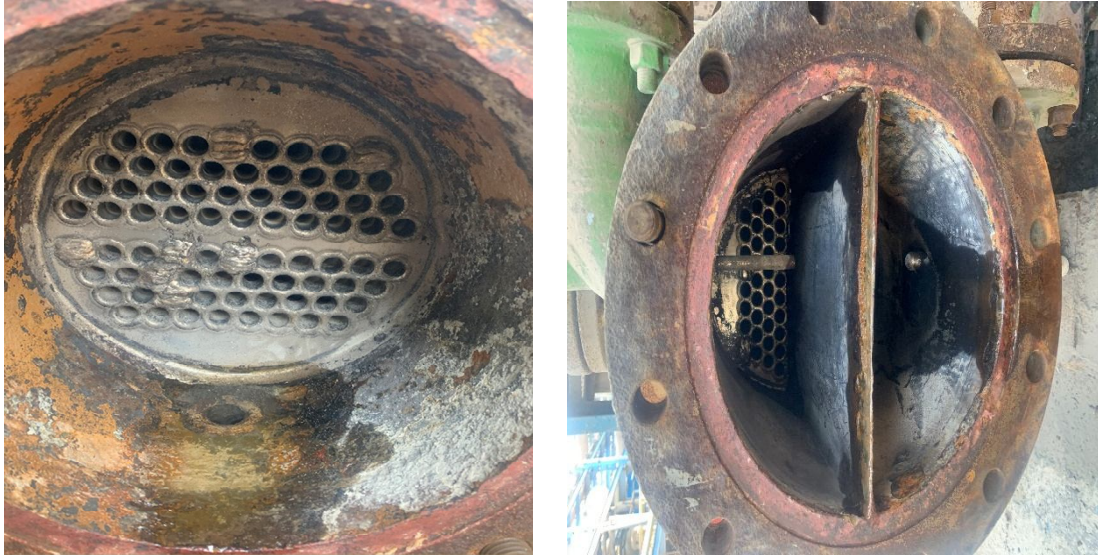
Fig 1.4.1(c) lube oil cooler

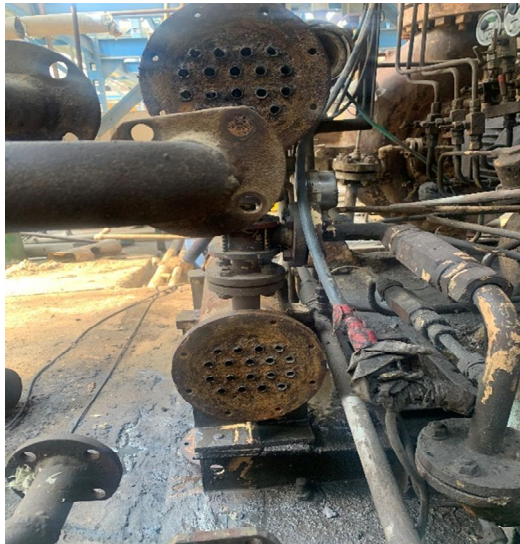
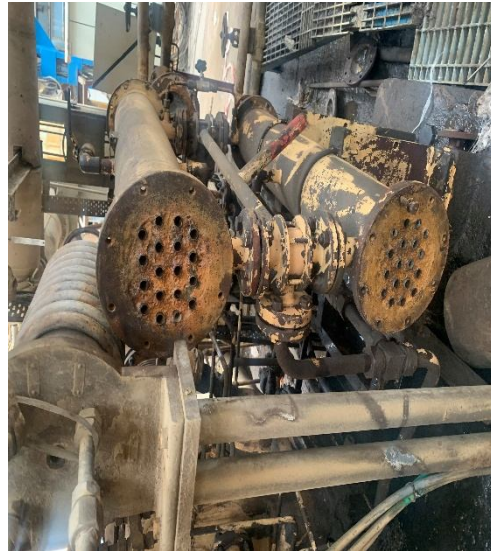
Fig 1.4.1(e) lube oil cooler of bcw turbine before and after cleaning

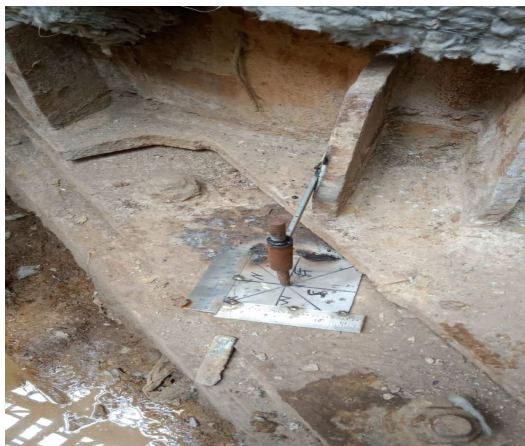
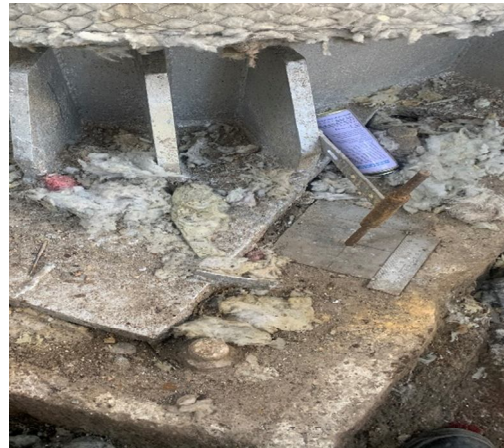
- ✓ Arrangement is made to measure the thermal expansion of boiler at its each supports and at steam drum.
- ✓ SH-1 & SH-2 support thermal expansion measurement is done along with boiler and steam drum.

Fig 1.5(a) Arrangement for boiler thermal expansion measurement

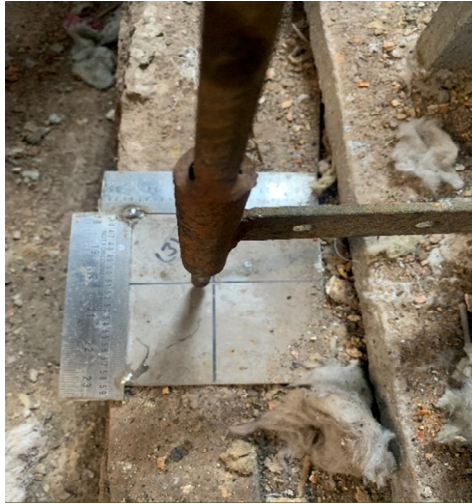
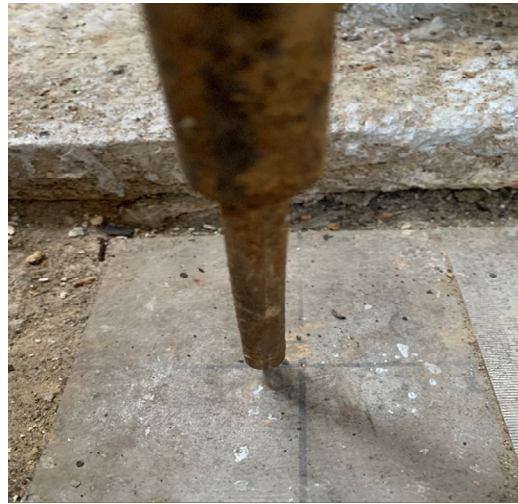
Fig 1.5(b) Samples after thermal expansion of boiler

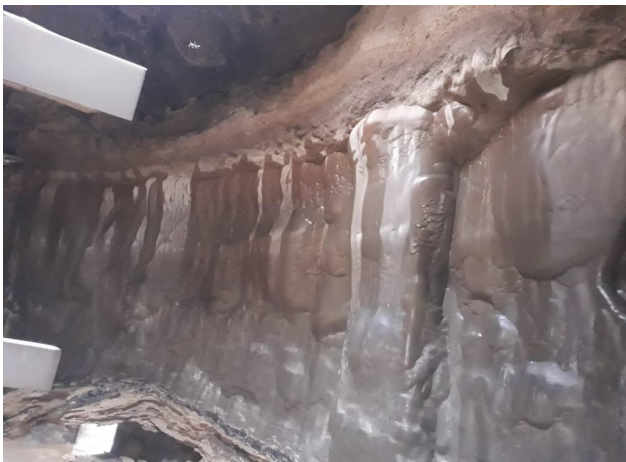
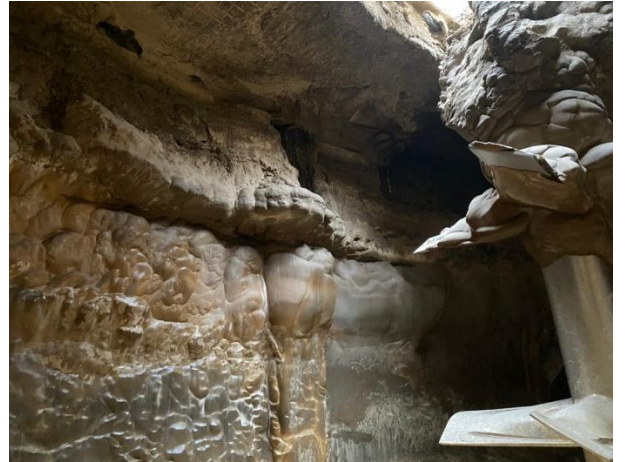
After opening of manholes, it was observed that there is huge deposition of very hard scale on reactor walls. Deposition was there on floor. Quantity of material in annular zone was approx. 350 MT. De scaling of both side walls of annular zone was done carefully with the help of one JCB machine with constant supervision and without any harm to brick lining. Care was taken to complete the activity in the safest manner. Entire scale material was removed through the agitator openings by net & rope (Jhula). Baffle columns cleaning was done. Cleaning of vacuum cooler 110,112 & 113 was done. All four vacuum coolers outlet pipe and seal leg cleaning & descaling done. Around 300 MT material was removed from these vessels. Complete cleaning of adjustment & Filter feed tank was done. Around 300 MT material was removed from both tanks. Heavy scaling was observed in VCST, around 350 MT material was removed from tank. Wall brick lining of agitator 130 compartment was in bulged condition. It was renewed.

Deposition on Reactor walls

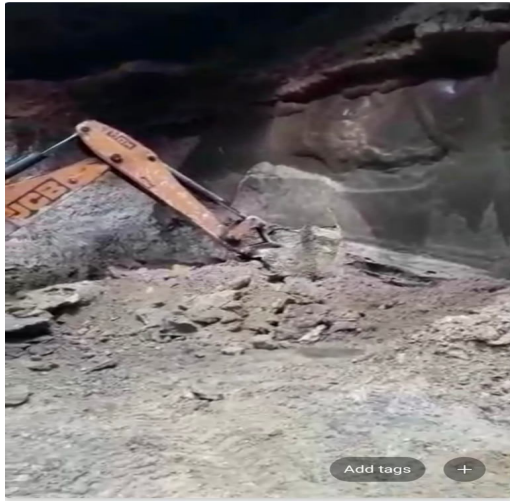
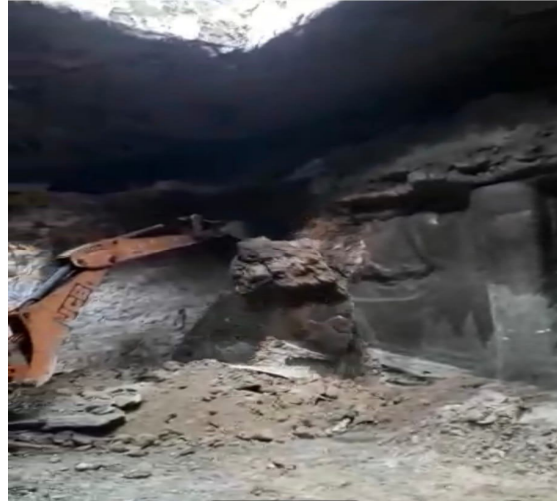
Reactor annular section inside cleaning with JCB

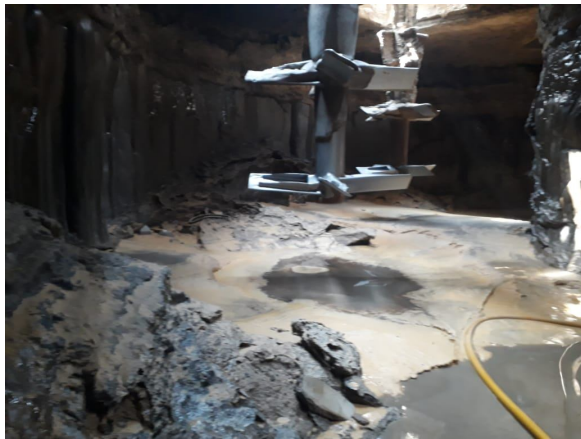
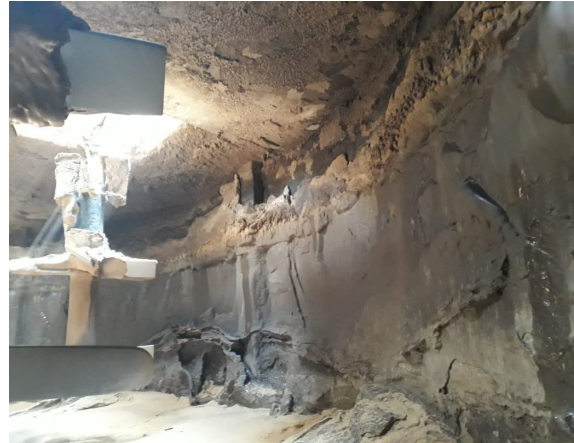
Annular section before cleaning

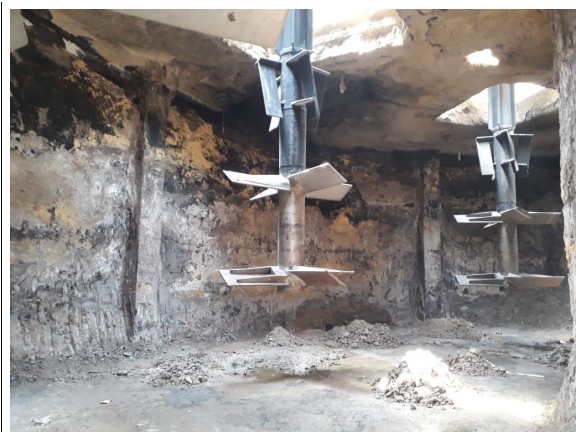
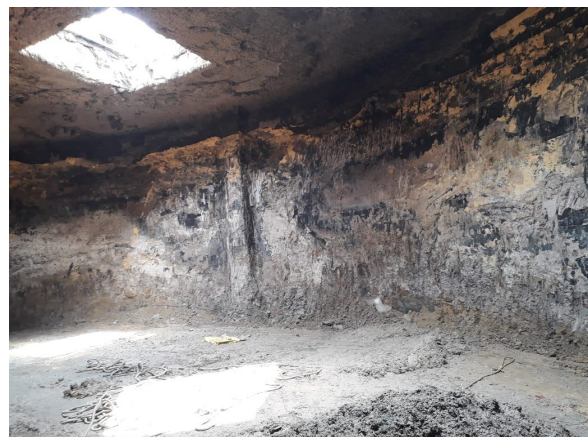
Annular section after cleaning

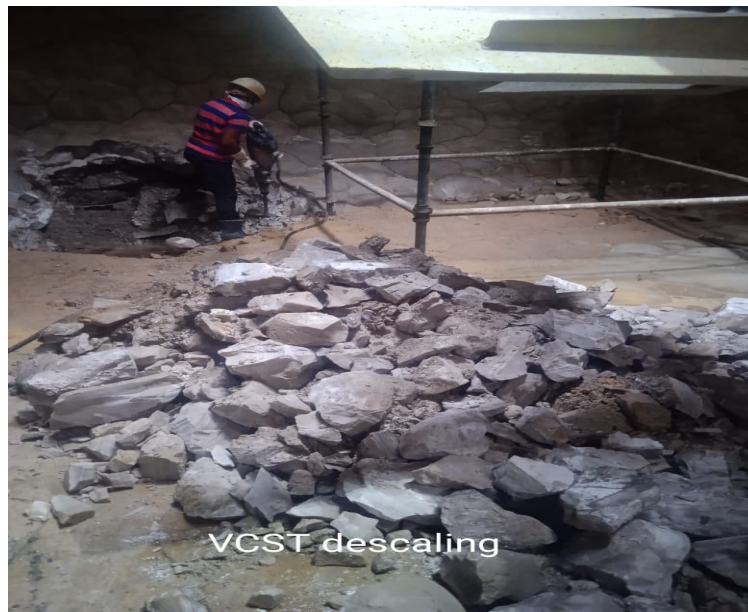
VCST wall before cleaning

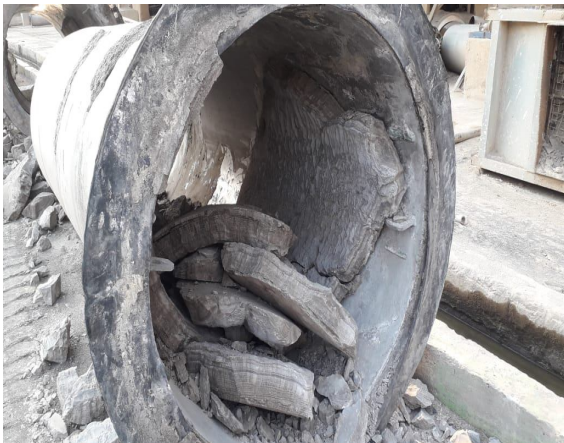
Seal Leg before cleaning

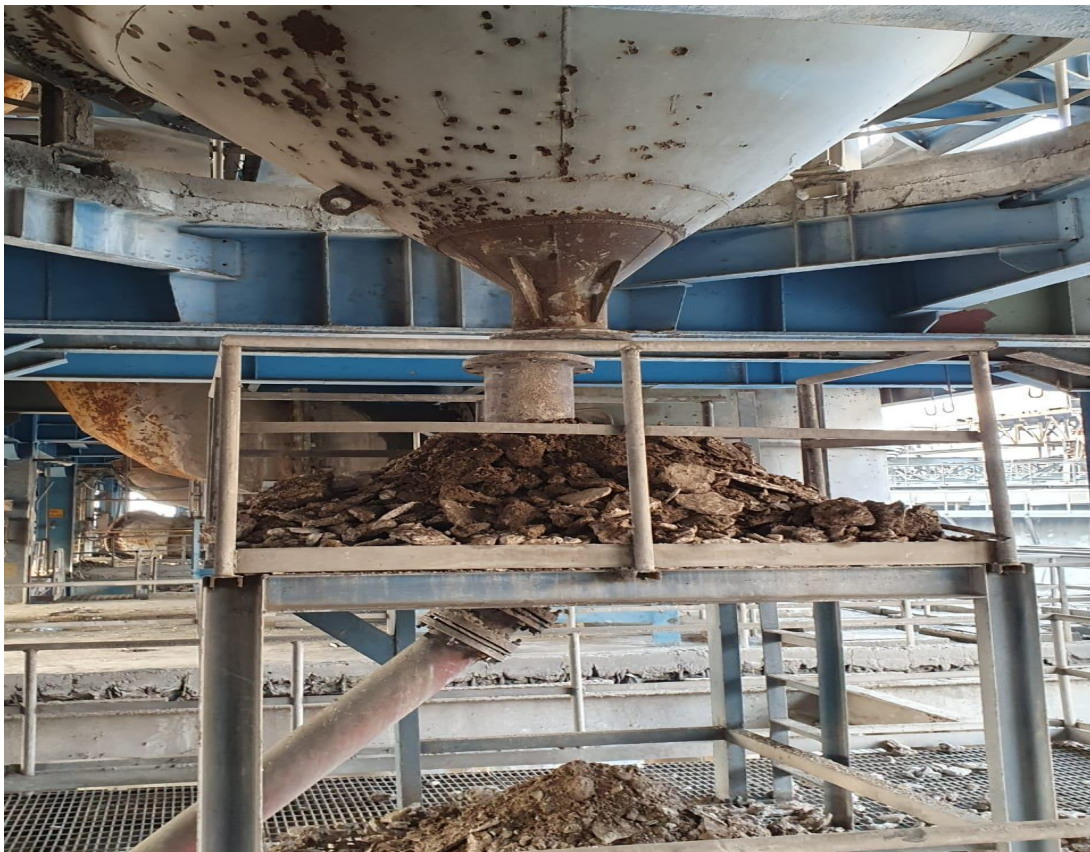
Evaporator entrainment separator cleaning

5. **Vac. Cooler Pre condenser seal tanks cleaning:** Depositions in Pre condenser seal tanks (both old and new) were also cleaned.
6. **Evaporator:** All evaporator entrainment separator and barometric condenser cleaned. Evaporator area sump cleaned and drain cleaned to take up major repairing jobs by Civil Dept.

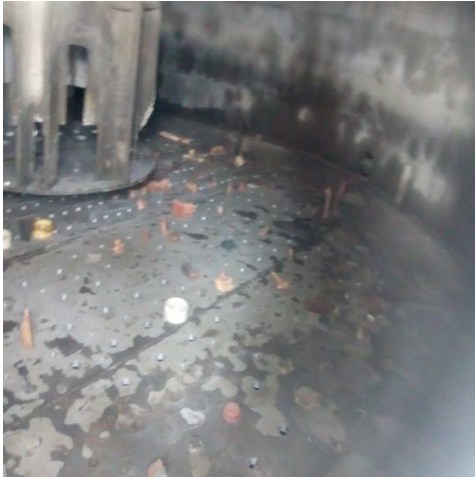
Evaporator barometric condenser before and after cleaning

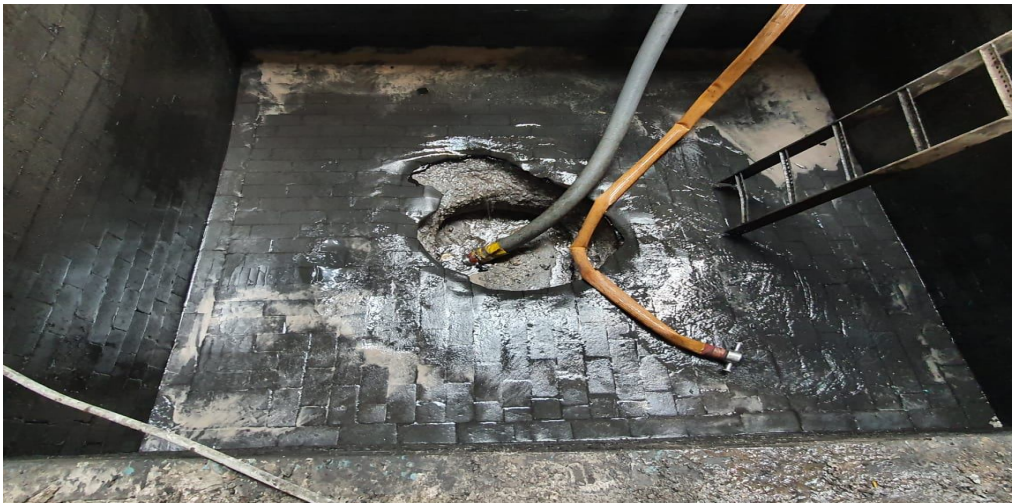
Evaporator area sump cleaning

18. Evaporator area sump cleaning done, civil work done and bottom portion is provided with SS plate.
19. Evaporator area drain brick lining done.
20. Evaporator B to H steam control valve replaced.

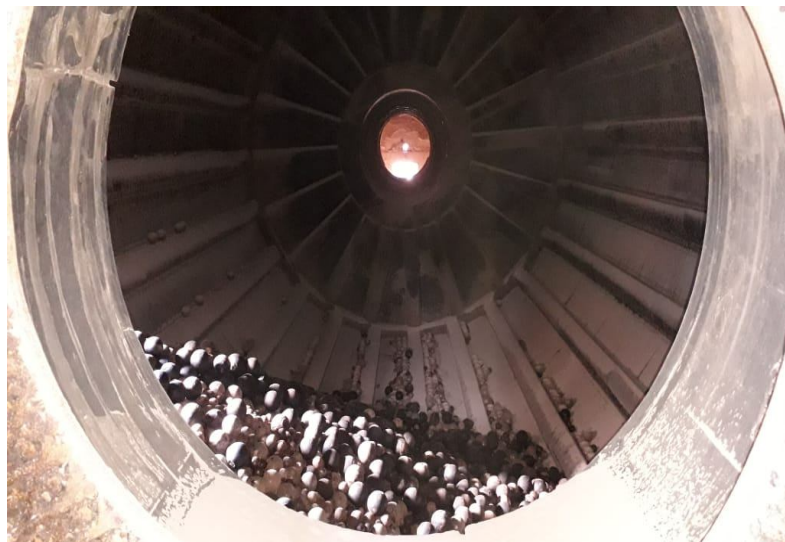
Ball mills charged with new and segregated balls

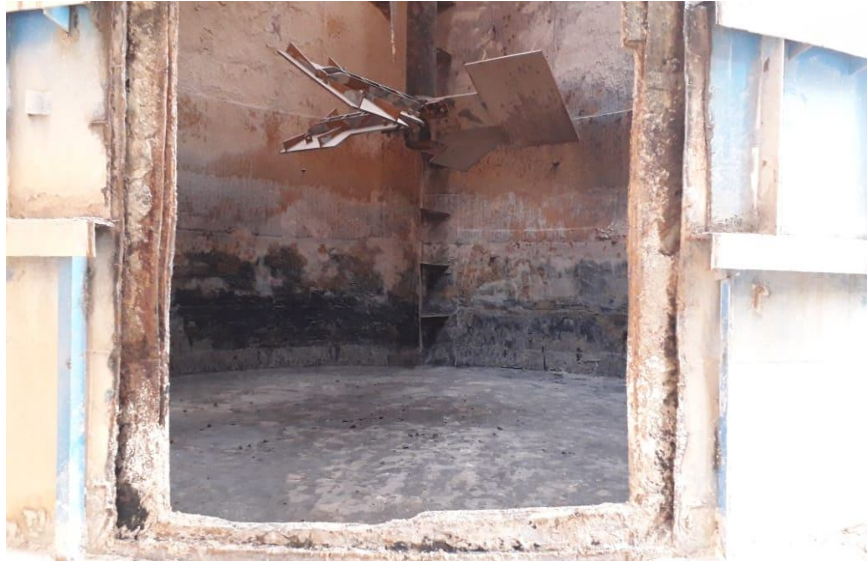
Old SST cleaned

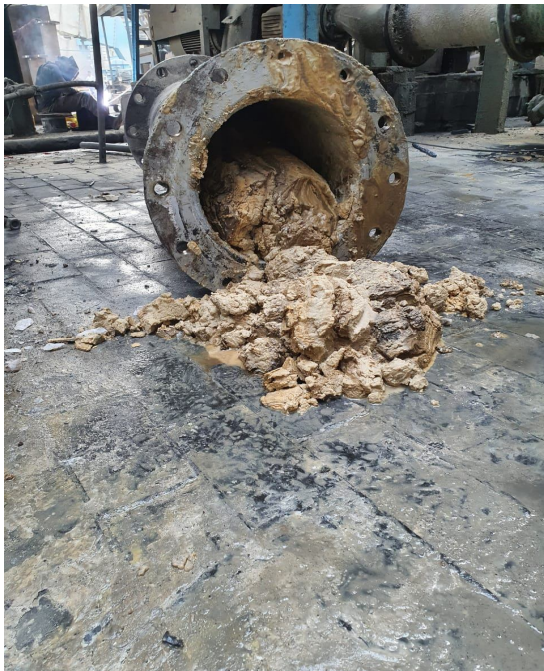
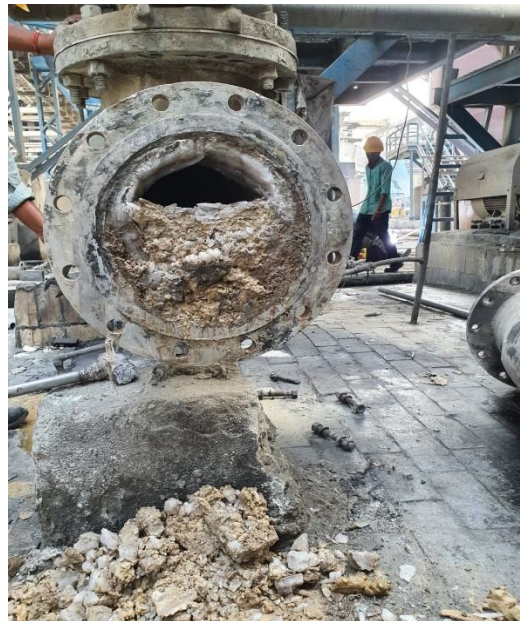
Misc Pipe Line before Cleaning

12. Vessel & Line Cleaning: All the suction & discharge lines of Acid transfer pumps were cleaned thoroughly.

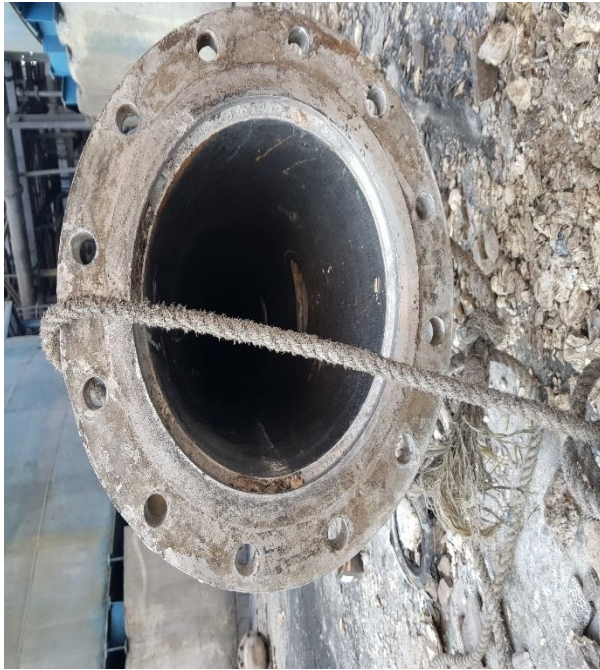
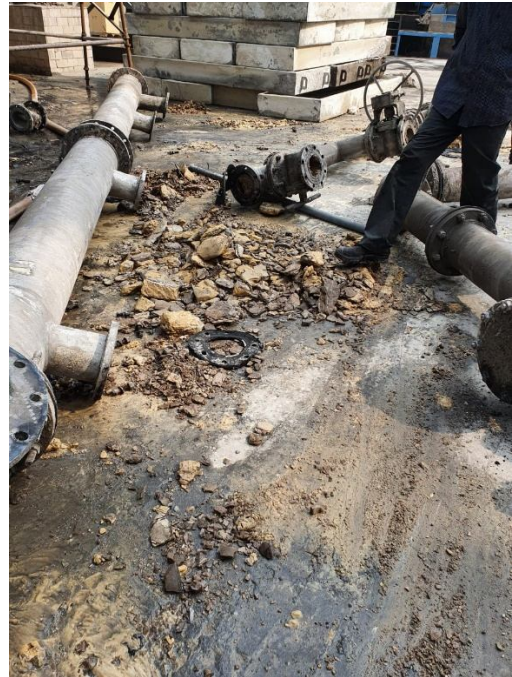
Misc Pipe Line after Cleaning

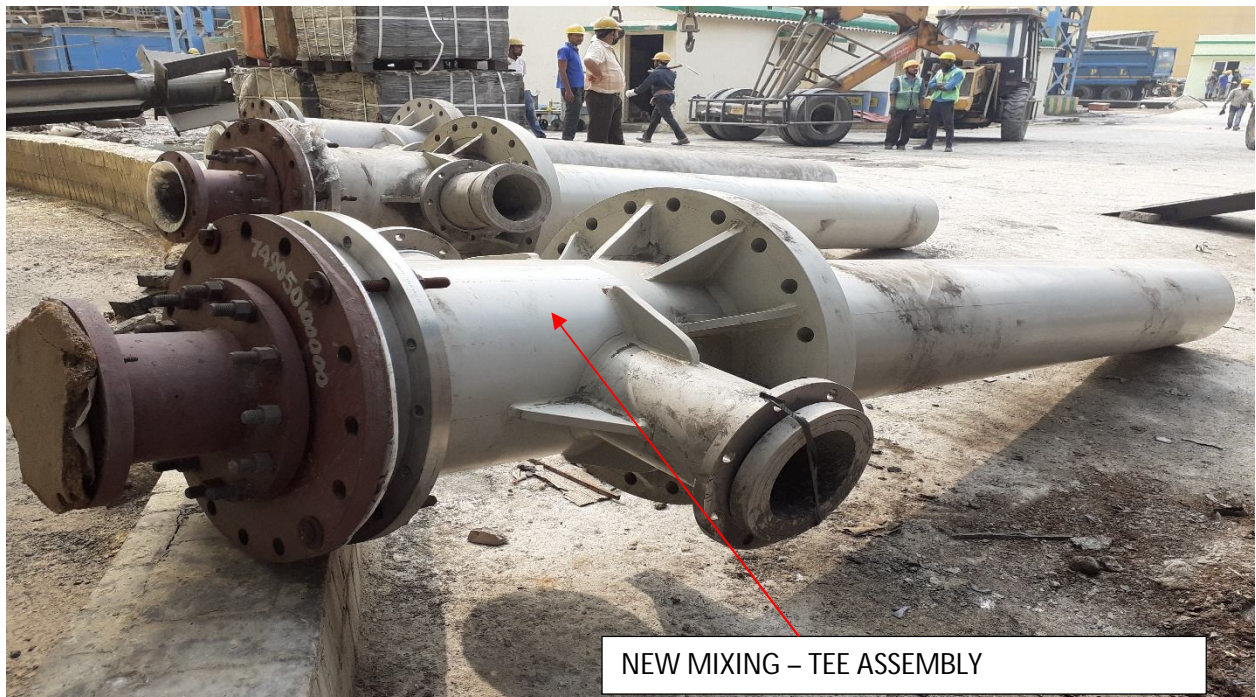
- All Mixing Tee (total: 04nos.) were taken out for Inspection & found damaged in the sulphuric acid inlet pipe (inner pipe) and complete mixing tee assembly (Four Nos.) were replaced with new one.

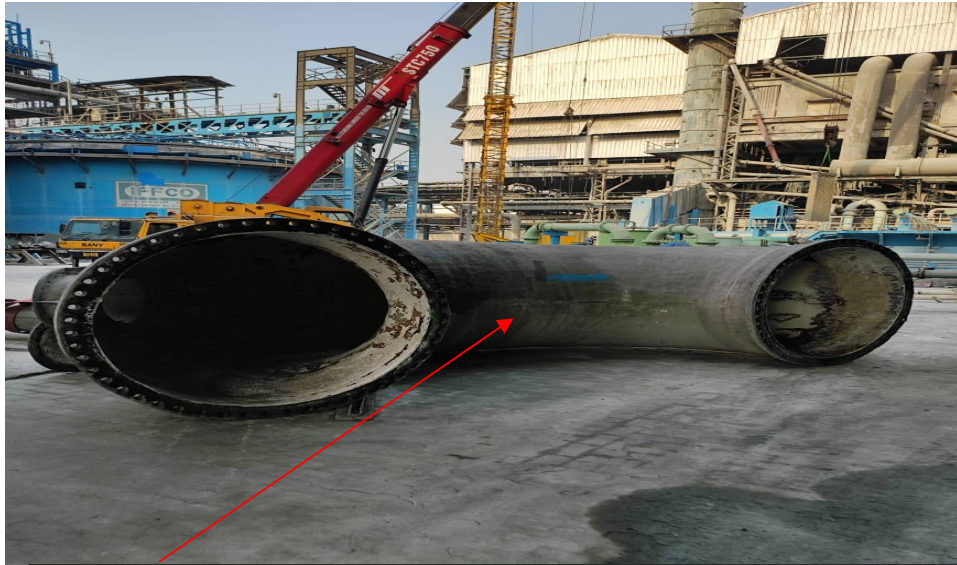
U- DUCT DISMANTLED FOR CLEANING PURPOSES.

- The 'U' Duct was removed from its position.
- The duct was cleaned by water washing on the ground & boxed up at its position.
- Necessary scaffolding was made in the pre-scrubber.
- All nozzles were dismantled, cleaned & fitted.

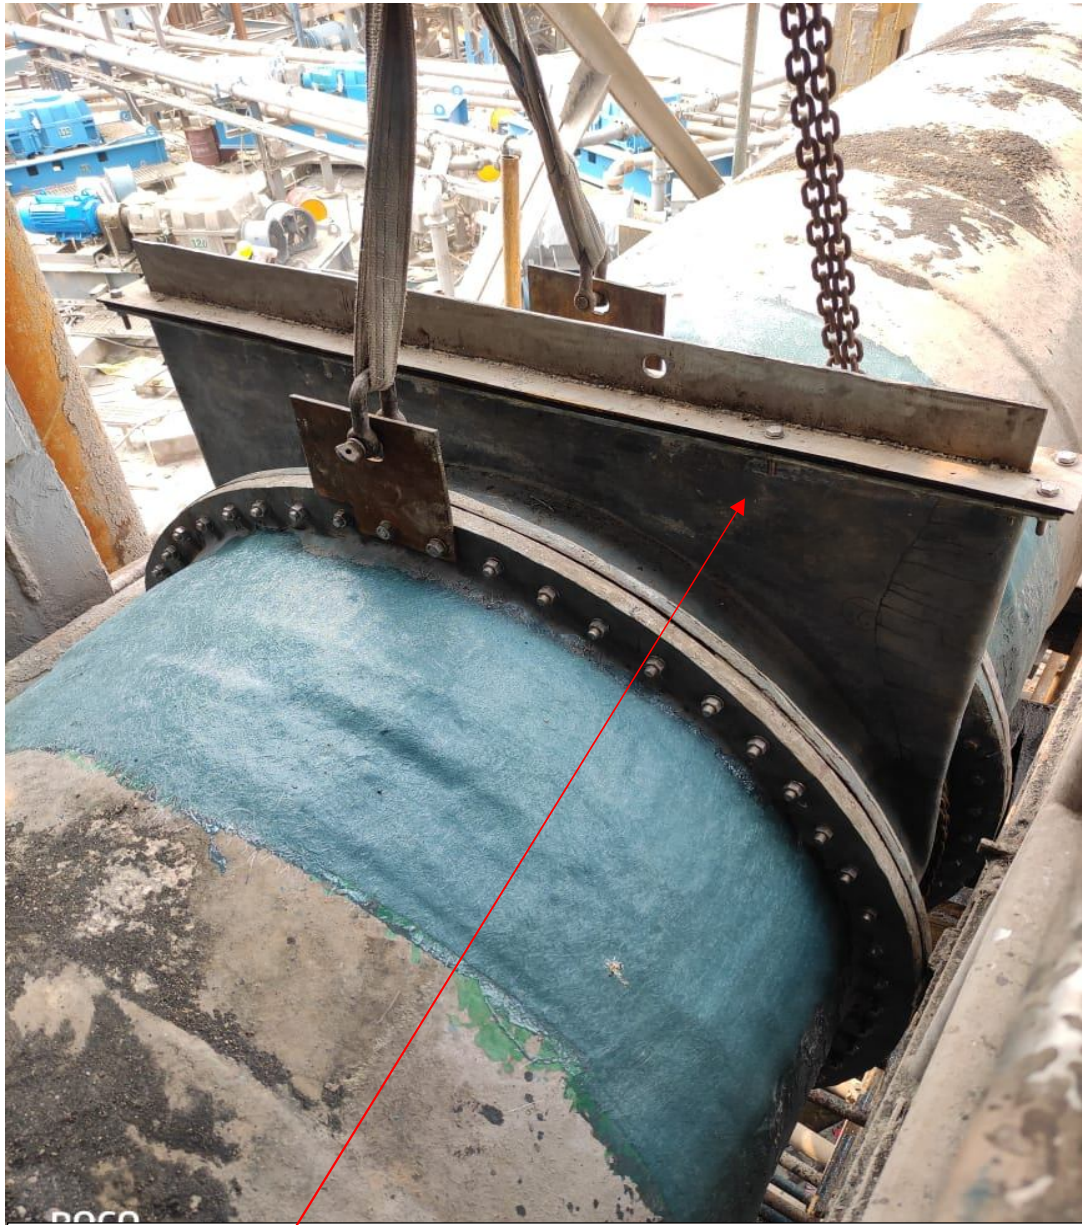
PROVISION OF DAMPER / ISOLATOR IN THE FUMES DUCT

- Damaged portion of the pre-scrubber inside duct was also repaired with **Vinyl ester resin**.
- Provision is made by putting a damper on the fumes duct line for isolation purposes, so that maintenance jobs in the duct can be taken during shut down.

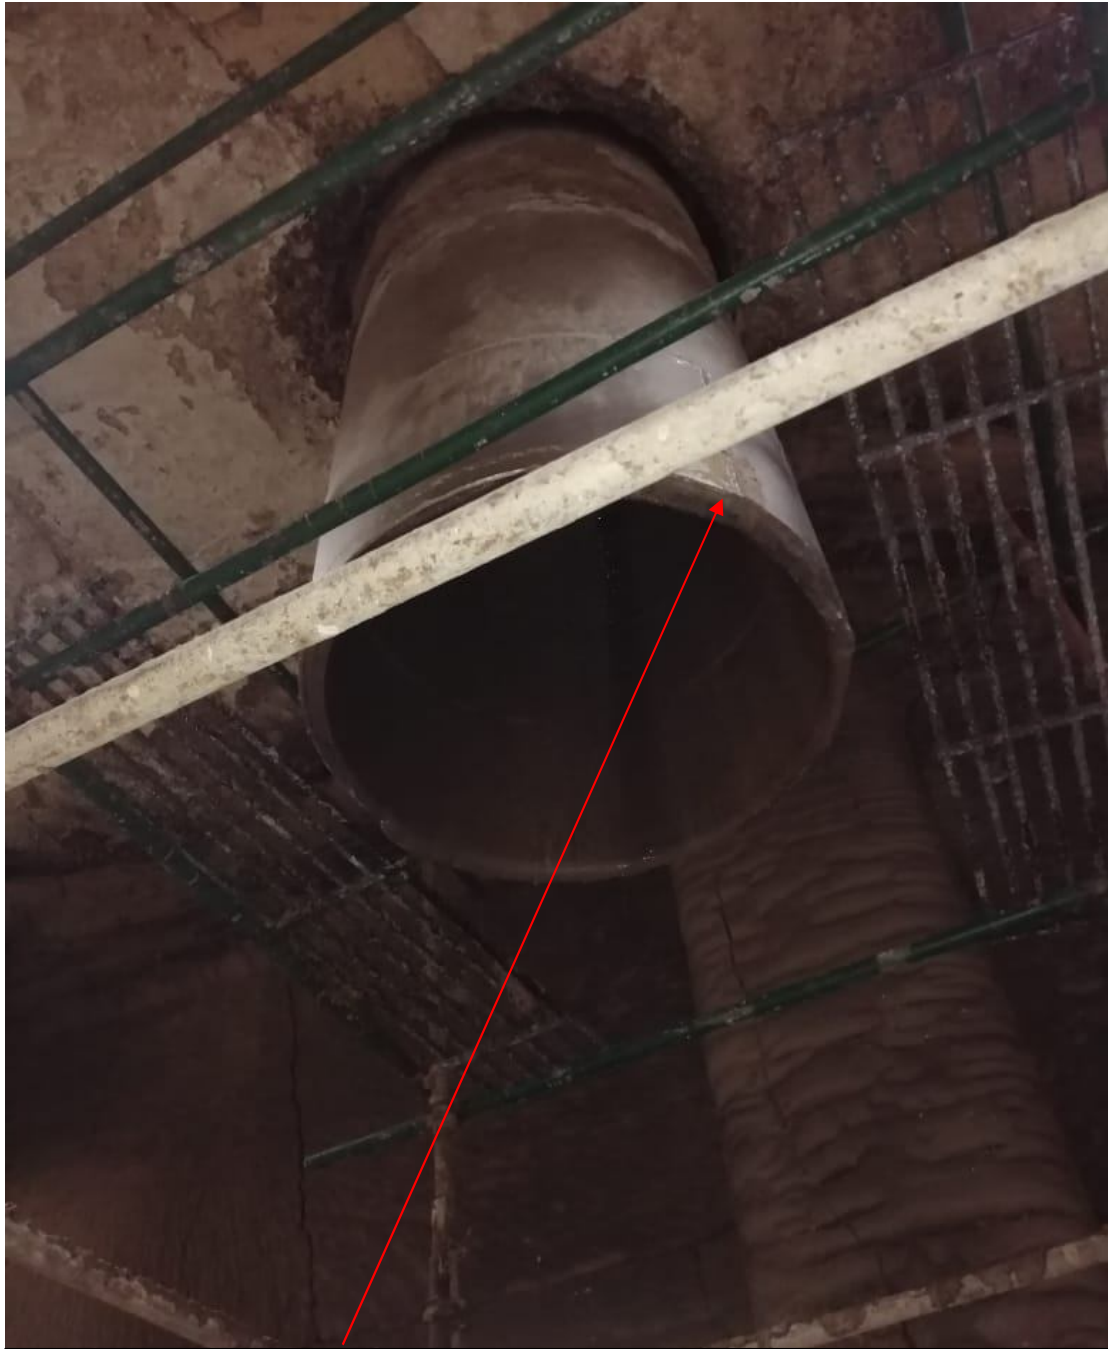
- 110, 111, 112, and 113 all the vacuum cooler inlet and outlet T pieces opened, cleaned & boxed-up.
- 110,111,112 and 113 vacuum cooler seal legs were dismantled and it was observed that the wall thickness has been altered (eroded / corroded) considerably, which may affect the pipes ability to meet relevant operation requirement. Thus, all the four vacuum cooler seal legs were replaced with new / fabricated seal legs.

NEW FABRICATED SEAL LEGS PROVIDED IN ALL FOUR VACUUM COLLAR OF SIZE: 1200 mm dia. X 3 mtr. Lg. (each.) X 10 mm Thk. MOC: SS 904L.

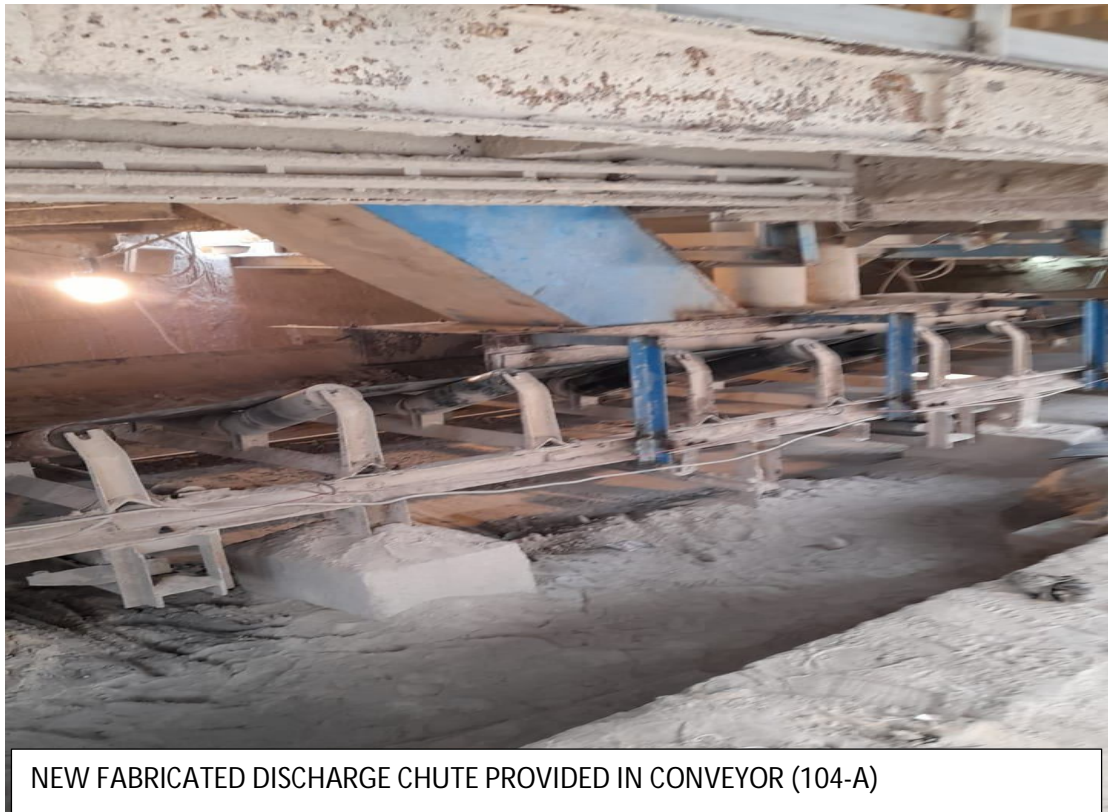
- Discharge chute of conveyor (104-A) was found damaged / corroded and replaced with a new fabricated chute.

NEW FABRICATED DISCHARGE CHUTE PROVIDED IN CONVEYOR (104-A)

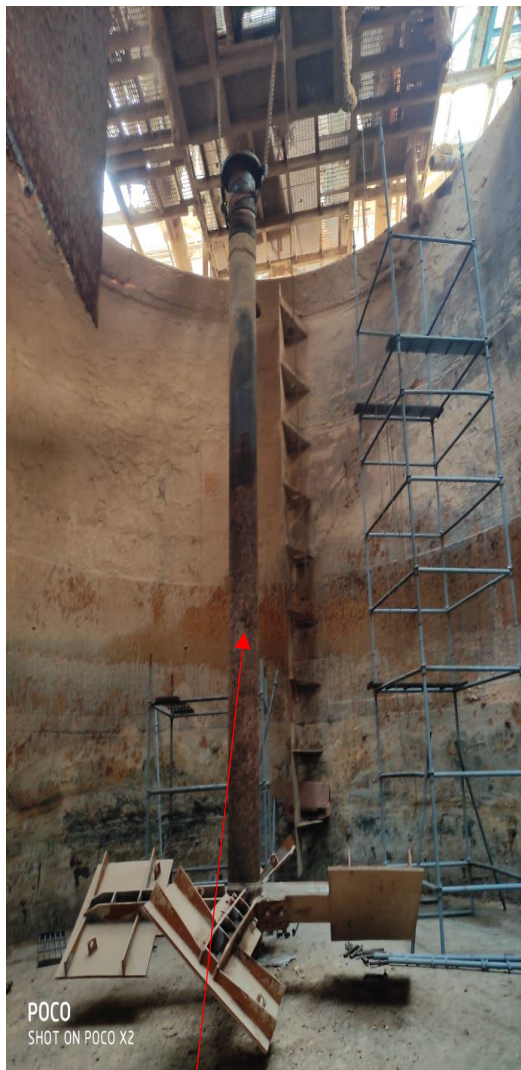
OLD / WORN OUT AGITATOR ASSEMBLY

- Manhole opened for inspection.
- Necessary scaffolding made for replacement of damaged agitator blade.
- Old / damaged agitator shaft and blades were removed.
- New agitator shaft with blade assembly was installed.

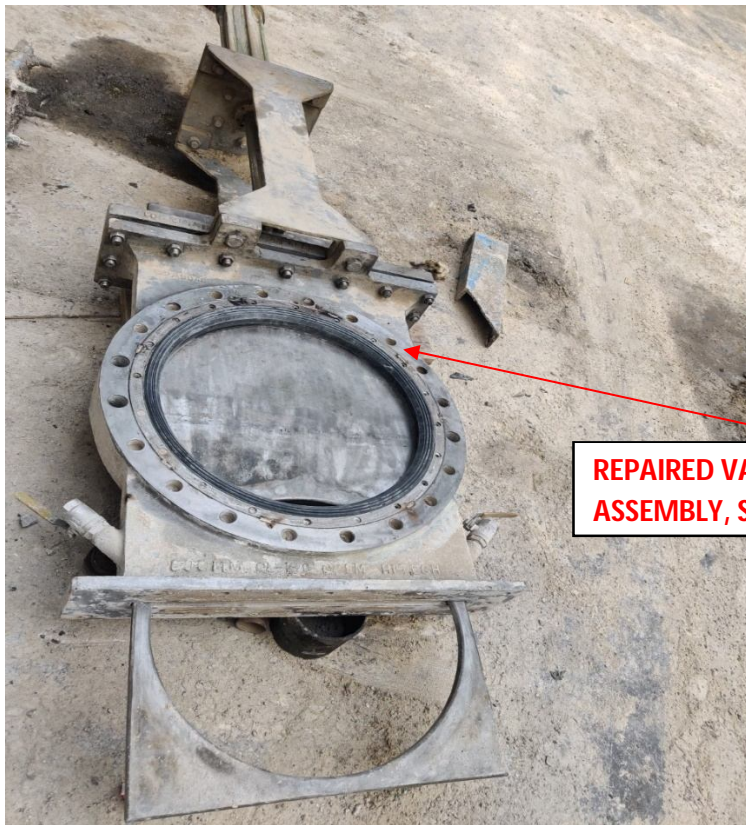
**REPAIRED VALVES WITH NEW SEAT & LINER
ASSEMBLY, SIZE: 600 MM NB**

- Two nos. of Gypsum Pump discharge header valve (24” NB) was replaced with new one, as it was observed hard to operate during plant operation.
- Remaining valves of Gypsum Pump discharge line (24” NB) were repaired by replacing seat & liner assembly.

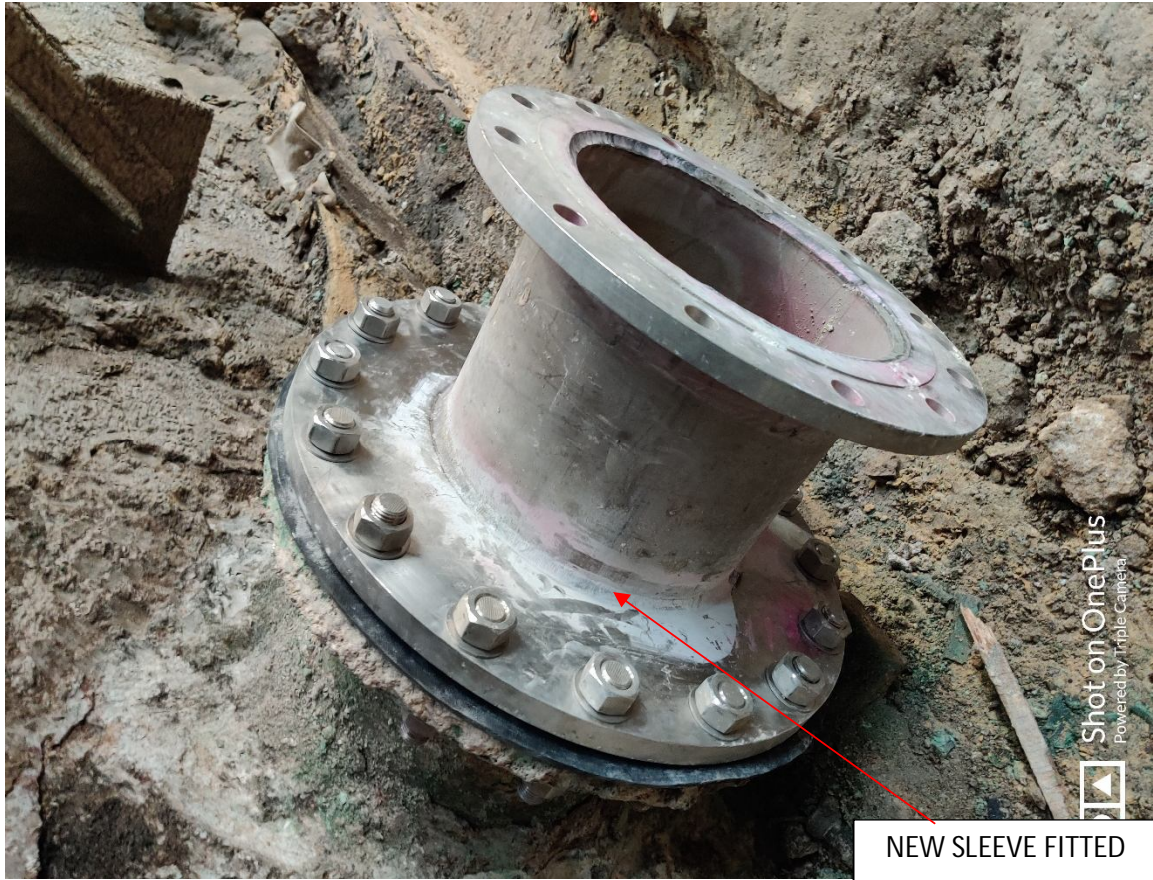
There are total 12 nos. of nozzles exists in Filter feed compartment in Reactor and Filter Feed Pumps are connected thru. These nozzles and discharges to Belt Filter. It is observed that the sleeve inserted in-to the nozzles are completely corroded and worn-out and there is a chance of leakage thru. These nozzle. Further, the nozzle flange (MOC: MS) also found corroded. The subject job was very challenging and critical in nature, as the nozzles are connected to Reactor. The subject job was carried out successfully by removing the worn-out sleeve with new fabricated SS-904L sleeve and the sleeve flange attached with tank nozzle was also upgraded to SS-904L.

NEW SLEEVE FITTED

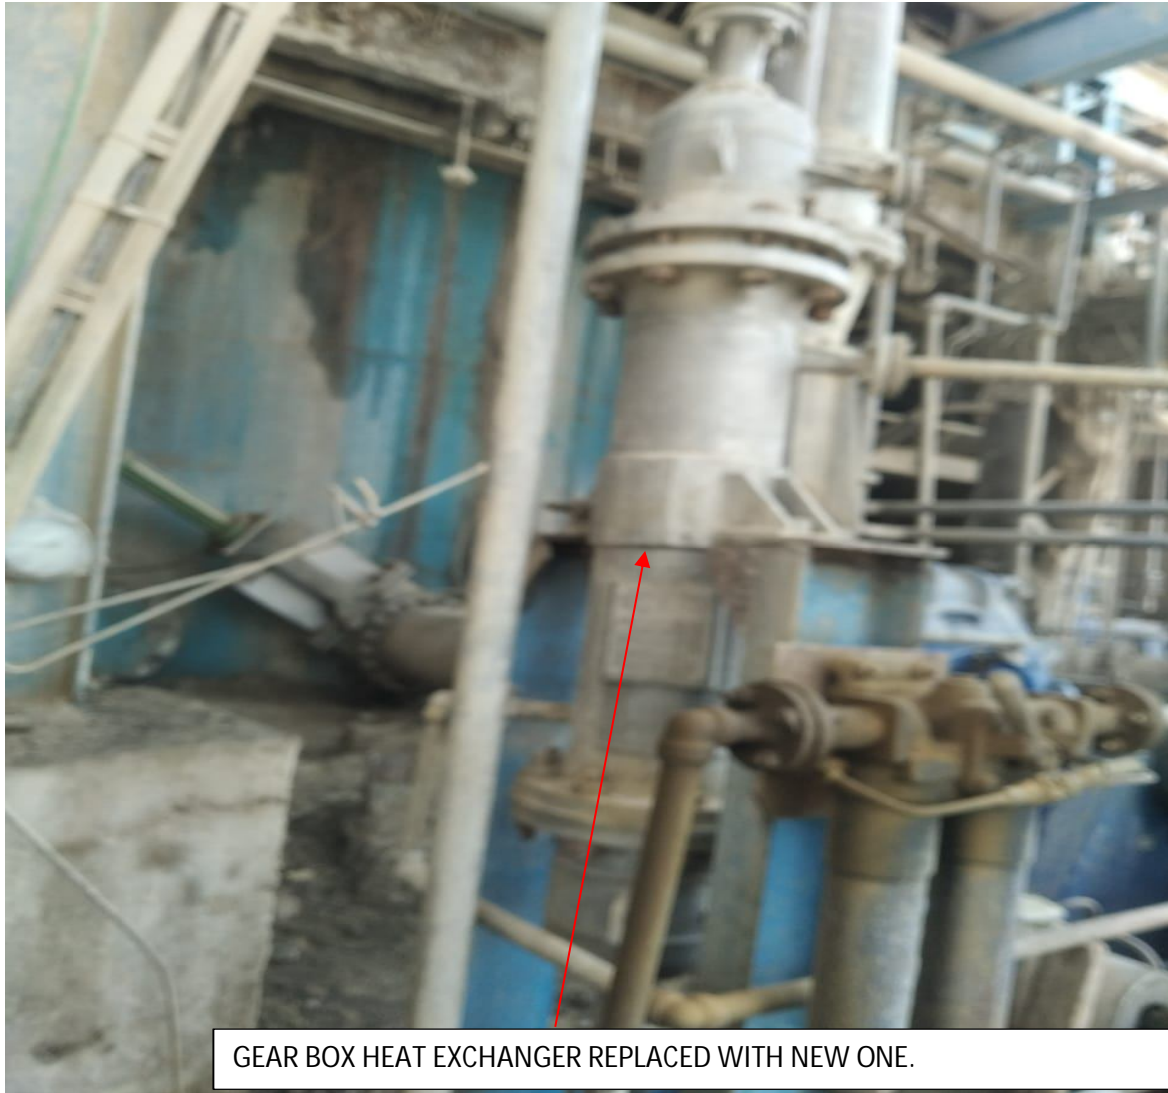
REPLACEMENT OF GYPSUM SLURRY PUMP (P-293) GEAR BOX HEAT EXCHANGER:

GEAR BOX HEAT EXCHANGER REPLACED WITH NEW ONE.

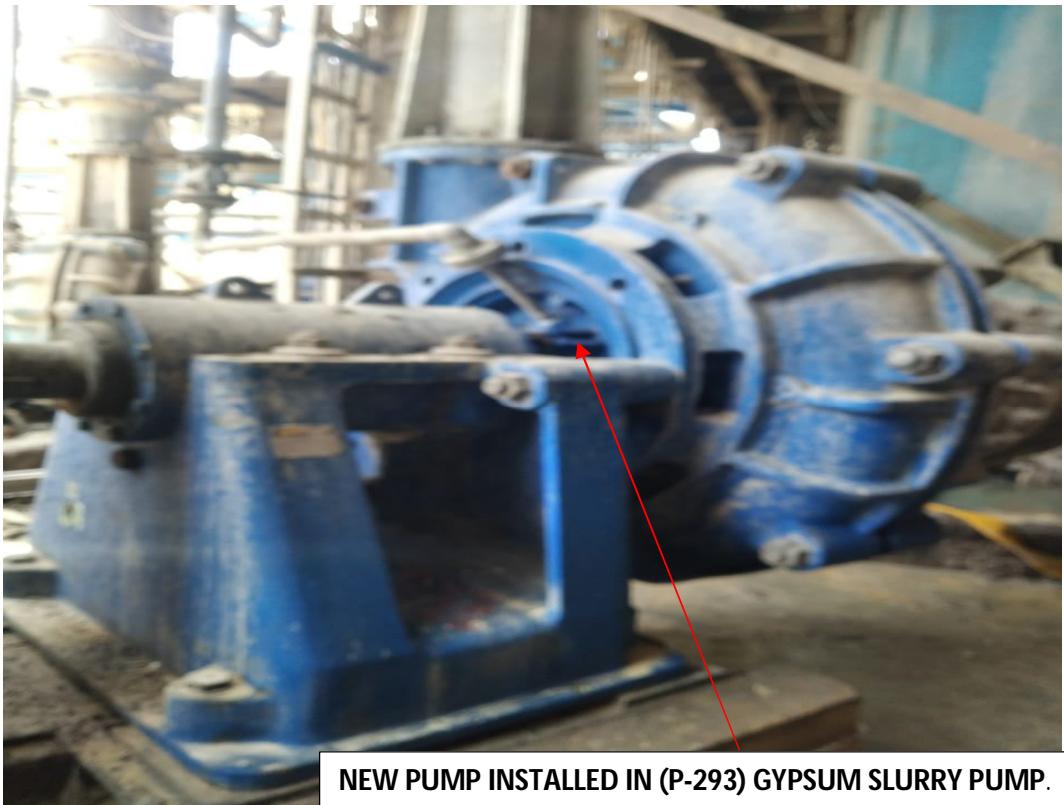
It is observed that the flow rate in the subject pump (P-293) is too low due to worn-out pump internals / components (observed crack from volute liner) and the base of fluid coupling and Motor was damaged / corroded, causes vibration in the system. Further, the temperature of the fluid coupling hydraulic oil was very high during operation and the performance of the fluid coupling was found not satisfactory. Thus, the complete system was revamped as per the following activities and completed successfully.

NEW PUMP INSTALLED IN (P-293) GYPSUM SLURRY PUMP.

- 1) Complete New Pump with new Pump base was installed by replacing the existing (old) Pump.
- 2) Motor and Fluid Coupling base was repaired / revamped.
- 3) New Fluid Coupling was installed by replacing old one.
- 4) Lubrication system were overhauled.
- 5) Complete system alignment was done i.e. from Pump to Gear box, Gear box to Fluid Coupling and Fluid Coupling to Motor .
