ATR REPORT-2021

**INDIAN FARMERS FERTILISERS CO OPERATIVE LTD.
PARADEEP UNIT**

ATR REPORT: 2021

DAP PLANT

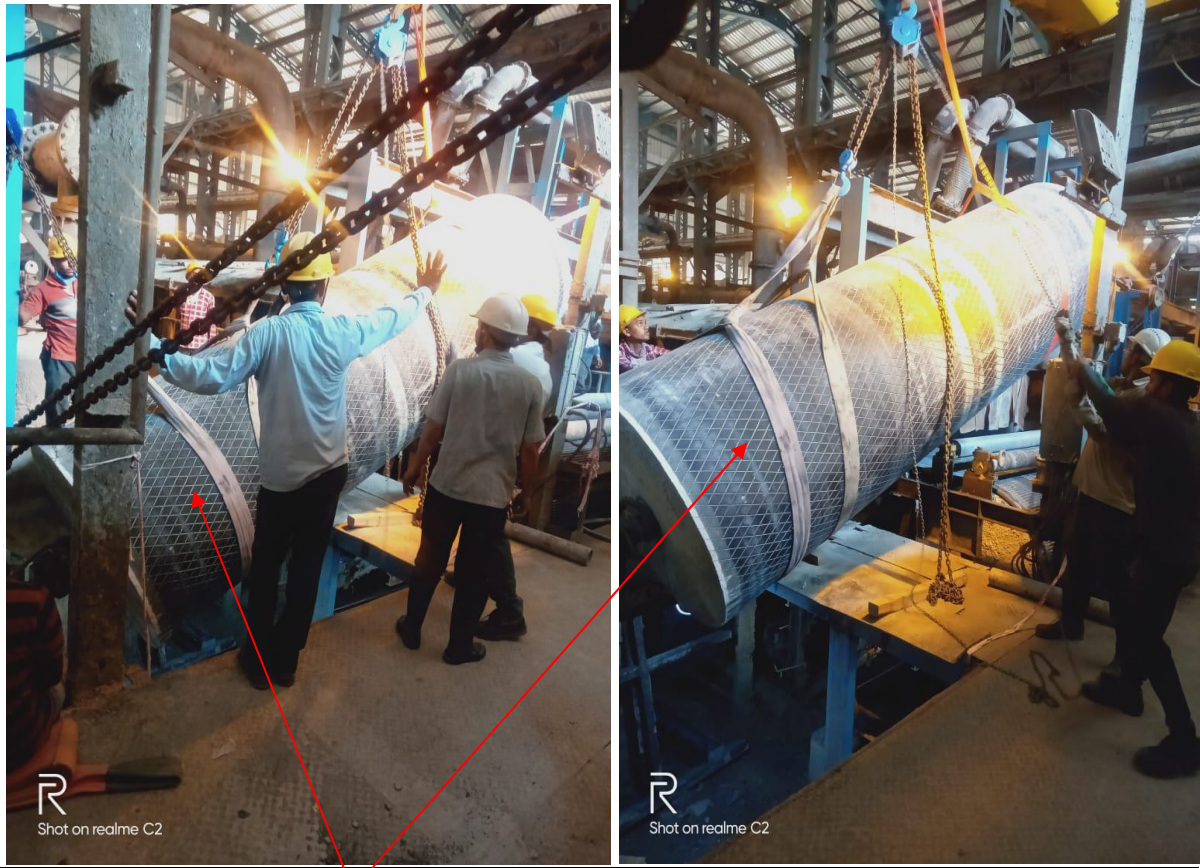
- Continuous abnormal sound was observed from Tail Pulley of Belt Filter 'E'. Pulley was checked & inspected thoroughly. Cracks were observed near the shaft of the pulley. Thus, replacement of the subject pulley was carried out with a new Pulley as per following activities :

Installation of Belt Filter E Tail Pulley under Progress

- Installed new pulley with help of Chain block arrangements.
- Installed Floor and associated structure which was removed from gear box side to make space for pulley removal. Also installed necessary cloth return Rollers.

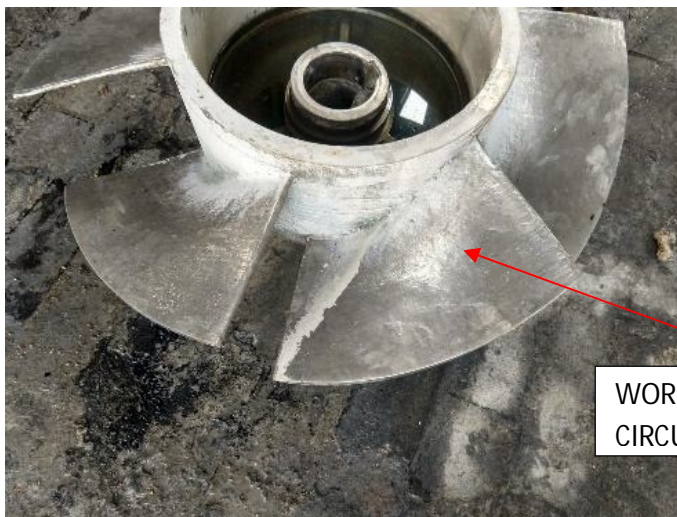
Eva D: Impeller and casing wear ring replaced. Suction bellow replaced.

WORN OUT IMPELLER REMOVED FROM EVAPORATOR CIRCULATION PUMP –D

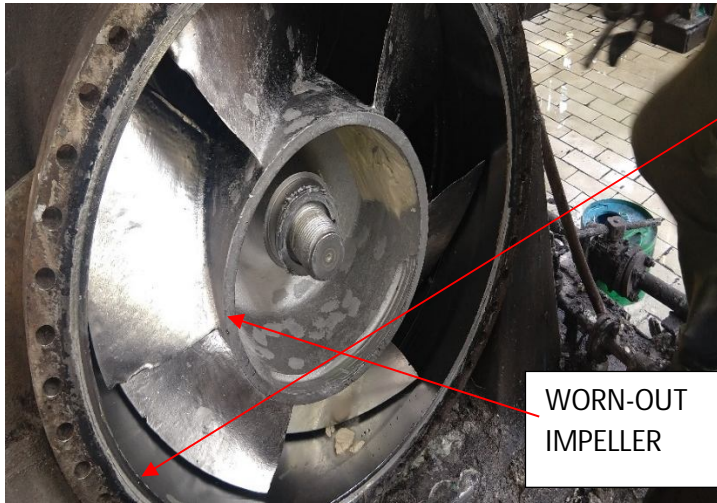
Clearance between impeller vanes and casing wear ring was high (6 to 10 mm).

WORN-OUT IMPELLER

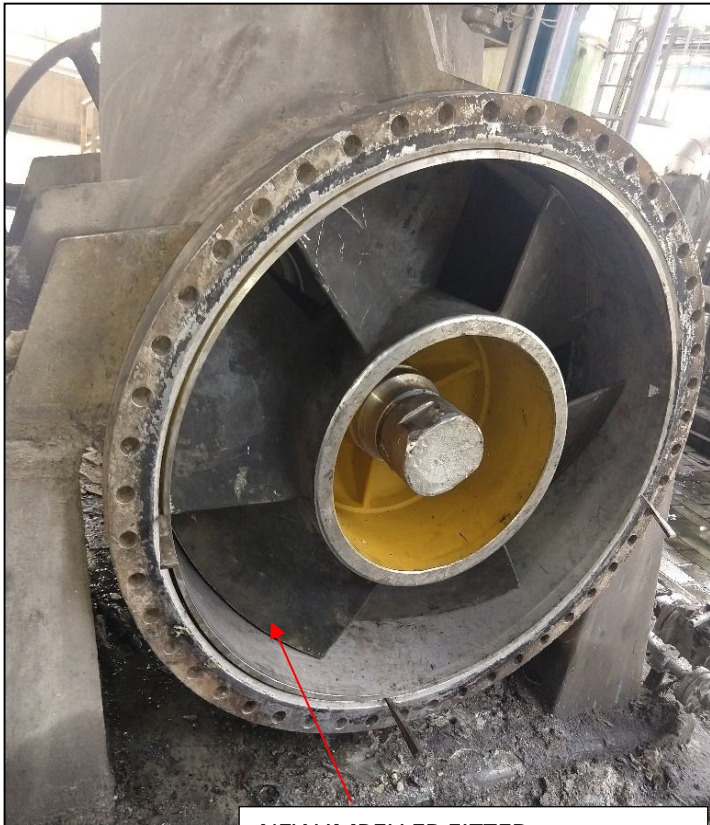
New impeller fitted with less clearance (2.5 to 4.5 mm), resulted to increase in Flow & thereby increasing velocity in heat exchanger tubes which will reduce chocking of tubes & improve heat transfer, resulted to enhance overall performance of evaporator circuit.

NEW IMPELLER FITTED

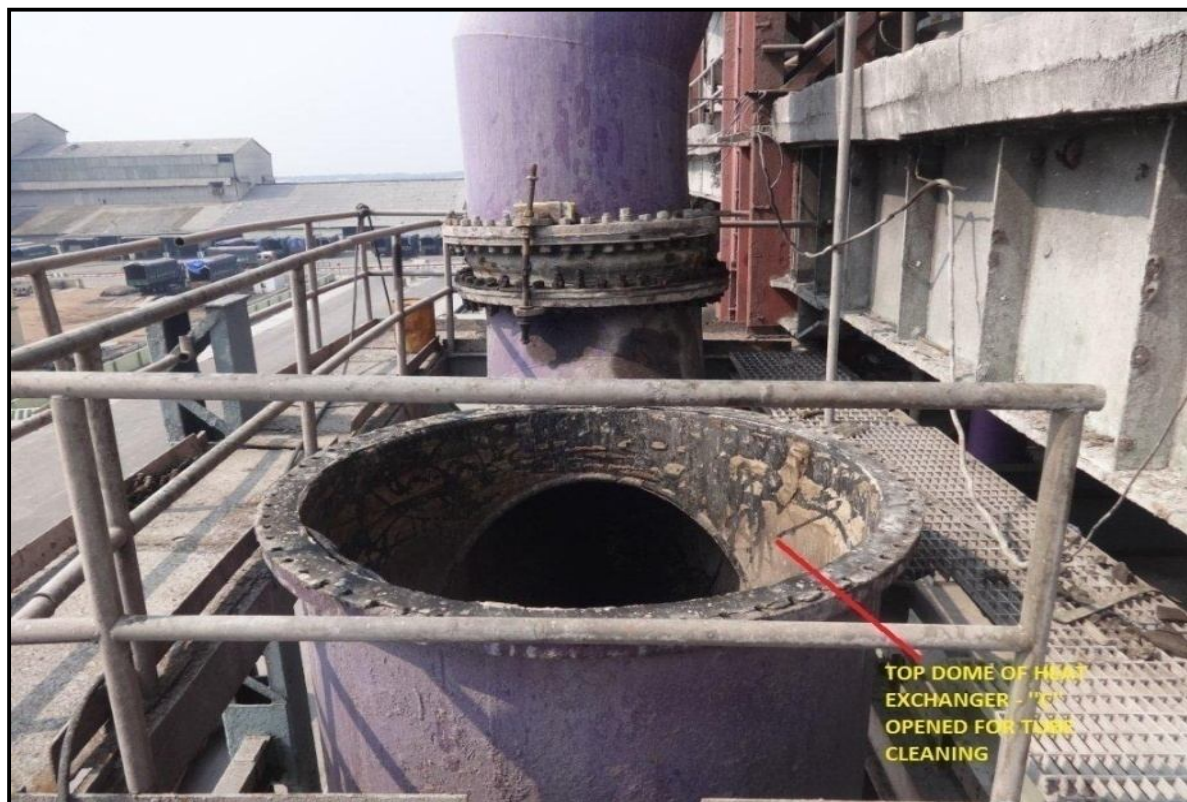
MAINTENANCE OF GRAPHITE HEAT EXCHANGER:

In heat exchanger A to F, Shell to top tube sheet flange joint used to have heavy leakage during hydro test in case of tube failure checking/after tube cleaning. Scaffolding was erected along the periphery to check the joint, some bolts were found loose. All bolts were cleaned properly and then tightened. All heat exchanger tube cleaning done and Hydro tested @ 3.5 kg/cm² and no leakage observed from the above said joint . Leaked tubes were plugged and plugs of already plugged tubes were examined for defect. Re- hydro test was done after tube plugging.

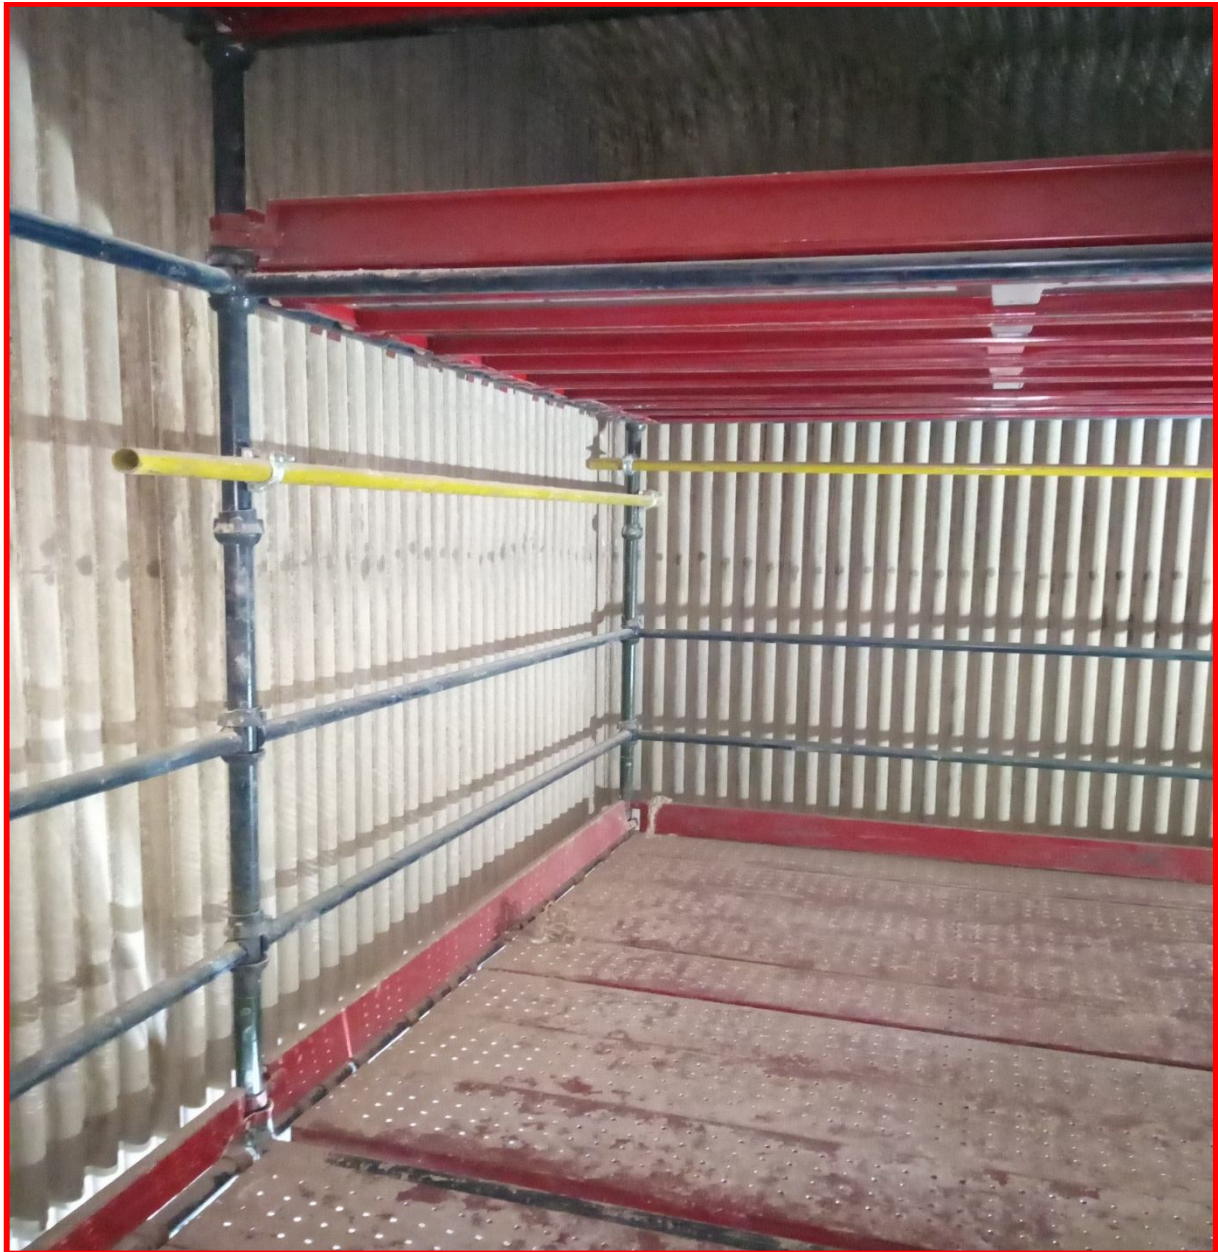
FIXING OF CUPLOCK TYPE SCAFFOLDING IN BOILER FURNACE FOR CLEANING & INSPECTION.

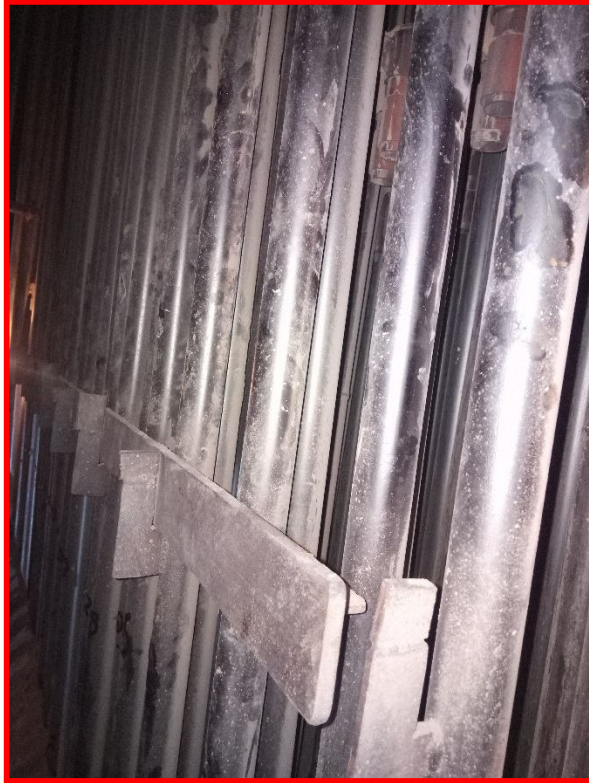
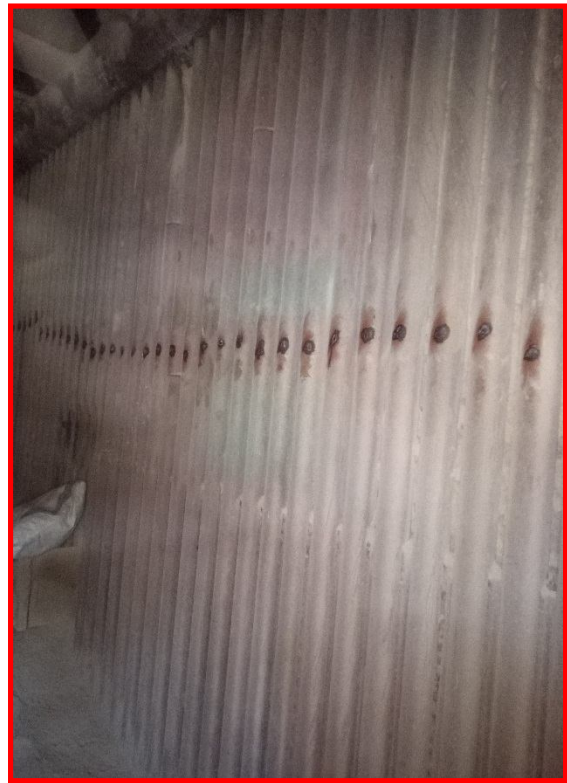
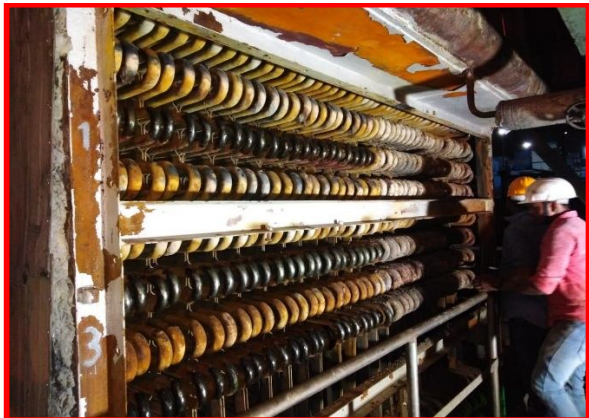
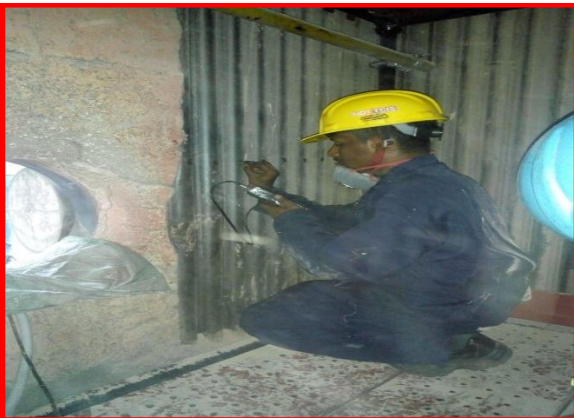
Thickness measurement carried out at various pr.parts in boiler

.Thickness measurement of various pr. Parts as follows

- Panel tubes
- Evaporator coil
- Economiser coil
- IBSH coil
- Primary sup.htr coil
- Convection bank

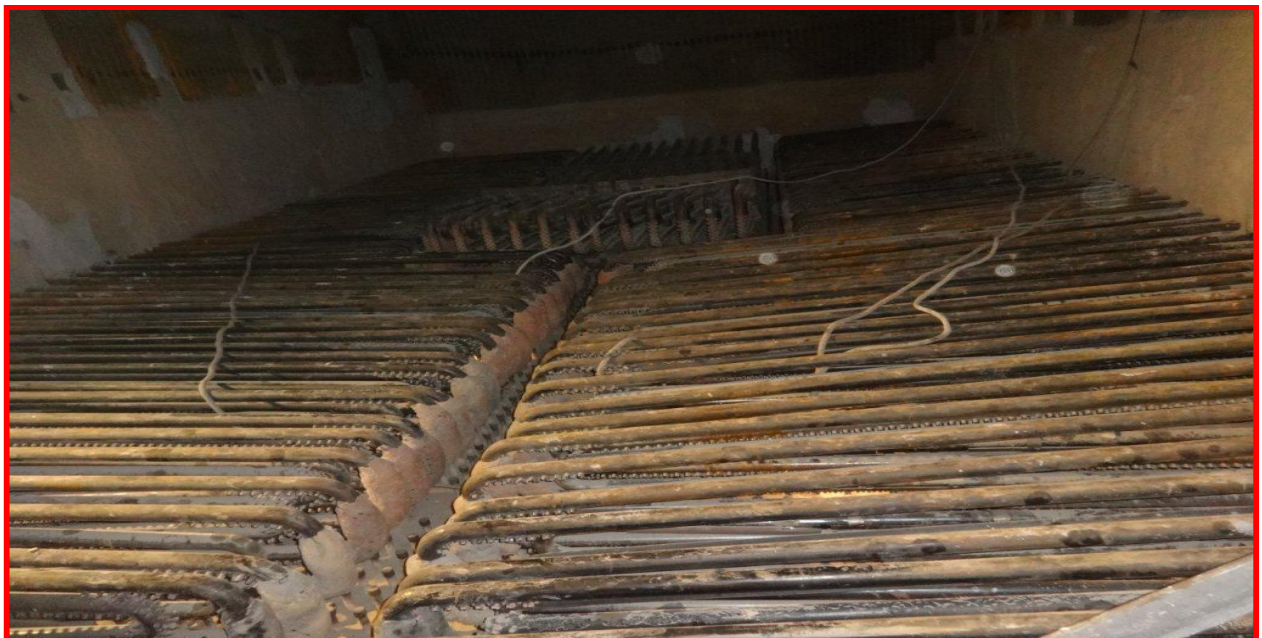
FURNACE JOB

- 1. Furnace bed material cleaning cleaning/nozzle pinning & charging**
- 2. Application of phoscast-90 XR refractory in evaporator coil in furnace.**

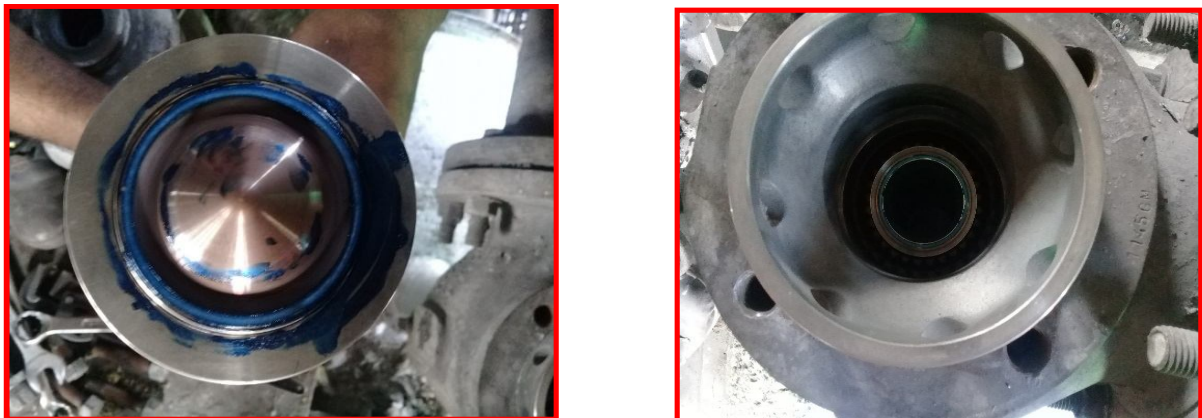
**OVERHAULING OF SAFETY VALVE STEAM DRUM-RHS
BOILER -OR 805**

22	Steam drum safety valve(RHS)	2-1/2"	Overhauling, Lapping, Blue matching done.	Found OK(No spare consumed)	Trevi test will be done by M/s Nicco Engg during start-up (Design set pr. 75 Kg/Cm2)

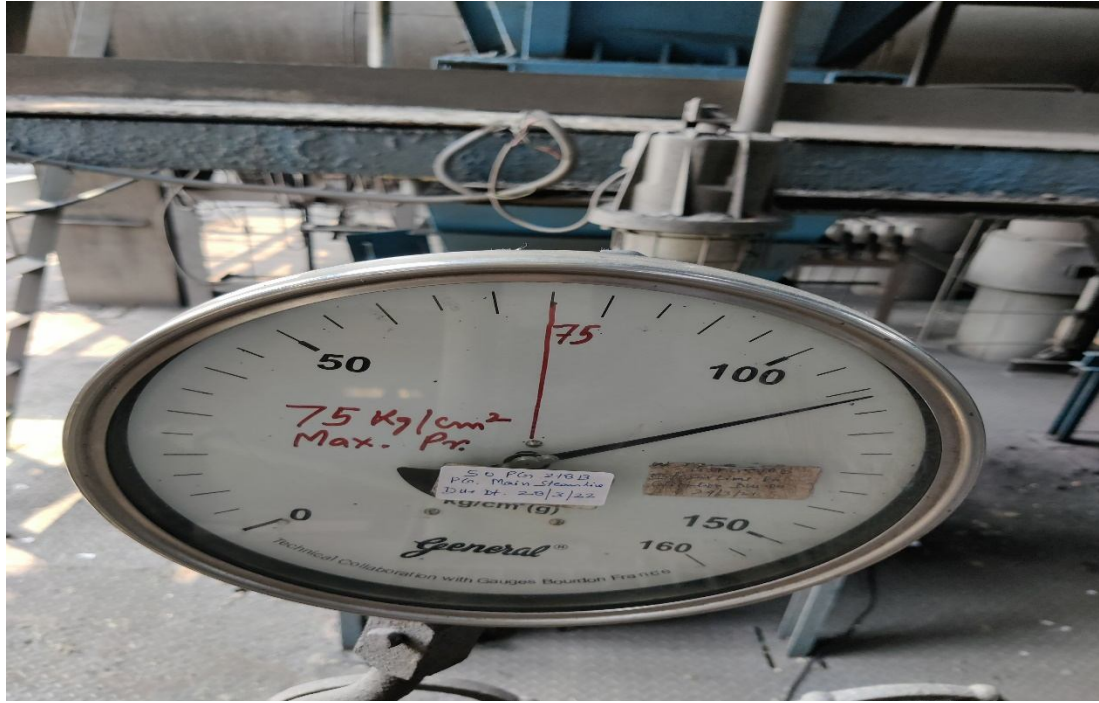
HYDROTEST

Boiler-2 hydrotest done on dtd. 05.04.2021 at 112.5 Kg/cm² in presence of ADFB.

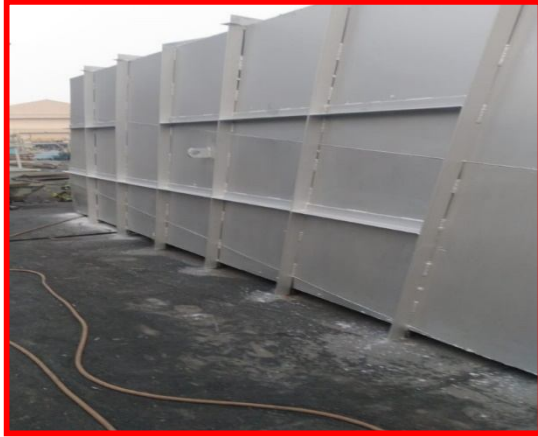
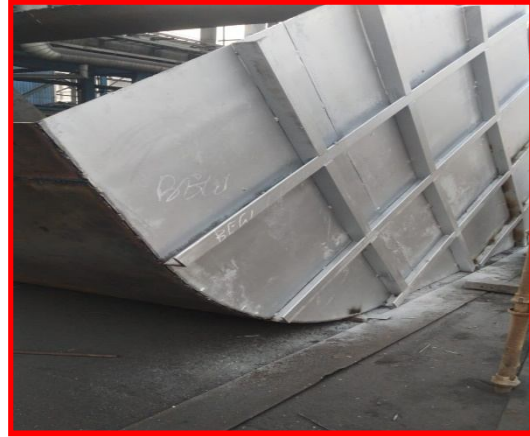
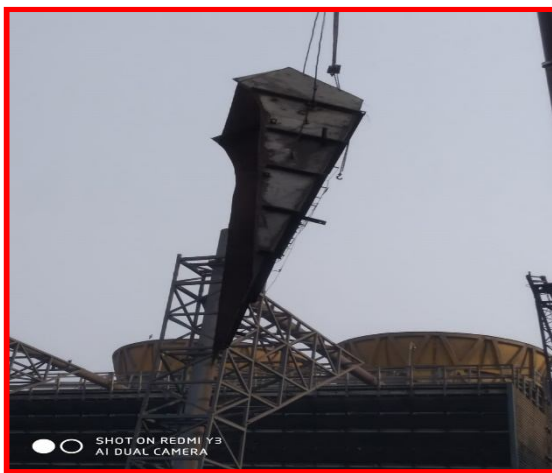
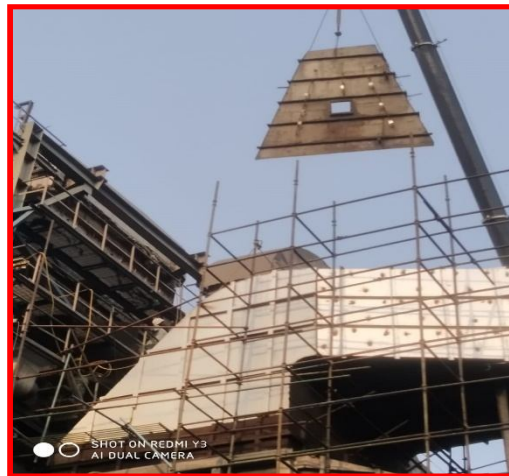
Boiler-2 ESP inlet duct replacement

Problem: Flu gas leakages was observed and corrosion found at various places in the duct and due to this it create the turbulence iin ESP and cause of high SPM, high load on ID/FD fan also occurred due to this.

Activity: Corroded ESP inlet duct replaced in Boiler-2

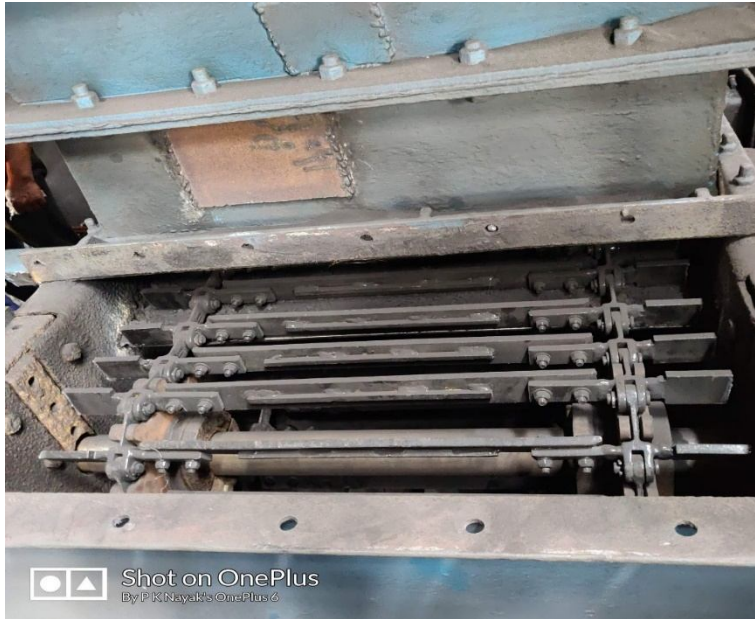
Drag chain, Sprcket replacement of DCF1 of Boiler # 2

Problem: Drag Chain with sprockets were damaged.

Planning: It was planned to replace the Drag chain with integral sprocket .

1. Removal of old chain
2. Removal of drive sproket.
3. Removal of Bearings
4. Sprocket with shaft assembling
5. Fixing of both drive wheel and Trailing wheel. With new bearing
6. Erection of new drag chain
7. Tension giving to chain.
8. Trial run taken

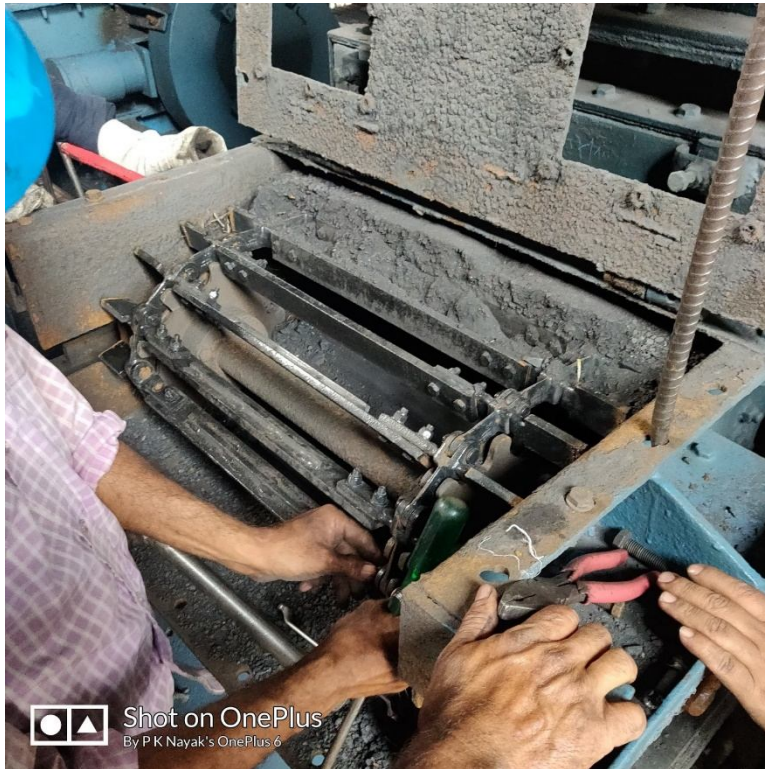
Drag chain, Sprcket replacement of DCF3 of Boiler # 2

Problem: Drag Chain with sprockets were damaged.

Planning: It was planned to replace the Drag chain with integral sprocket.

1. Removal of old chain
2. Removal of drive sprocket.
3. Removal of Bearings
4. Sprocket with shaft assembling
5. Fixing of both drive wheel and Trailing wheel. With new bearing
6. Erection of new drag chain
7. Tension giving to chain.

8. Trial run taken

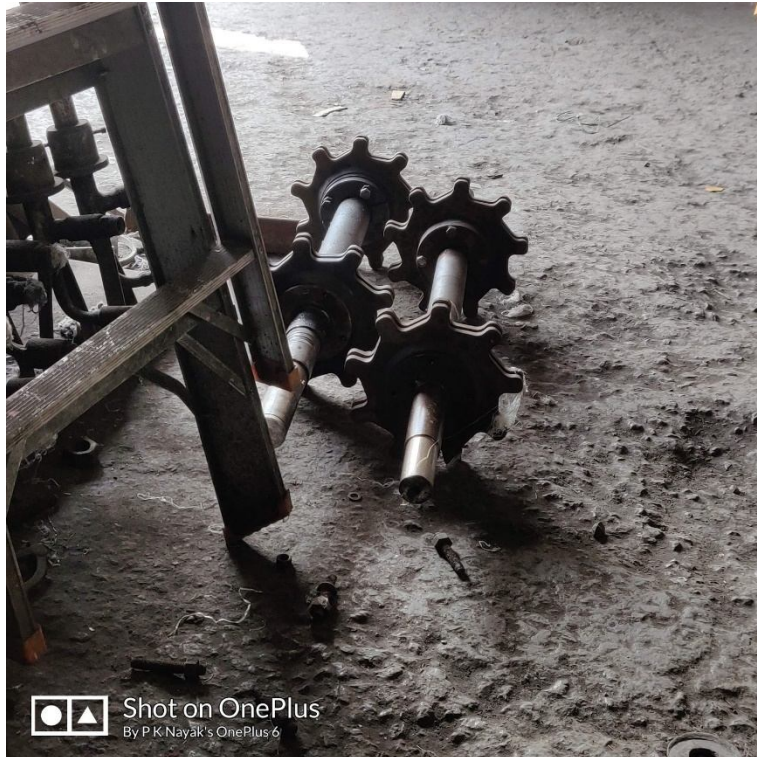
Drag chain, Sprcket replacement of DCF4 of Boiler # 1

Problem: Drag Chain with sprockets were damaged.

1. Removal of old chain
2. Removal of drive sprocket.
3. Removal of Bearings
4. Sprocket with shaft assembling
5. Fixing of both drive wheel and Trailing wheel. With new bearing
6. Erection of new drag chain

7. Tension giving to chain.
8. Trial run taken

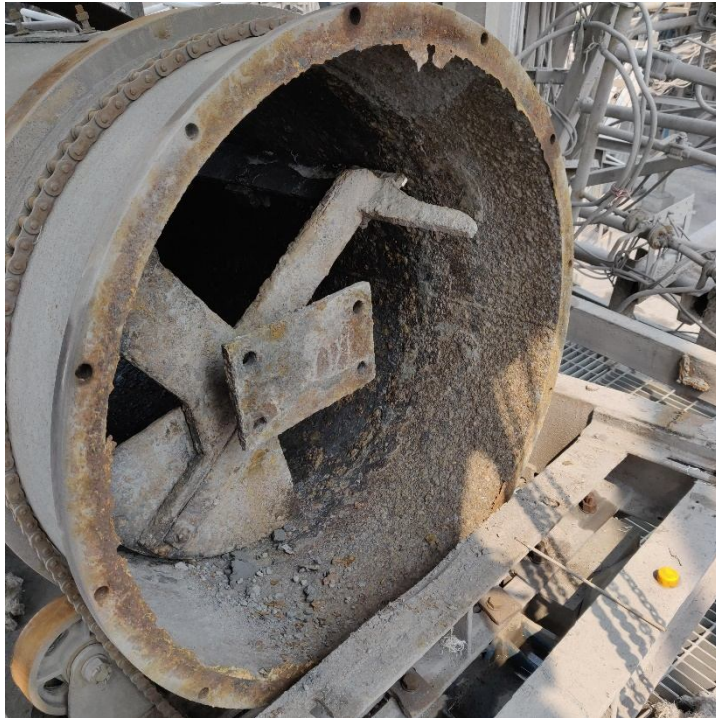
Drum sprocket replacement of Ash Unloader-1 of Old Silo

Problem: Drum sprockets was damaged.

1. Removal of old Intake valve
2. Removal of drive chain with adjuster
3. Removal of pedestal
4. Removal of old sprocket
5. Fixing of new sprocket

6. Fixing of pedestal
7. Refitting new chain, seal.
8. Refitting of adjuster
9. Trial run taken

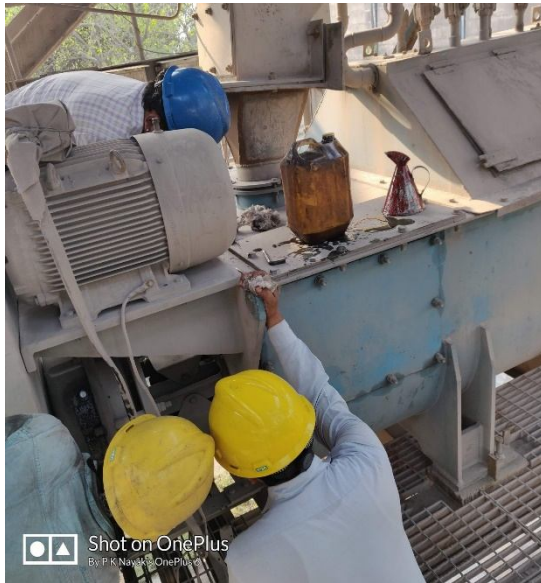
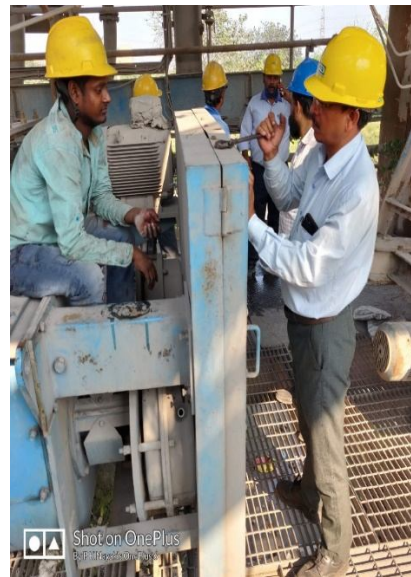
Bearing and gearbox inspection of New Paddle mix unloader

Problem: Drum sprockets was damaged.

1. Removal of bearing cover
2. Cleaning of bearing with diesel
3. Fixing of bearings
4. Greasing of bearings

5. Draining of old oil of gearbox
6. Refilling new oil
7. Removal of timing belt cover
8. Tension giving to the belt
9. Trial run taken

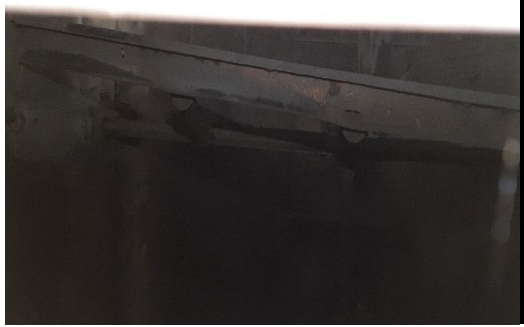
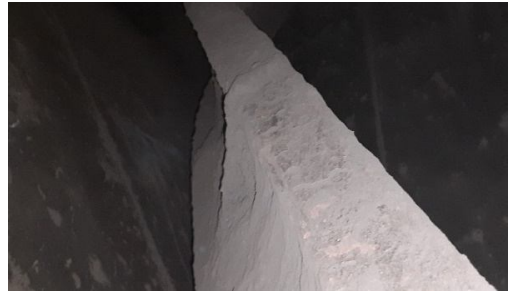
- **04 Nos of Hopper Tie Beam found damaged & dropped in the Hopper.**
- **Boiler # 2 side Coal Bunker floor some chequered plate found corroded.**

DAMAGED BEAM INSIDE BUNKER

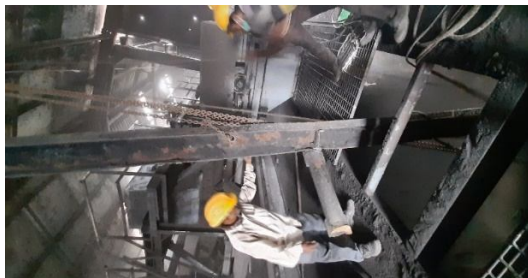
DAMAGED BEAM REMOVAL WORK

- Dropped Beams are removed from Boiler # 2 Coal Bunker.
- New Beams are fitted in appropriate position.
- Corroded Chequered Plates are replaced by New Plates.

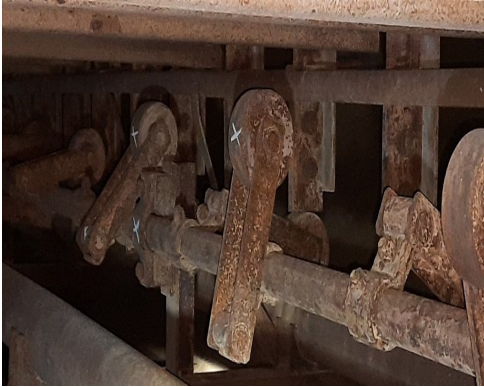
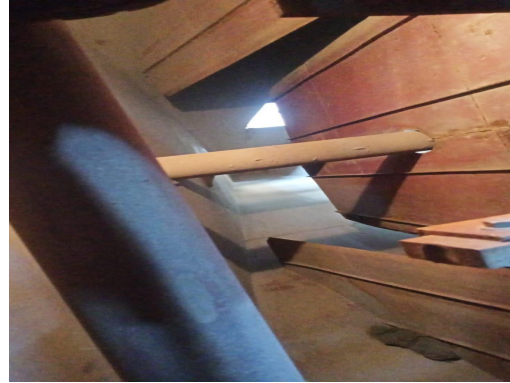
- Some Collecting Hammers, Emitting Hammers , CI Bearing, found damage in Boiler # 2 New & Old ESP.
- Some Collecting & Emitting Anvil Pads Bolt found missing & some in loose condition.

- 02 Nos of Collecting plate found misaligned.
- Boiler # 2 Old ESP Hopper guide plate found shifted.

**DAMAGED HAMMERS MARKING DONE IN BOILER # 2 ESP
BOILER # 2 HOPPER GUIDE PLATE IN SHIFTED POSITION**

- All the damaged Collecting Hammers, Emitting Hammers & CI Bearing replaced with new one.
- All the Collecting & Emitting Anvil Pads new bolt fitted and tightened & then Tac Welding done.
- 02 Nos of Collecting plate Aligned.
- Boiler # 2 Old ESP Hopper plate positioned to its original place.

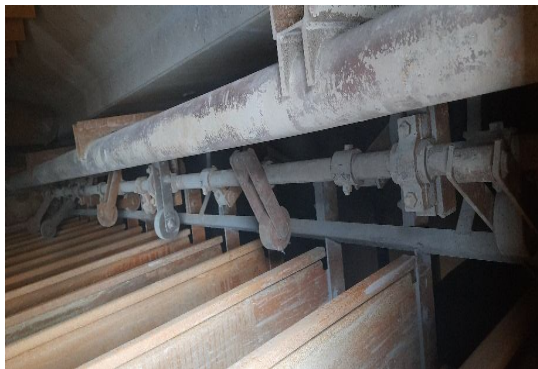
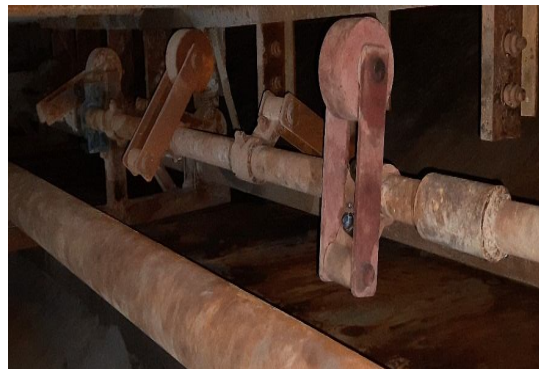
NEW HAMMERS & CI BEARINGS FITTED IN EMITTING ZONE OF BOILER # 2

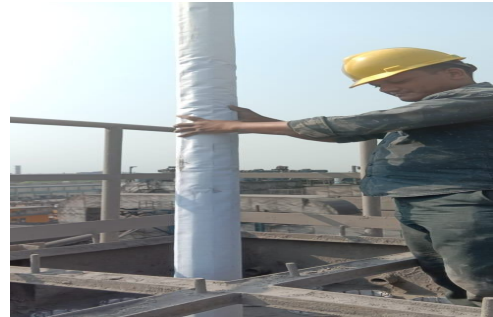
NEW BAGS FITTED

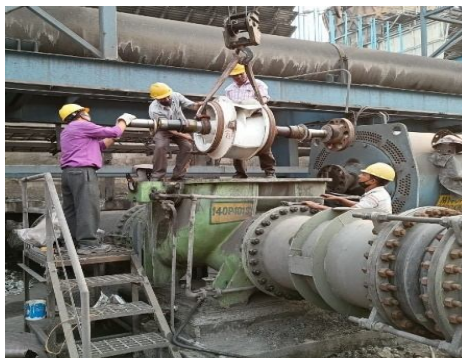
During shut down in the year 2019 it was observed that the impeller of TG CT Pump C & S was eroded.

TG CT PUMP S IMPELLER FITTING

1. Removal of Top casing of TG CT pumps A, C & S.
2. Cleaning of top casing and parting plane of pumps.
3. Inspection of white metal lined journal bearings and Ball bearing.
4. Replacement of Rotor assembly in TG CT Pump C & S due to erosion on impeller vanes with spare rotor.
5. Repair of bottom casing of pump A, C & S done near neck ring area with Steel putty.
6. Boxed-up Pump with proper gasket.
7. TG CT pump A impeller also found slightly eroded.

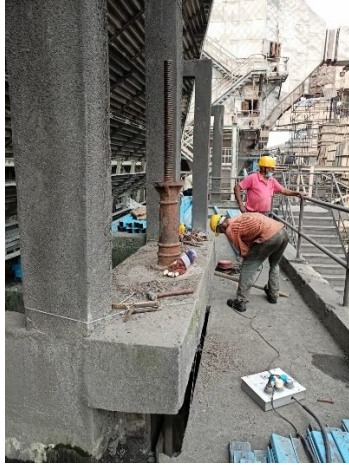
All four sluice gate were non-operational and rusted.

Before overhauling

Overhauling of 4 sluice gates has been done Shafts and gearbox has been replaced with new one. After overhauling painting has been done. Now it's working smoothly.

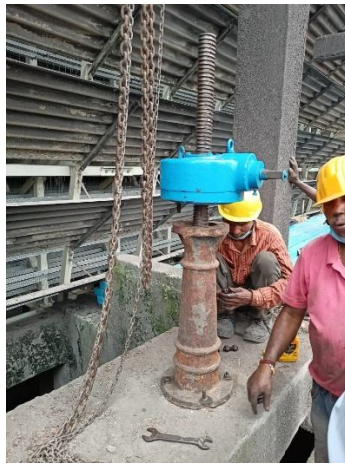
During overhauling

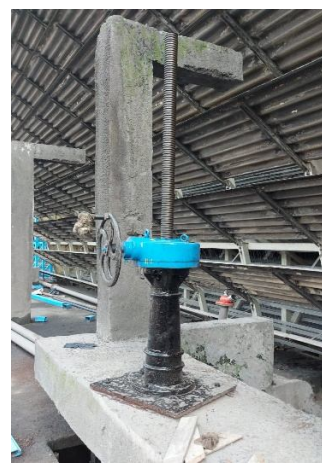
After overhauling

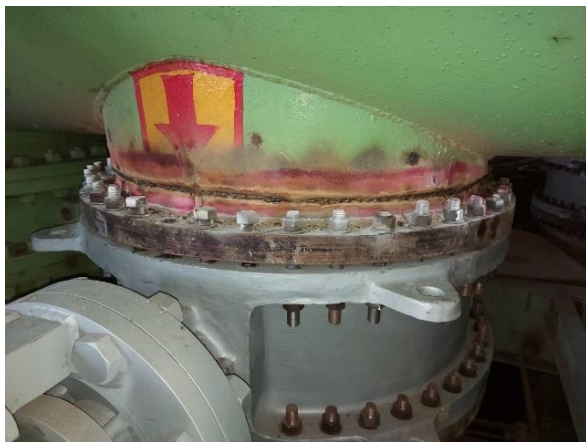
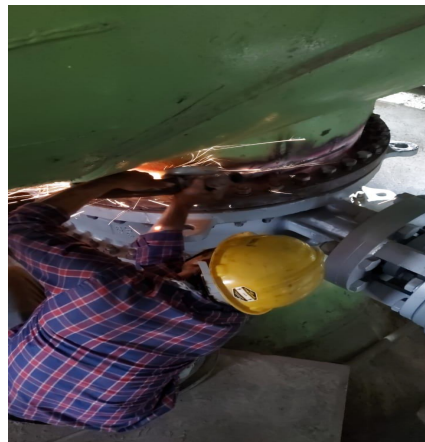
IX. TG-2 CONDENSER INLET AND OUTLET VALVE REPLACEMENT

It was observed that the old condenser inlet and outlet valve did not isolate properly.

It was planned to replace one pair of TG-2 condenser inlet and outlet valve will be replaced with triple offset butterfly valve.

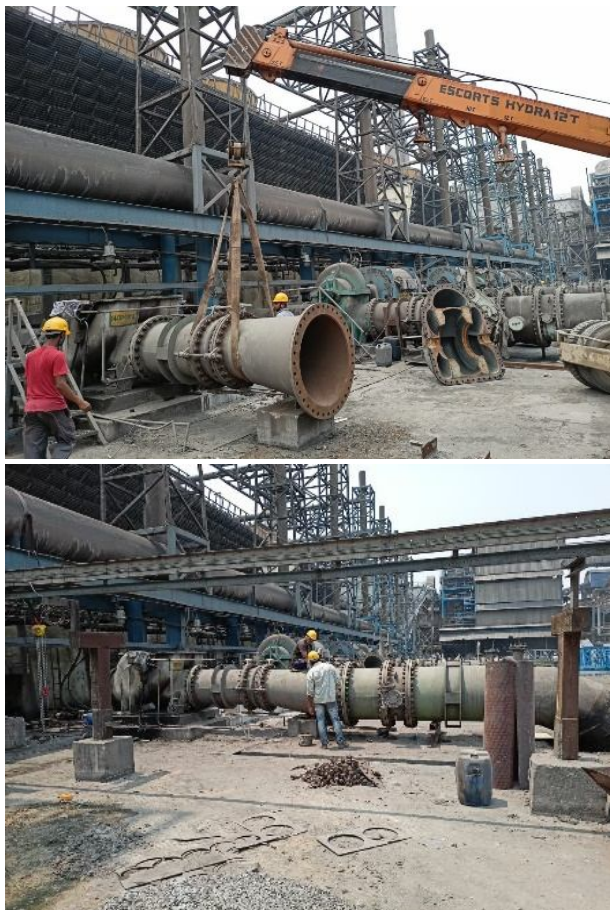
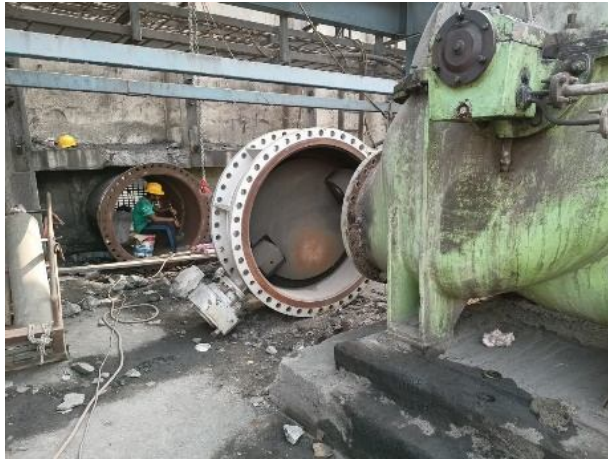
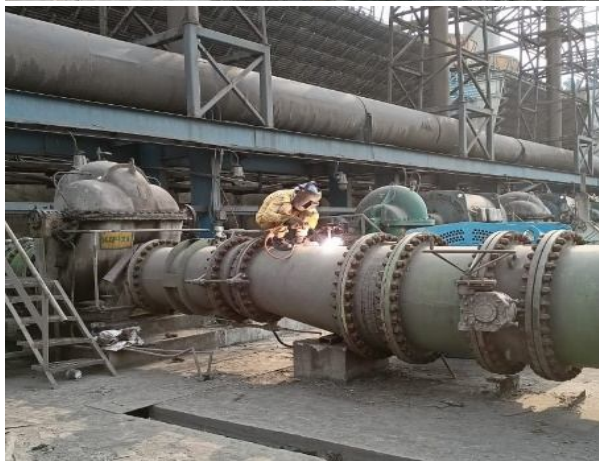
X. SUCTION AND DISCHARGE VALVES & PIPING REPLACEMENT OF TG COOLING TOWER PUMPS A, C & S AND DISCHARGE PIPING REPLACEMENT OF TG COOLING TOWER PUMPS B & D.

Suction valve and discharge valves of TG Cooling tower pumps A, C & S were not operational and also the suction and discharge header thickness reduced due to corrosion & erosion.

It was planned to replace old suction and discharge valve of TG cooling tower pump A, C & S and also their suction and discharge header. Also it was planned to replace discharge header of TG cooling tower pump B & D. New suction and discharge header expansion bellow purchased.

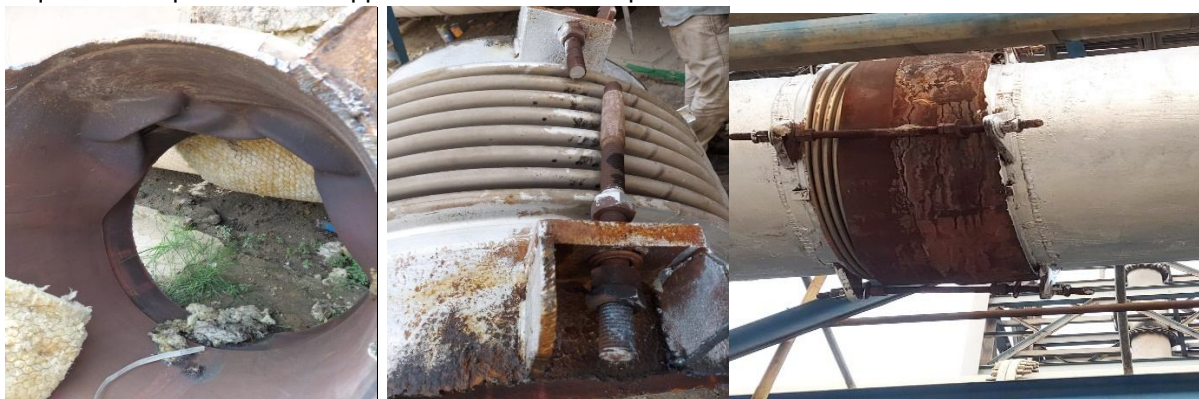
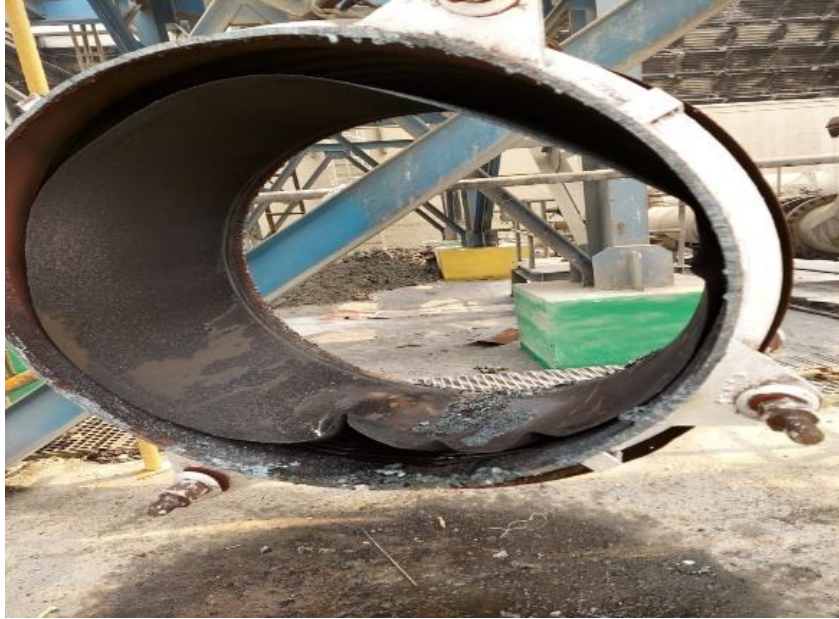
I. Replacement of Expansion Bellows (5 Nos) in LP steam header

Steam bellows were procured from M/s Flextherm after recommendation of replacement of bellows from M/s Systech during their flexibility analysis to improve the reliability & safety of LP steam header. Old bellow photo are attached and it shows the condition of bellows in operation. This was urgently required for replacement. Supports were rectified to position the header.

It was planned to replace old expansion bellow of LPS2 header (5 Nos) with new one.

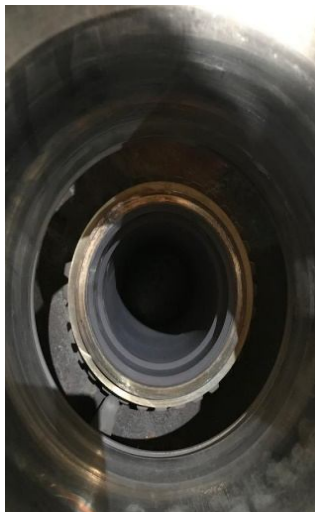
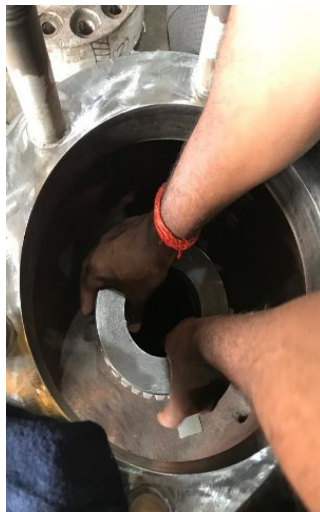
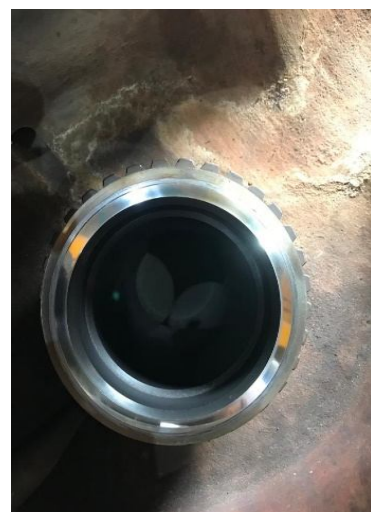
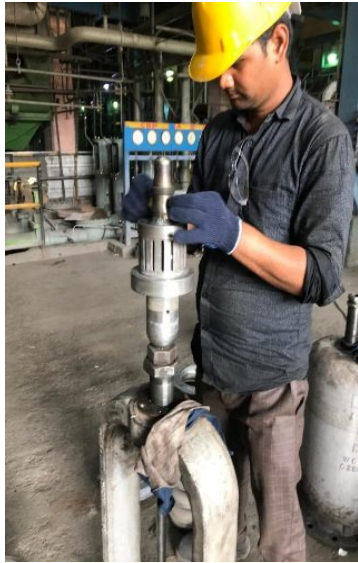
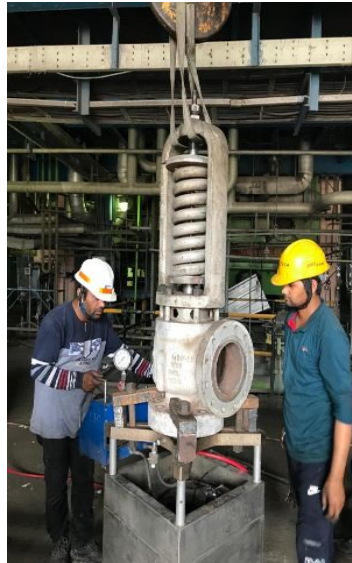
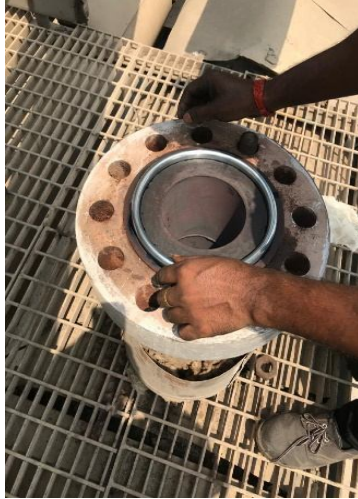
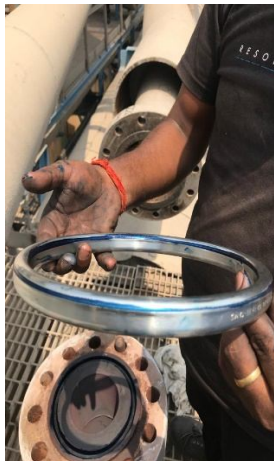
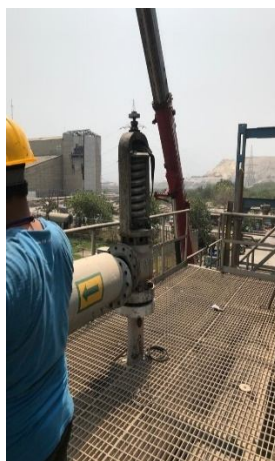
(18). HP Safety valve .

1. Technical Detail :- Safety valve 150NB,1500# .(02 Nos.)
2. Procedure of overhauling:
 - . Dismantling
 - . Cleaning of all parts
 - . Lapping of valve seat
 - . Lapping of valve disc
 - . Assembly of valve
 - .Set pressure testing

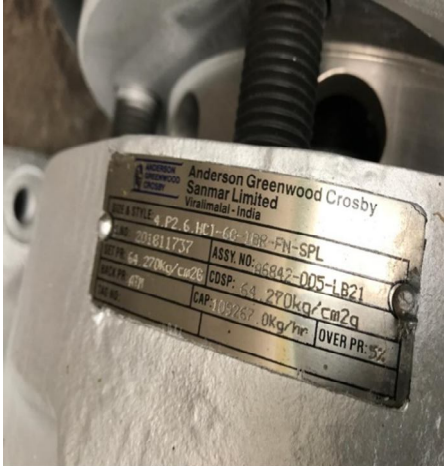
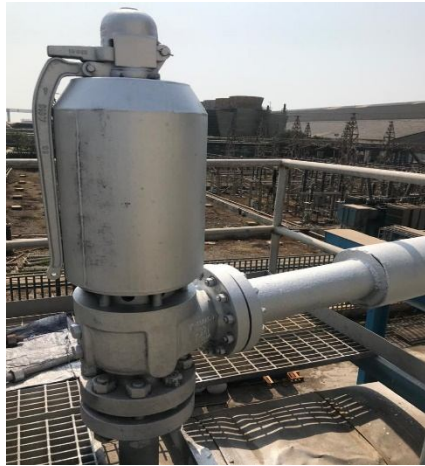
(19). Replacement of HP Safety valve (New)

1. Technical Detail :- Safety valve 100NB,1500# .(01 Nos.)
2. Procedure of overhauling:
 - .Set pressure testing

. After overhauling and testing of spare HP safety valve (100NB, 1500#) send to store. (Repaired code-2520142230044511)

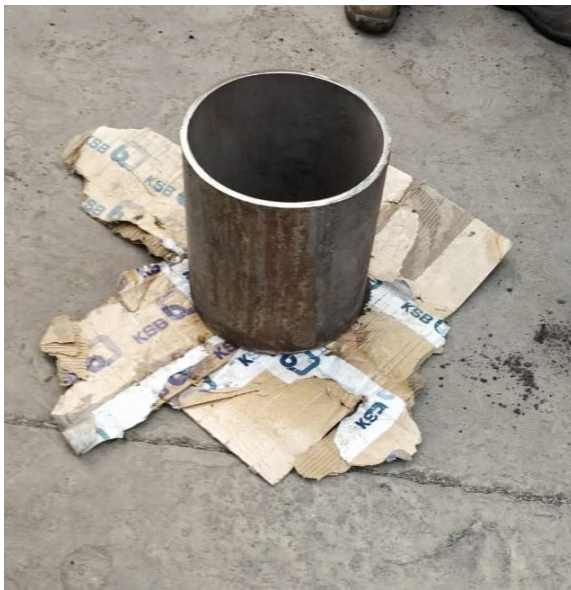
Figure 2: Short piece

A short piece of 250NB pipe of 300MM length was added to complete fit up of steam header. There are two 100MM joints and two 250MM joints in this steam header job. One branch was prepared in 250MM steam header for installation of nozzle assembly.

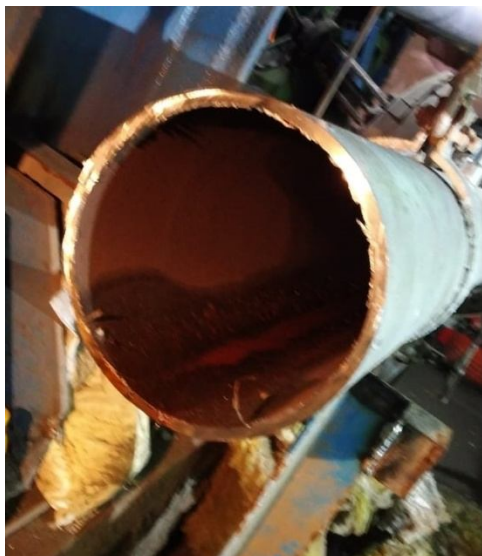
Figure 8: Header cutting

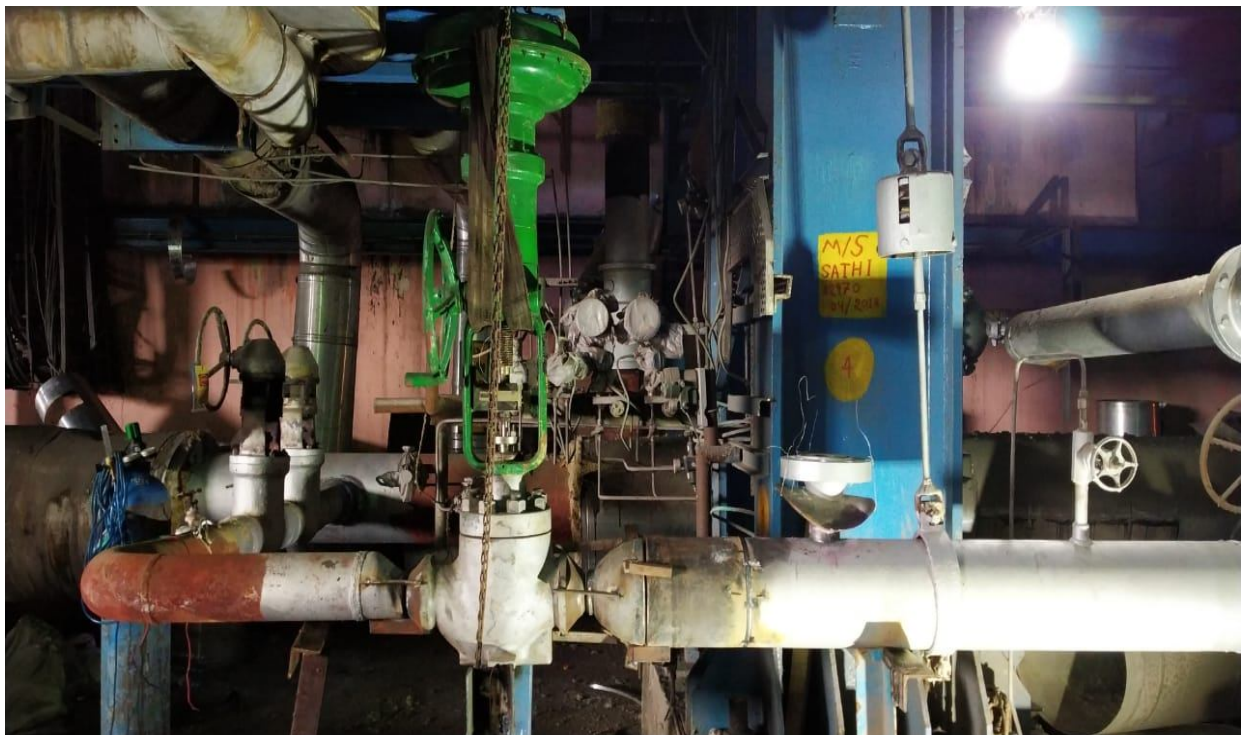
Figure 12: All items are fitted

New PCV was positioned and fit up of PCV, reducer, short piece and branch pipe were done & checked for its fitment for welding. Preheating of joints was done for welding.
