ATR REPORT-2021

**INDIAN FARMERS FERTILISERS CO OPERATIVE LTD.
PARADEEP UNIT**

ATR REPORT: 2021

DAP PLANT

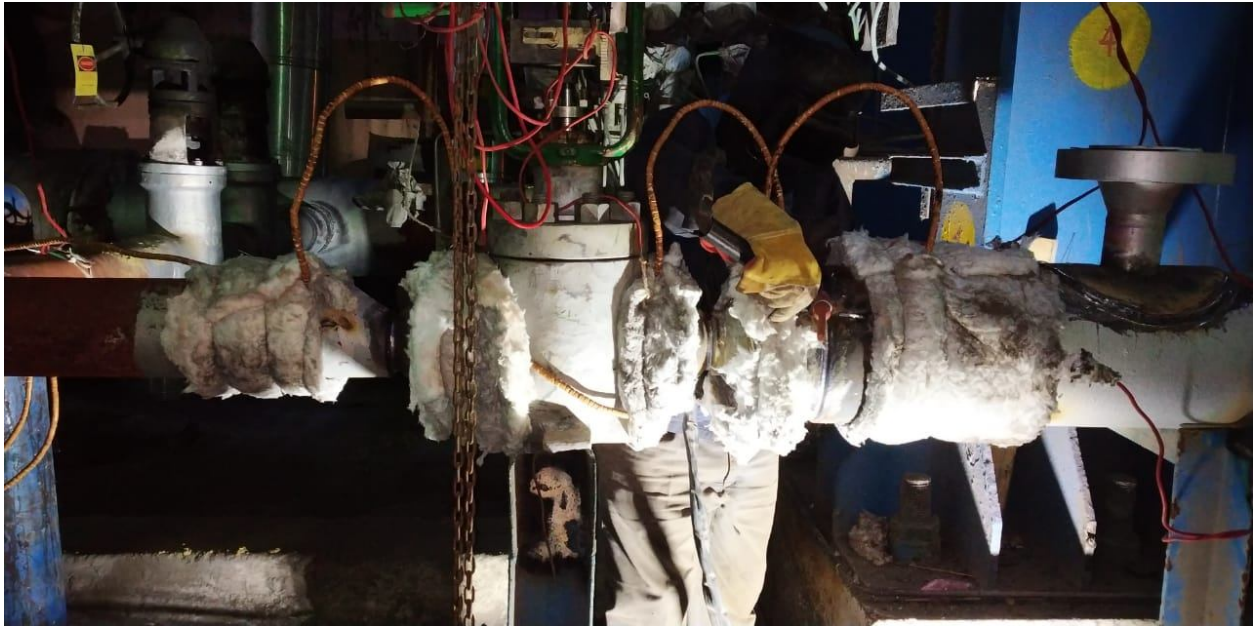
Figure 13: Preheating and root welding

Root welding started with TIG and hot pass was with arc. Radiography test was carried out as per requirement. After that fill up & final welding done. The surfaces of weld joints were finished. Again RT was carried out. SR of steam header was done.

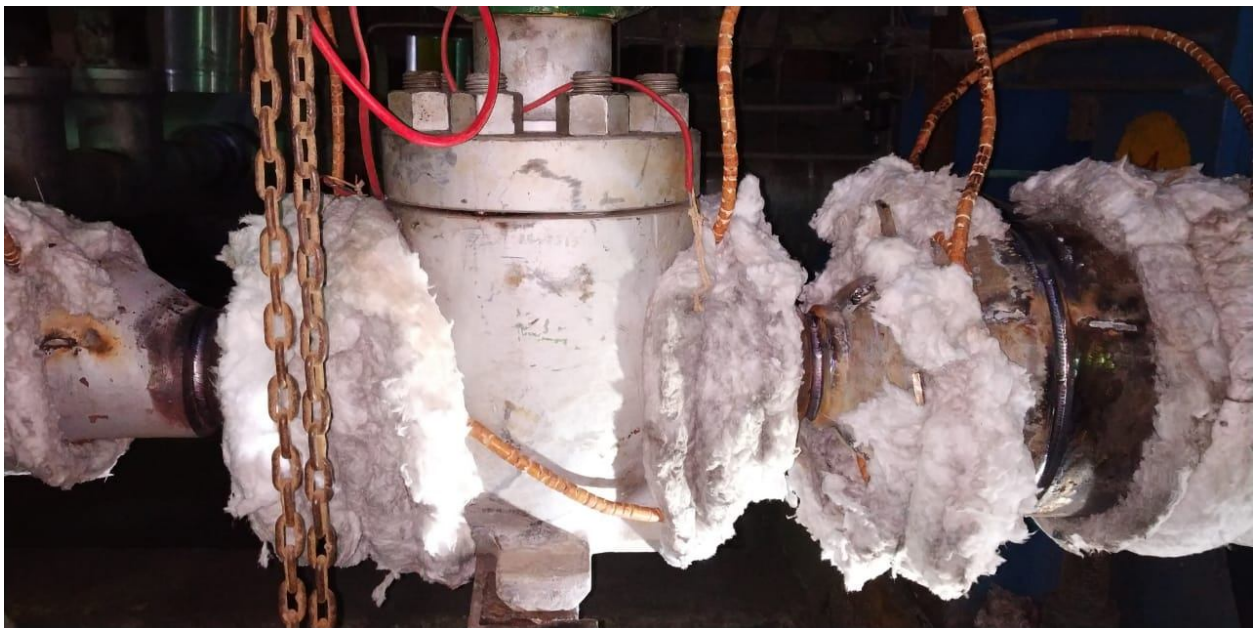
Figure 14: Root welding & hot passes completed and preheating for fill up & final welding

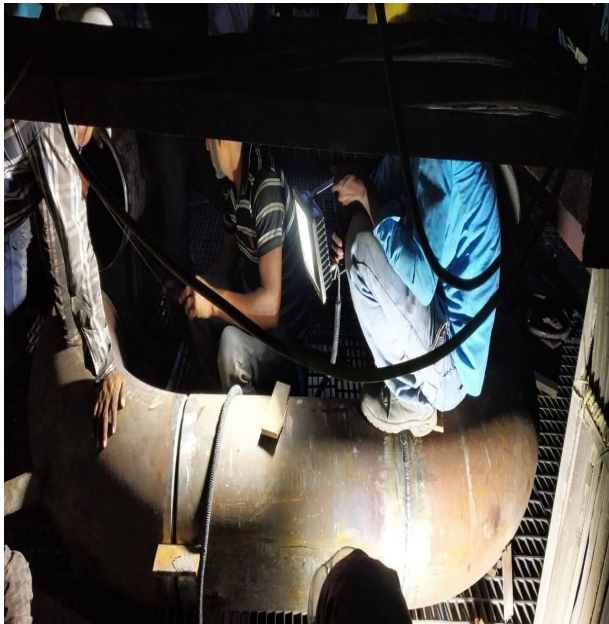
Figure 4 & 5: Elbow & Pipe fit up under progress

Fit up of the elbows were done & checked for its fitment for welding.

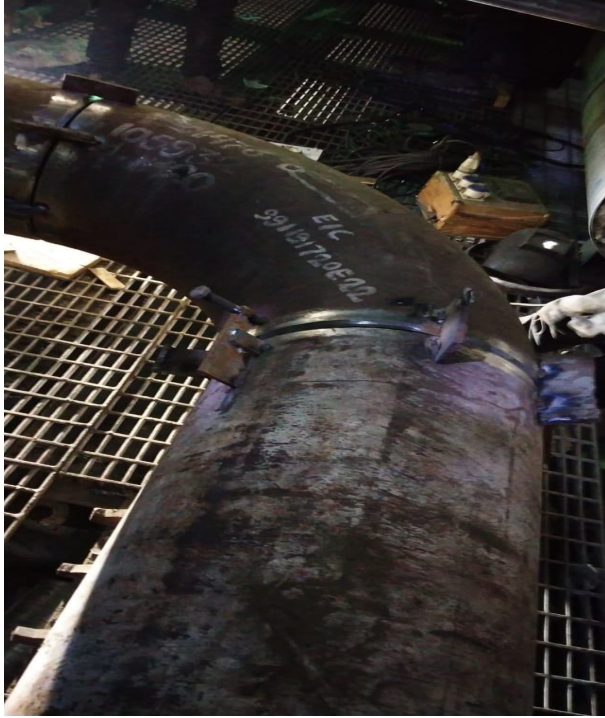
Figure 7 & 8: Both Elbows are fitted and ready for welding

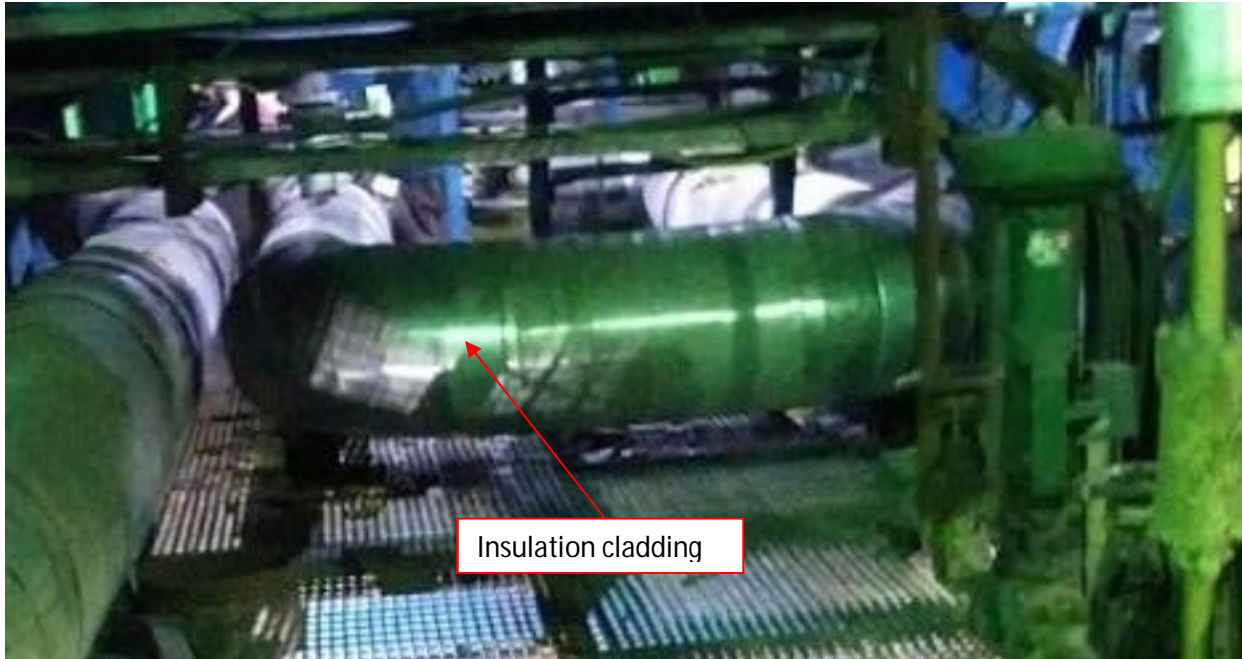
Figure 15: Insulation completed

Proper insulation was applied before charging of header.

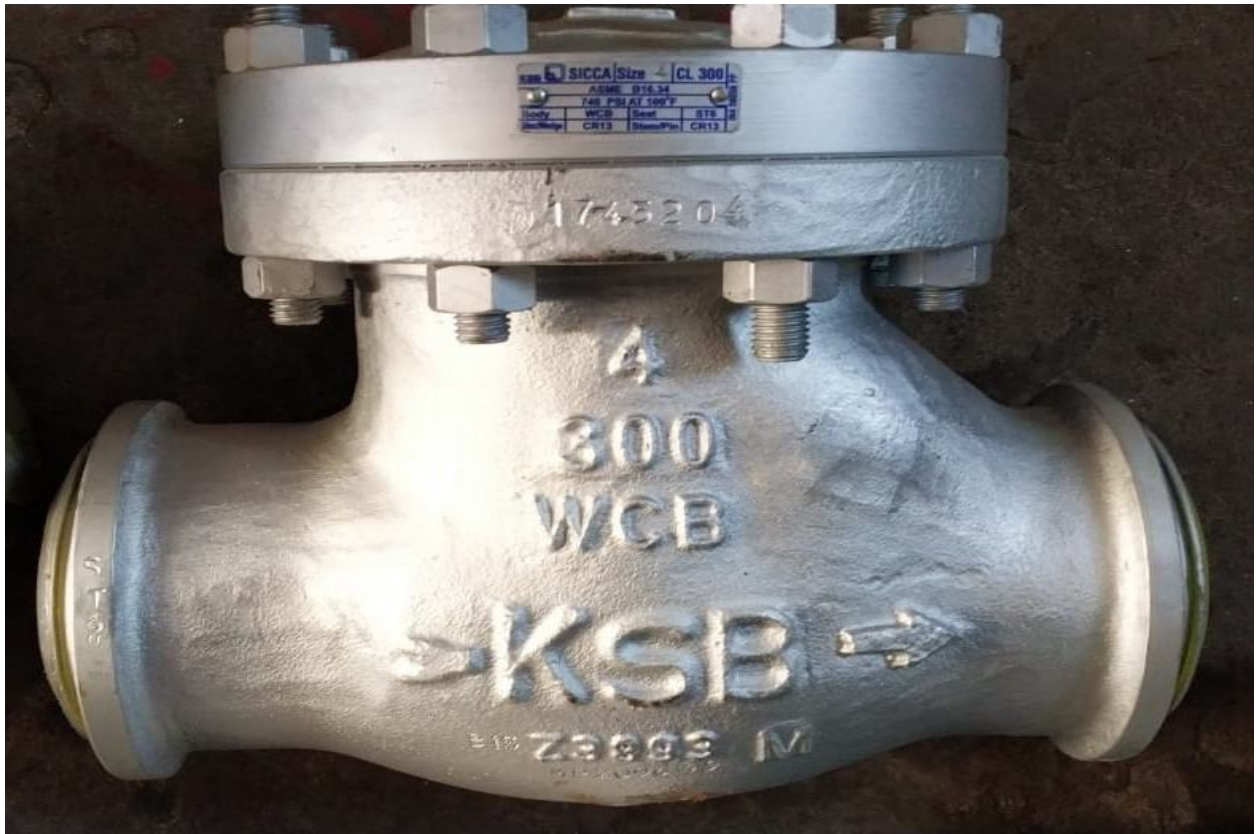
During operation of the plant passing observed through NRV in discharge header of both governing oil pumps at TG-1. Maintenance was tried for several times but it was not succeeded. Then it is decided to replace these NRVs with different type of NRV. The difference between old & new NRV is old NRV disc was mounted on cover plate but new NRV disc is mounted on valve body.

Figure 1: New NRV

NRV in discharge header of both governing oil pumps at TG-1 are replaced.

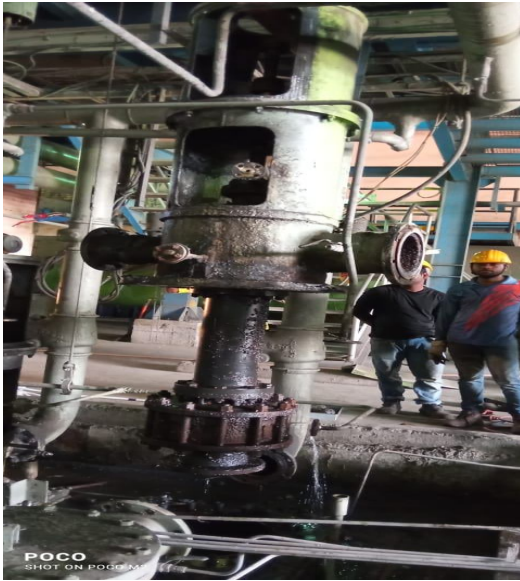
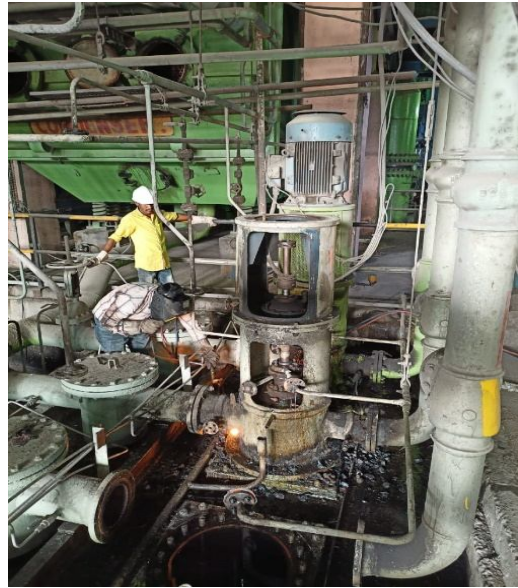
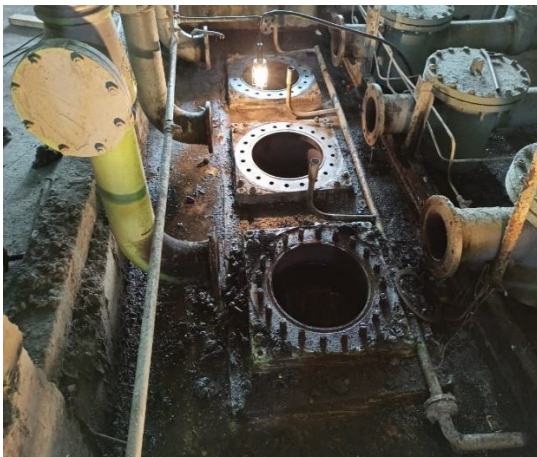
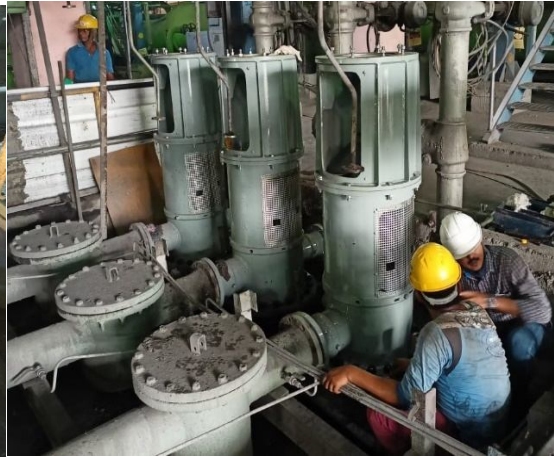
9. Replacement of TG-1 Condensate Extraction Pump A, B & C

Problem: Low pressure was observed during high load in old pumps.

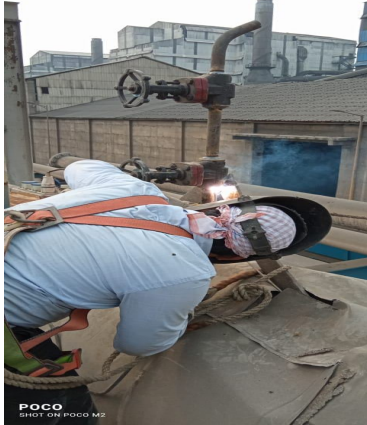
10. HP steam header vent valve replacement

Problem: Passing of steam observed

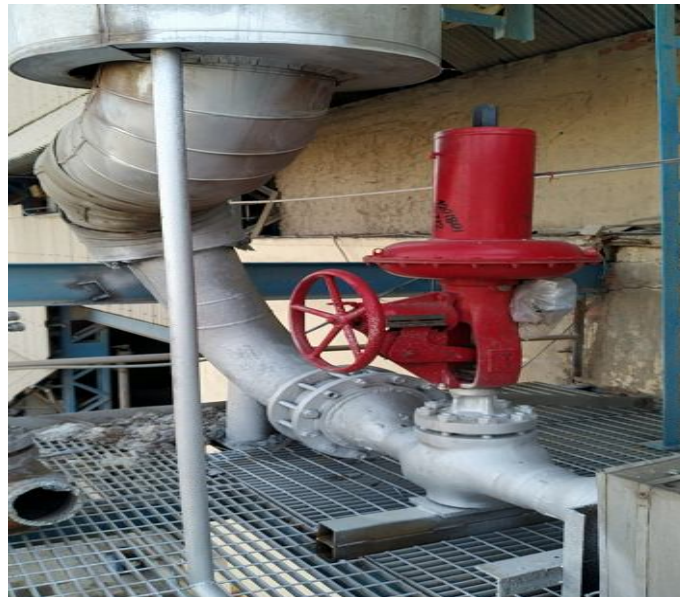
11. Replacement of MP vent control valve

Problem: Crack in body of PCV observed

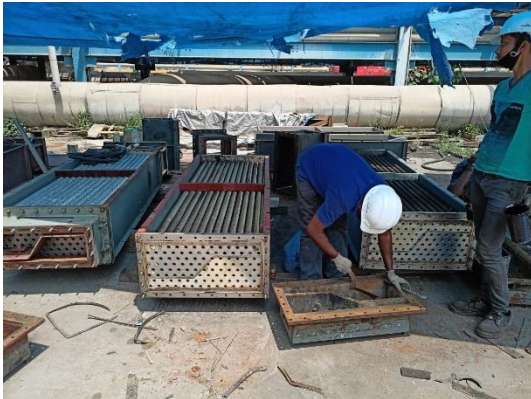
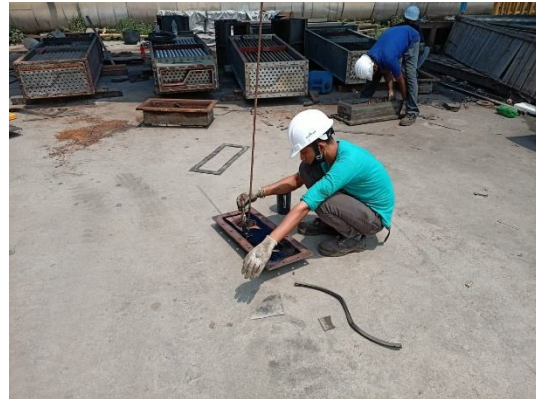
Problem: Choking of cooler was suspected as gen temperature observed high.

TG-1 Generator cooler dismantling & Cooler tube cleaning.

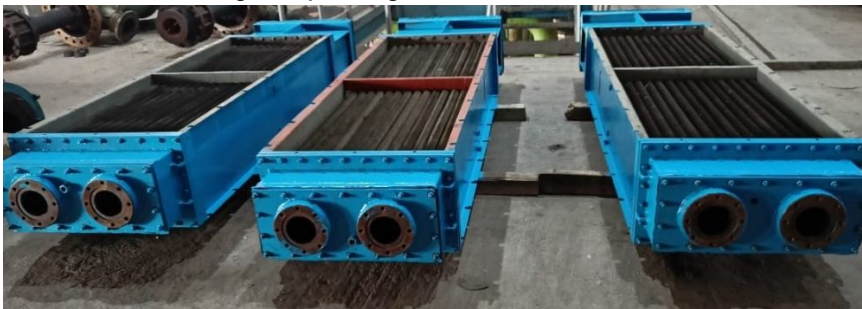
Cooler tube cleaning and painting.

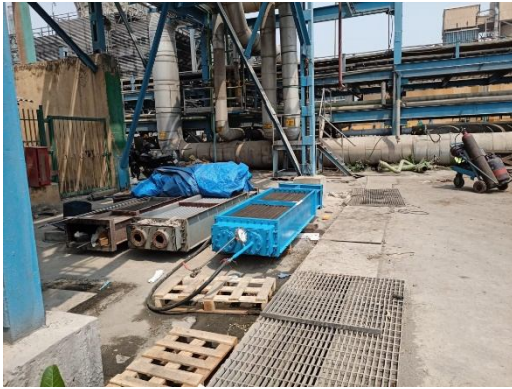
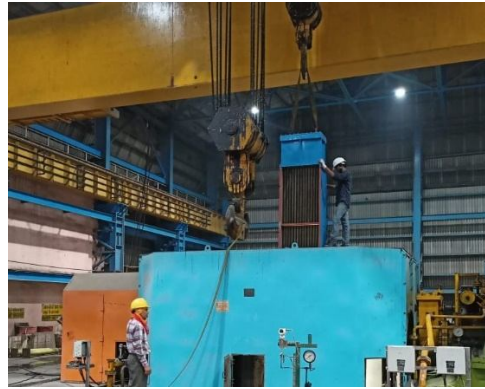
Cooler hydro tested & fitted in position.

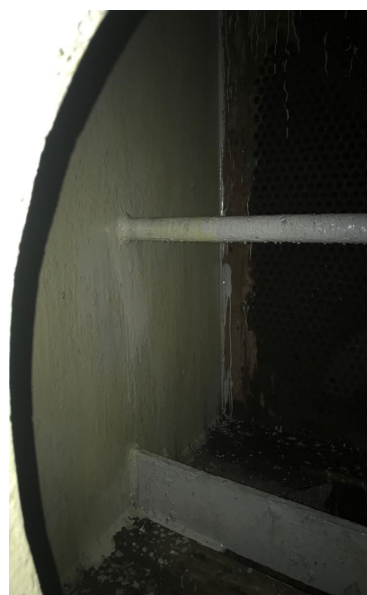
Final ceramic coating

Action taken: To prevent further rusting of tube sheet area, action was taken and coating work was allotted to M/s Wearrist Technologies against P.O. No.-6600 /252004202619 to carry out the coating job for both condensers.

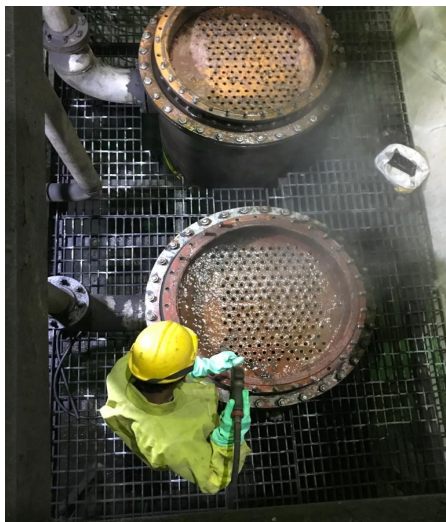
Problem: Due to deposition of ash & sludge in the tubes it is observed that the oil temperature rises.

Cooler tubes cleaning

Job execution: Job was carried out by the Usha Hydrodynamics in one day under the supervision of IFFCO Engineer. Cleaning was done at 180-200 bar pressure. Job started on 26/03/2021 and completed on same day.

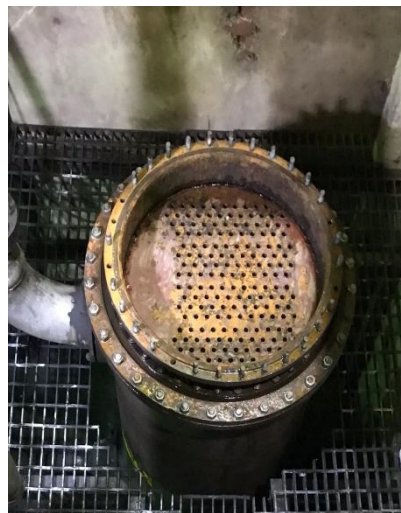
After cleaning

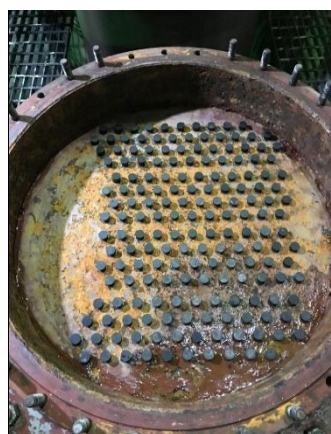
Problem: During inspection of oil cooler tube sheet it was observed that at some locations of tube sheet area, previously applied coating was damaged and become rusted.

Plugging of tubes faces

Action taken: To prevent further rusting of tube sheet area, action was taken and coating work was allotted to M/s Wearrist Technologies agencies against P.O. No.-6600 /252004202619 to carry out the coating job for oil coolers of both Turbines.

Job execution: The job of coating for both oil coolers was executed by M/s Wearrist Technologies agencies under the supervision of IFFCO Engineer. Job started on 26/03/2021 and completed on 27/03/2021.

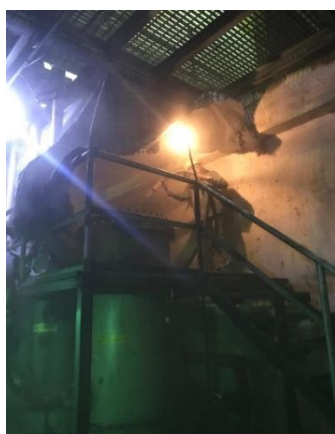
Sand blasting

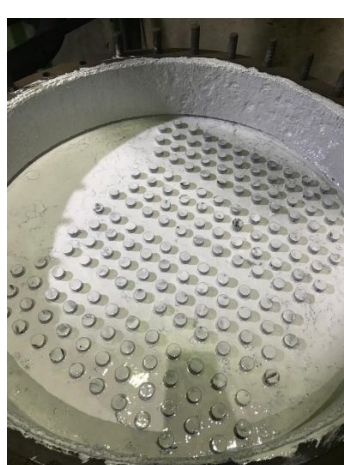
Final ceramic coating

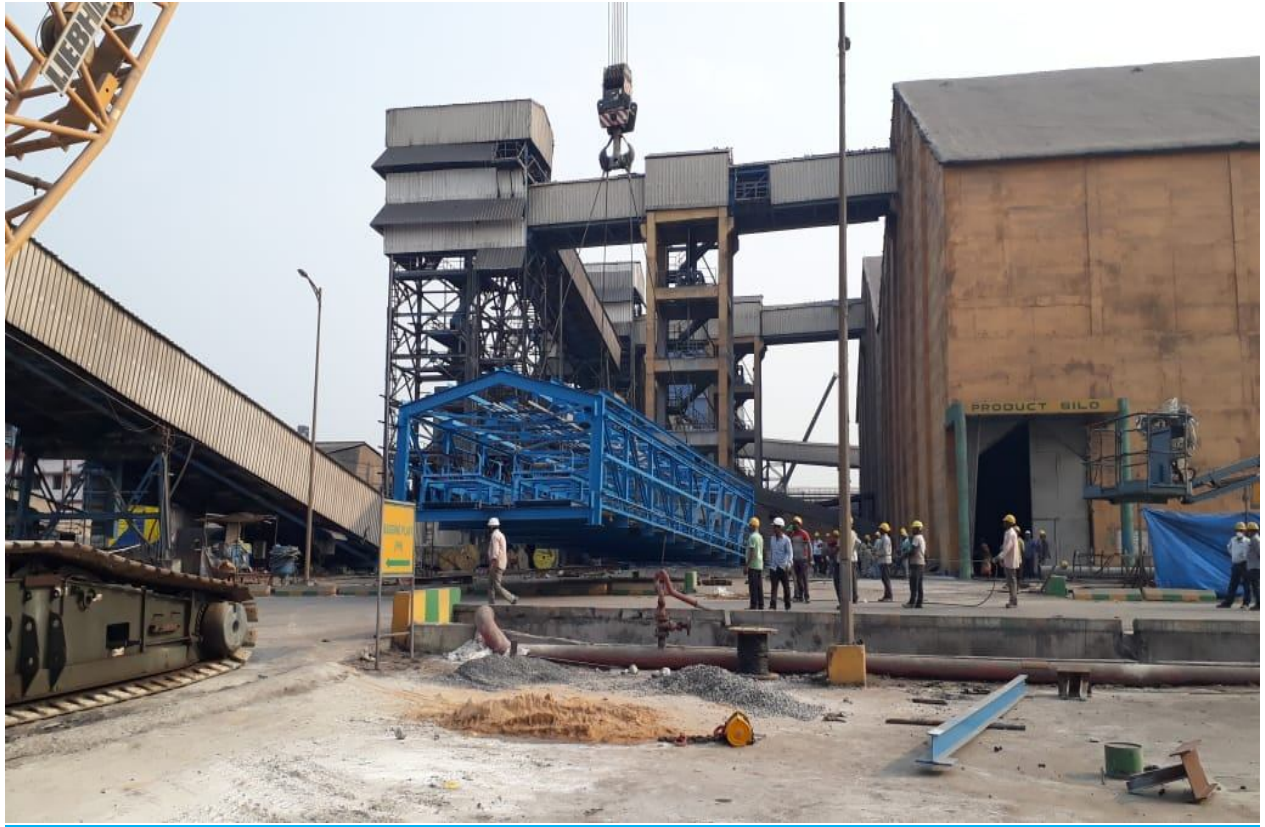
NEW GALLERY FOR ERECTION

1. The badly corroded portion (Gallery 1 & 2 -Around 45 Mtrs) of the conveyor gallery BC- 130 / 132 along with its support trestle No- 1 (4 leg support) & take-up structure (2 leg) including its platform had been replaced with complete new pre-fabricated structures during the ATR within a period of 18 days w.e f:16.03.2021. Further, the civil structures **(Total 06 Nos)** were also constructed over which the newly fabricated trestles were placed with base plates having 06 holes instead of 04 holes as earlier. **One no of additional support** structure was also installed near by the take-up structure prior to the cutting of gallery No-2.

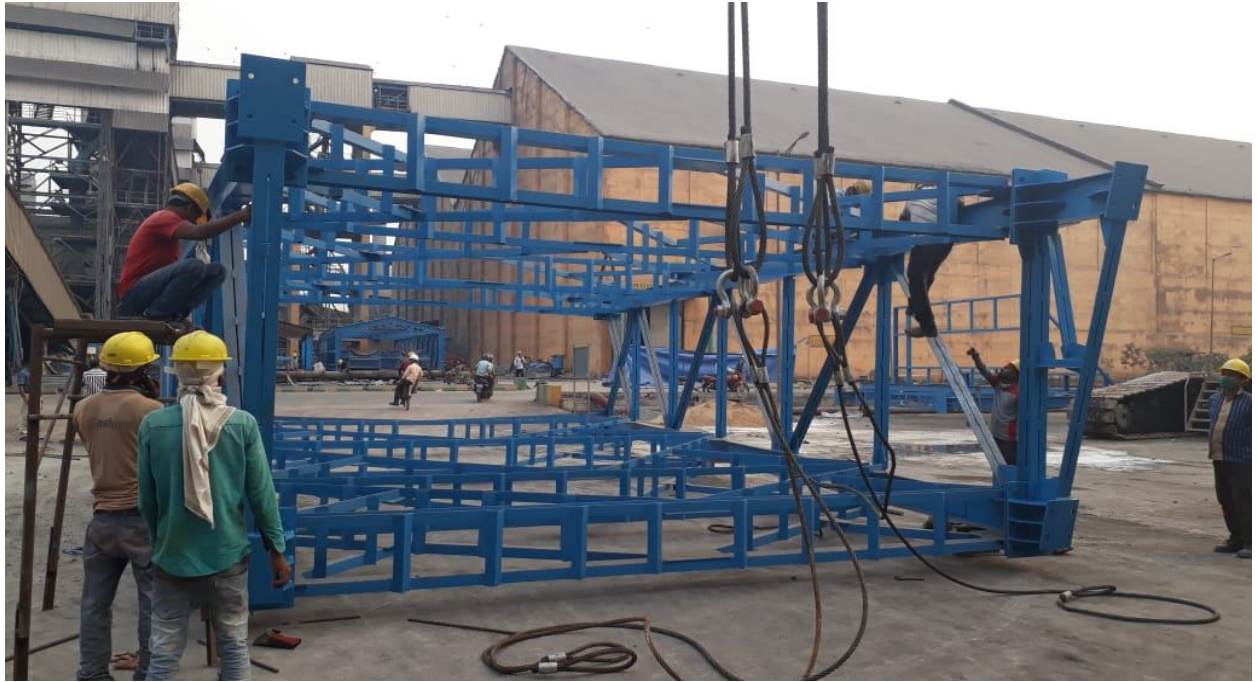
ALL NEW GALLERIES – 1 & 2 ALONG WITH TRESTLE NO-1 & 3 AFTER ERECTION:

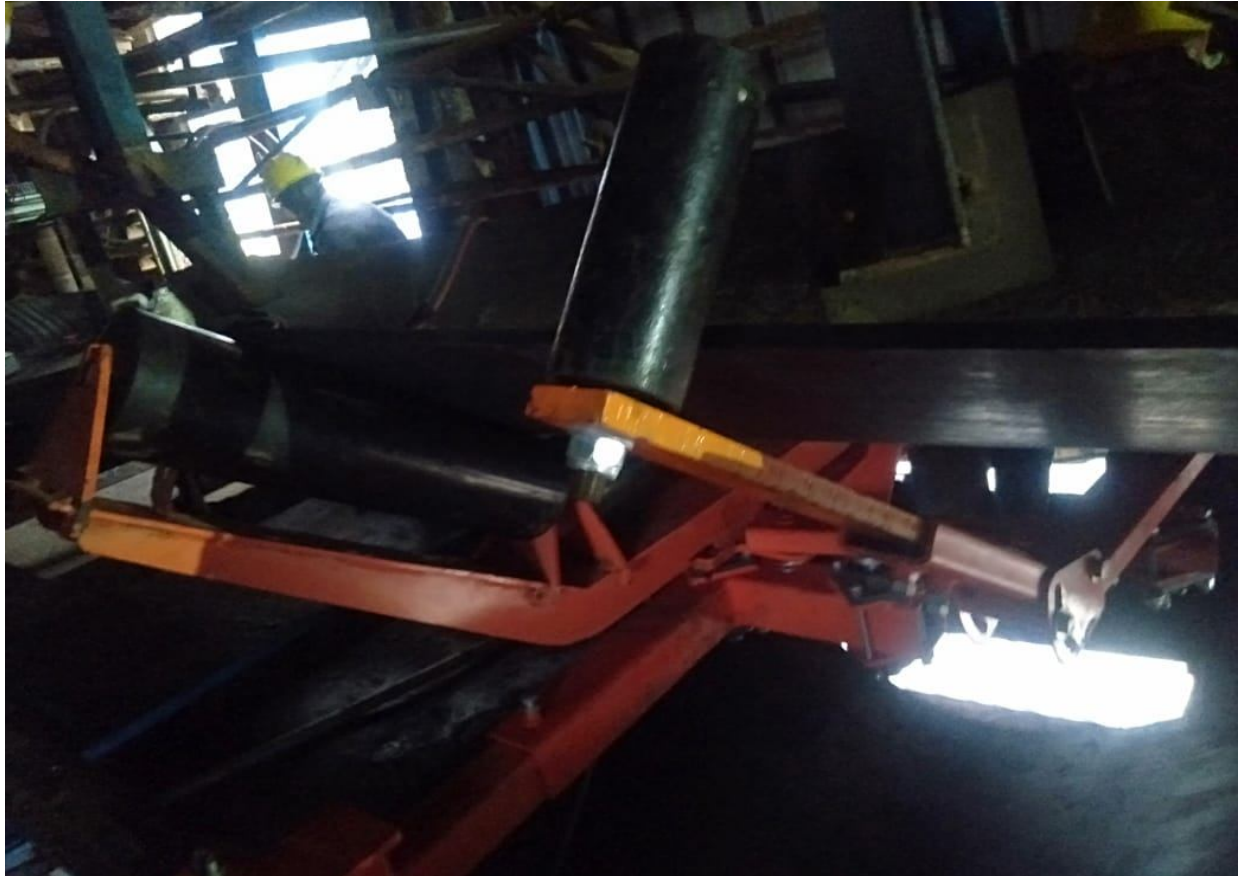
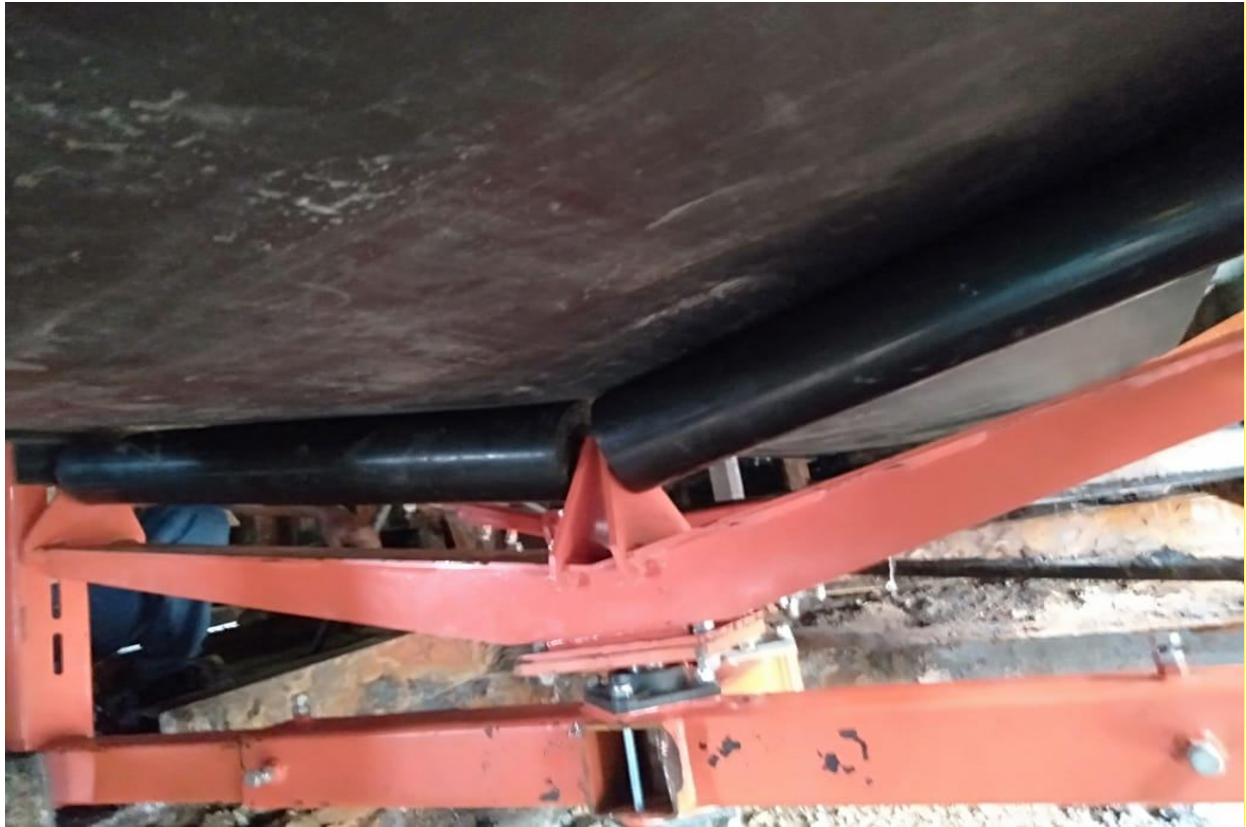
RETURN SIDE OF BC- 130:

Automatic belt trainers on trial basis have been installed on the carrying as well as return side of BC- 130 with a vision to minimise the spillage during running condition of the conveyor.

Now the installed trainers are working satisfactorily since installation .

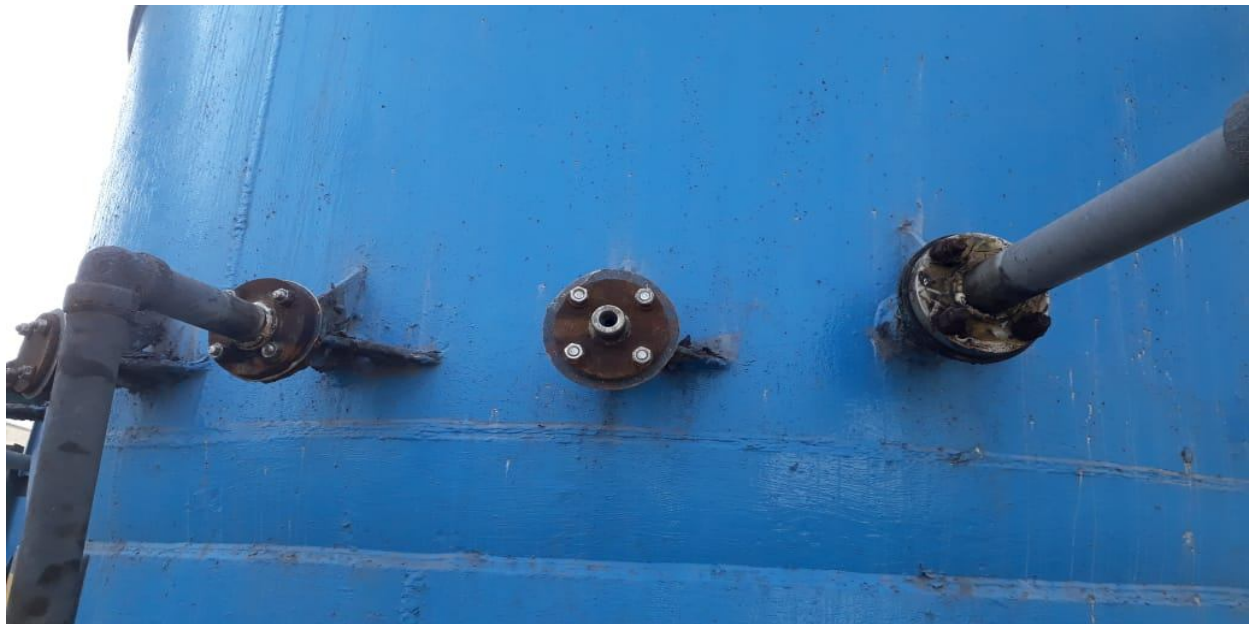
RESULT: SATISFACTORY (O.K). –FOUND TO BE FIT FOR USE.

HYDROTEST OF THE INSTRUMENTATION AIR TANK ALSO CARRIED OUT BY THE CENTRAL WORKSHOP IN CORDINATION WITH THE MAINTENACE & OPERATION TEAM OF BAGGING PLANT UNDER THE SUPERVISION OF THE COMPETENT PERSON DEPLOYED BY DIRECOR OF F& B- GOVT.OF ODISHA.

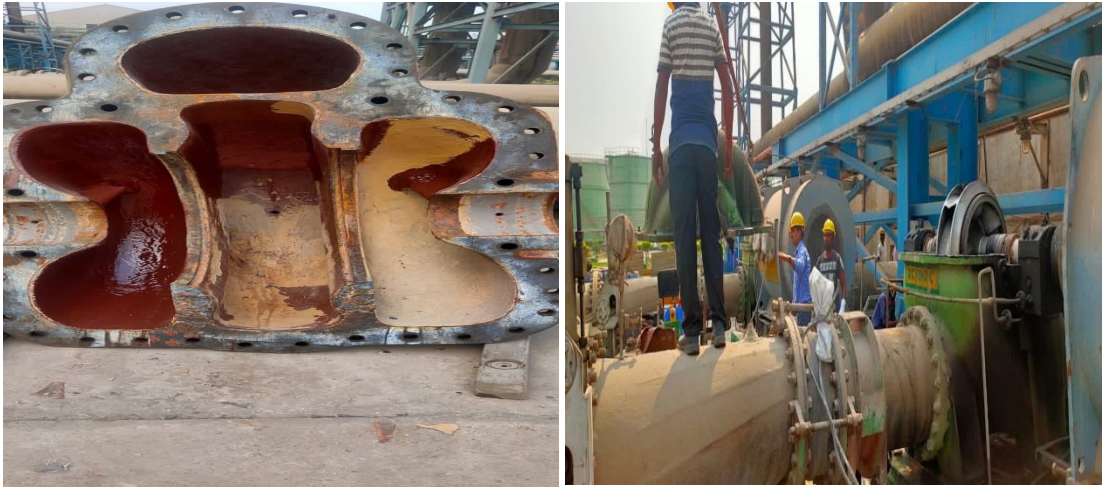
1. Minor Pitting found on both side of suction eye impeller area.
2. D.E & NDE side journal bearings found in good condition with little scratching & dents.
3. Gland packing were found severely worn out but Gland sleeves were in good condition.
4. Previously coated antifriction coating in the top and bottom casing found peeled off.

FIG: Pump C casing and Rotor assembly.

1. The pitting portion of impeller eye was welded properly and sent for dynamic mass balancing, balancing report attached.
2. Both side bearings housing were cleaned with diesel; throat bush, casing wear ring and gland packing position were also buffed.
3. Both side journal bearings are replaced with new journal bearings, journal bearings were polished and blue matching was done with an excellent matched area
4. NDE side THRUST Bearing replaced with a new 6318C3 bearing.
5. Top casing and bottom casing pitted portion were built up and applied with ITW coating.
6. New Casing gasket & Hollow core type PTFE gland packing provided.
7. Clearance of the both side journal bearings, DE and NDE, taken (0.12mm and 0.13mm) found within the permissible limit.
8. Finally pump boxed up, alignment done and readings are mentioned below.

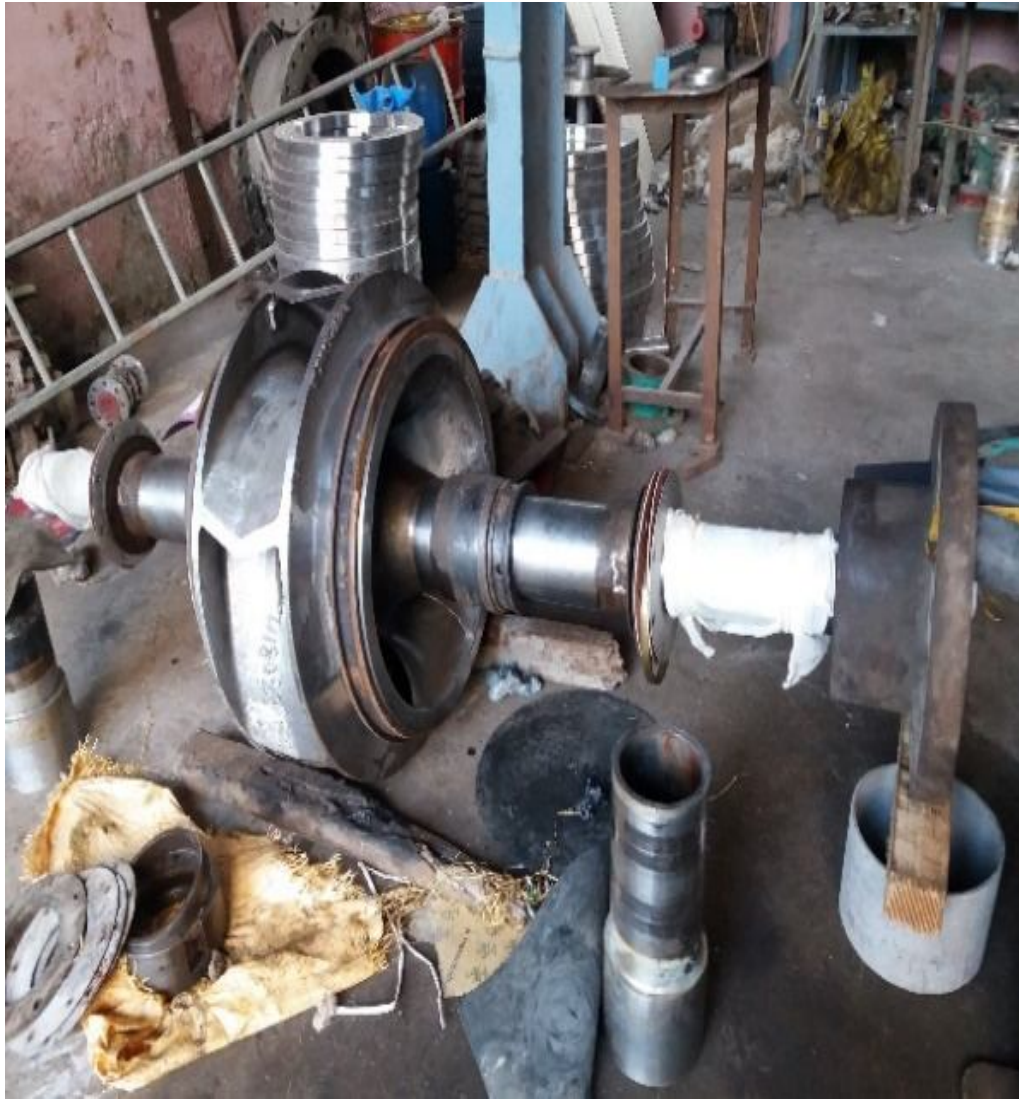
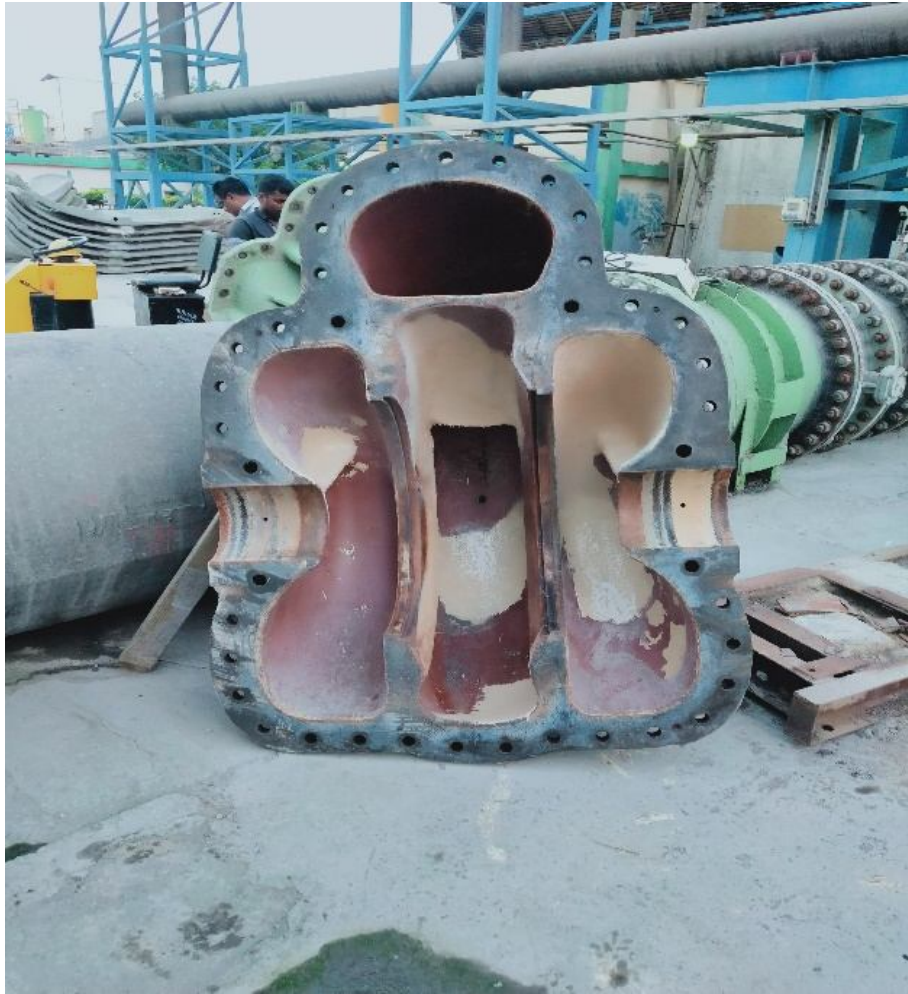
1. Minor Pitting found on both side of suction eye impeller area.
2. Thrust bearing found ok.
3. D.E & NDE side journal bearings found in good condition with little scratching & dents.
4. Gland packing were found severely worn out, DE side gland sleeve found damaged
5. Previously coated antifriction coating in the top and bottom casing found peeled off.

casing.

Fig: Rotor Assembly of pump S and Top

1. A complete rotor assembly (repaired) was made ready for erection.
2. Impeller vane shroud portion that were pitted severely were welded and sent for dynamic mass balancing, balancing report is attached.

3. Both the bearings housing were cleaned with diesel; throat bush sitting position, casing neck ring sitting position were also cleaned properly.
4. Both side journal bearings are replaced with new journal bearings, journal bearings were polished and blue matching was done with an excellent matched area.

5. DE side gland sleeve was replaced with a new gland sleeve.
6. NDE side THRUST Bearing was replaced with a new 6318C3 bearing.
7. New Casing gasket & Hollow core type PTFE gland packing provided.

8. Clearance of both NDE & DE side journal bearing were taken and are 0.12mm & 0.13mm respectively.
9. Finally bearing housing top cover and casing top cover tightened.

10. Top casing and bottom casing pitted portion were built up and applied with ITW coating.
11. Alignment was done by laser alignment machine and axial and radial reading are 0.05 and .04 mm respectively.

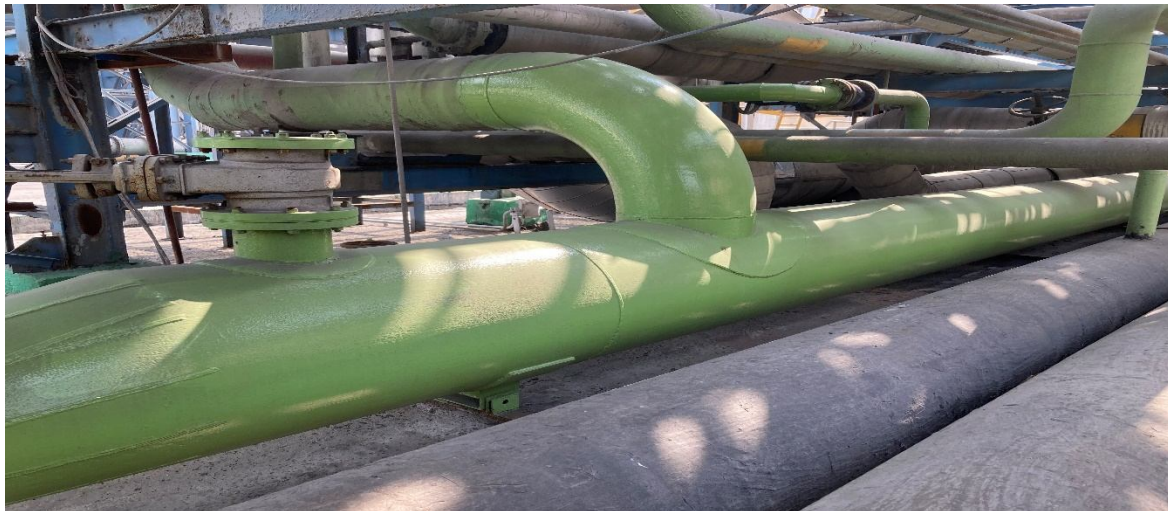
Fig-Filter water line after Replacement

1. Complete Shutdown was taken for 36 Hr for replacing 90 Mtrs length of 750 NB pipe.
2. Existing line's damaged portion was cut from both the side and hooked up with the new fabricated line.
4. DP test of the root run was carried out and found no defects.
5. After completion of welding drain points were boxed up and water charged in the line, found no leakage.

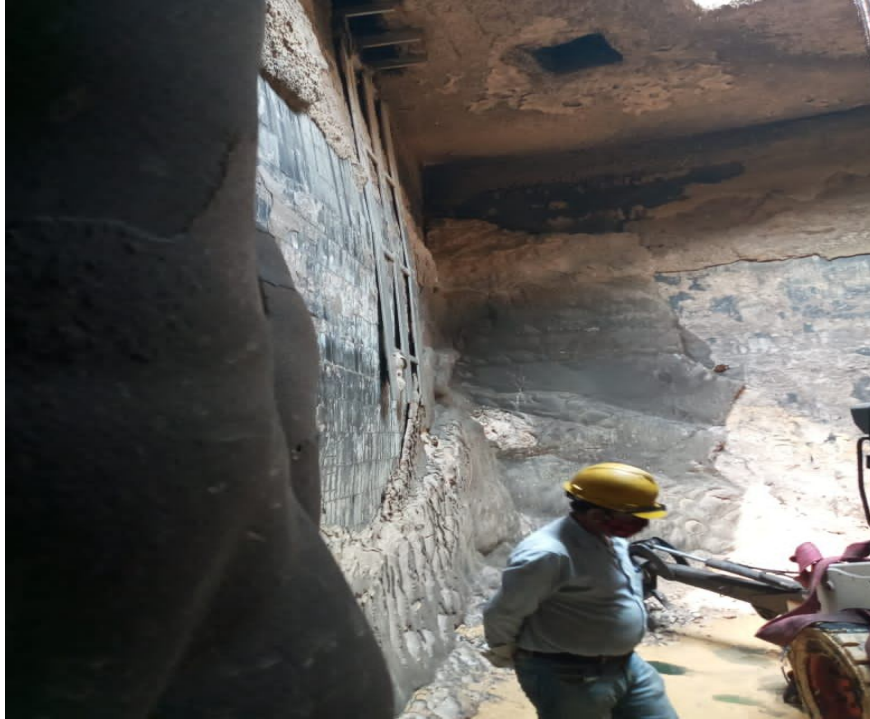
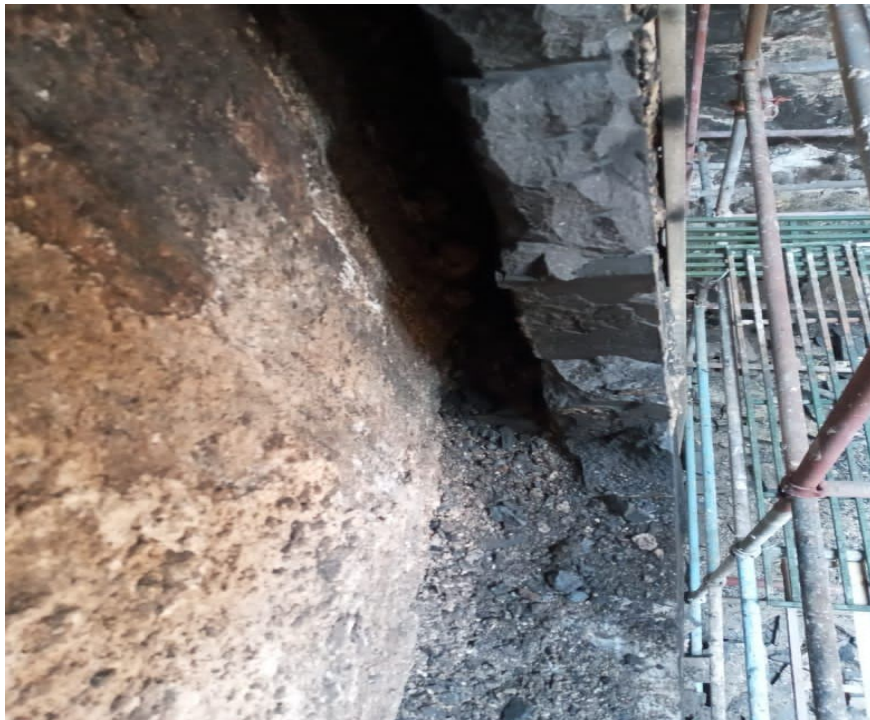
PHOTOGRAPHS (BEFORE)

Brick lining on one of the wall in compartment # 130 was found bulged and this was observed during ATR 2019 and metallic supports were provided to the brick wall to hold them in position. And it was decided to repair this wall during ATR 2020. Order was placed accordingly and material was also procured.

1. Dismantling of the carbon bricks on entire wall (gap observed between concrete wall and bricks as 80mm avg and maximum 115mm at centre portion).
2. Removal of deposits, grinding and cleaning (thru waterjet) of entire concrete surface.
3. Washing of entire surface with detergent soap solution.
4. Copper slag blasting over concrete surface.
5. Application of Arcopatch mortar (Avg 3 mm thick) over concrete surface as a conductive layer.
6. Buffing (thru grinder) of entire conductive layer to make the surface rough.
7. Laying of rubber lining, 4 mm thick Arcobutyl (Rubber) with the help of Arco AD -1 adhesive (cold bonding system) over conductive layer.
8. Application of Arfurane -C primer over rubber lined surface.
9. Laying of carbon bricks (horizontally) in 115 mm thickness by using Arfurane -C mortar.

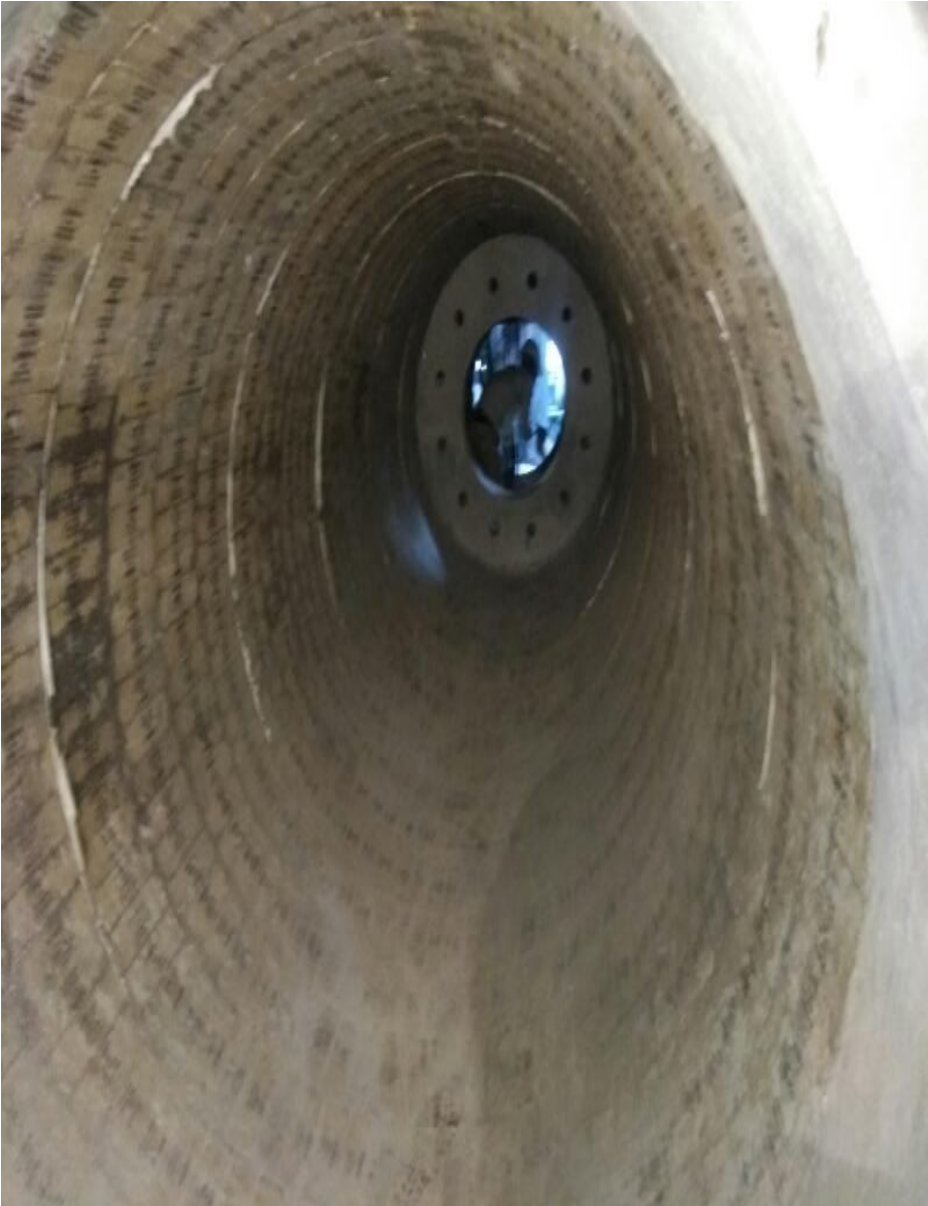
AFTER BRICK LINING IN COMBUSTION CHAMBERS

The combustion chambers at DAP Train-A, B & C required renovation of refractory and insulation brick work, it was taken up during the shutdown. Also, inside the duct of the chamber castable refractory brick work was repaired, this required dismantling of the existing refractory, castable & insulation bricks and carting the debris from combustion floor of respective DAP plants.

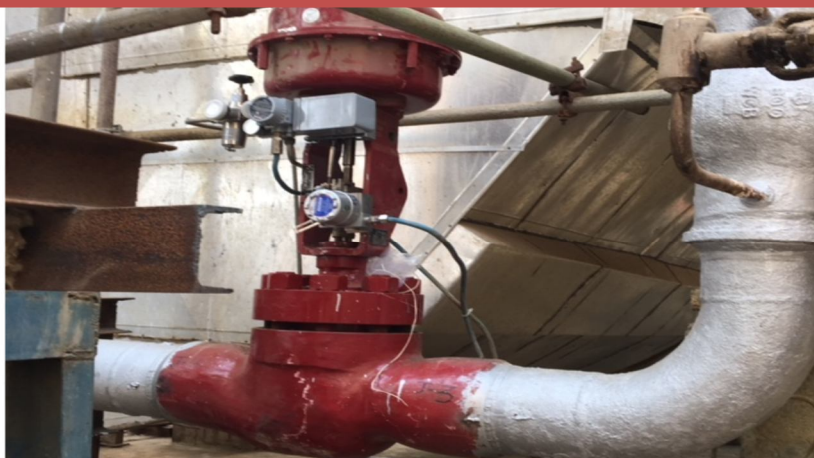
New 10LCV1301 after Replacement

- Old & Obsolete Boiler drum level control valve of SAP-1 (10LCV1301) was replaced with new Dresser make control valve.

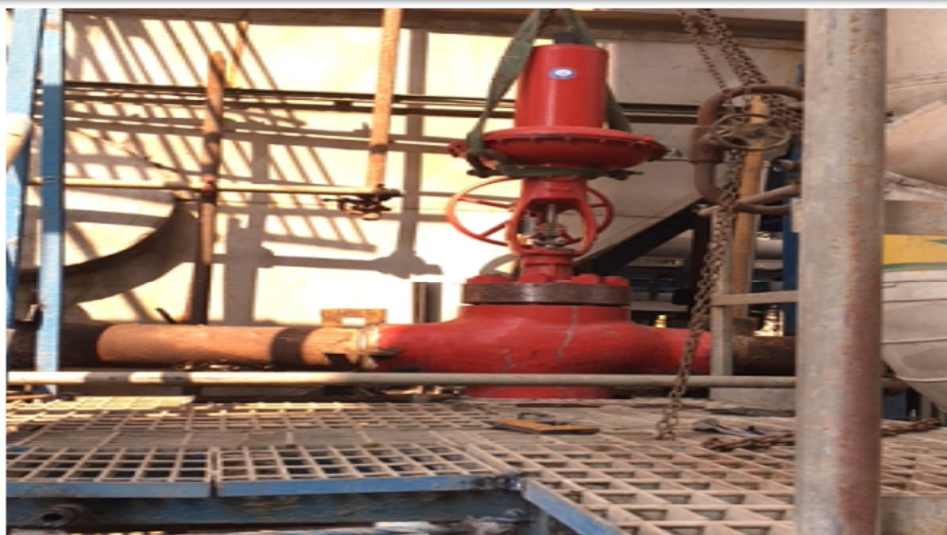
New Drum level Control Valve Tag 10LCV2301

- Old & Obsolete Boiler drum level control valve of SAP-2 (10LCV2301) was replaced with new KSB MIL make control valve.

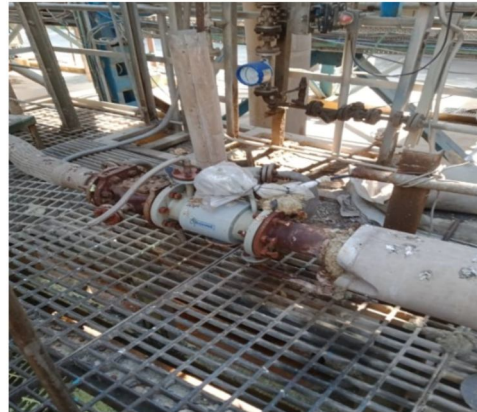
New Sulphur Flow meter

- Old damaged molten sulphur flow head along with transmitter was replaced with a new ones in SAP-2 (10FT2206).

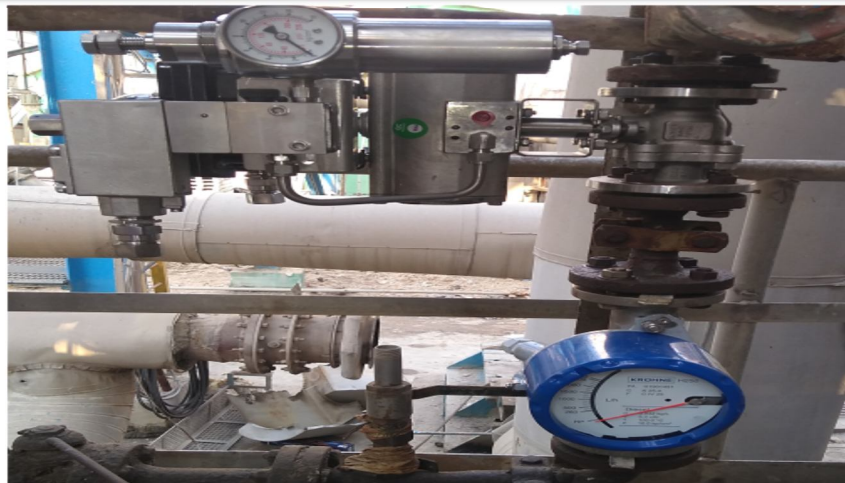
- Diesel flow meters for both burners of SAP-1 & 2 dismantled, cleaned & checked. Found ok

Diesel Flowmeter

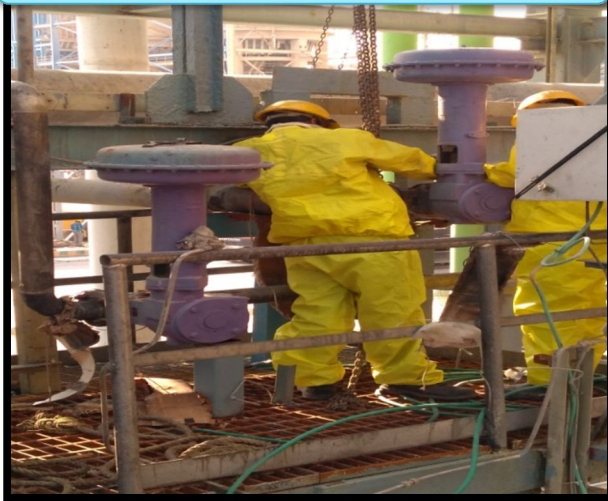
- The body of the following control valves were replaced due to gland & body leakage 10AV1450, 10LV1440.

10AV1450 body Replacement.
