ATR REPORT-2021

**INDIAN FARMERS FERTILISERS CO OPERATIVE LTD.
PARADEEP UNIT**

ATR REPORT: 2021

DAP PLANT

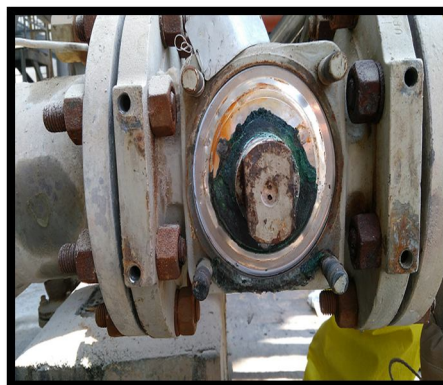
**Valve Body
Gland Leakage**

- Stroke checking & calibration carried out for all control valves of acid area in both the trains.
- Valve body of 10LV1460 level control valve was replaced with a new AL20 MOC valve body.

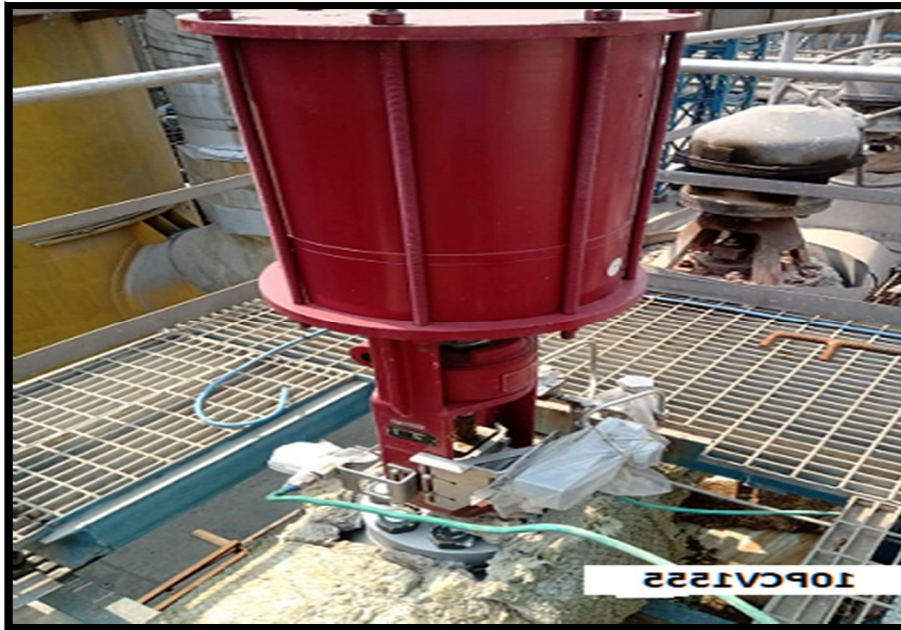
New PCV-1555 Control Valve

- Old & damaged Pressure control valve of LPS-1 (10PCV1555) was replaced with new Dresser make control valve.

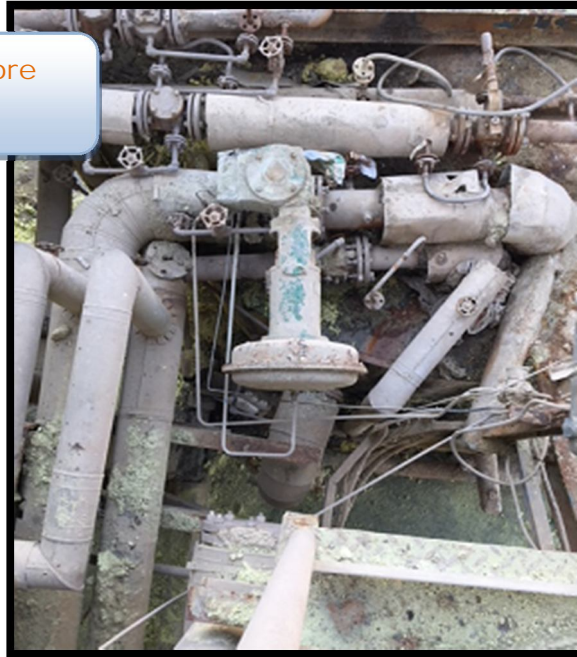
Control valve before relocation

Control valve after Re-location

- Melter-132 VPT re-circulating control valve 10LCV0132 was relocated for ease of maintenance.

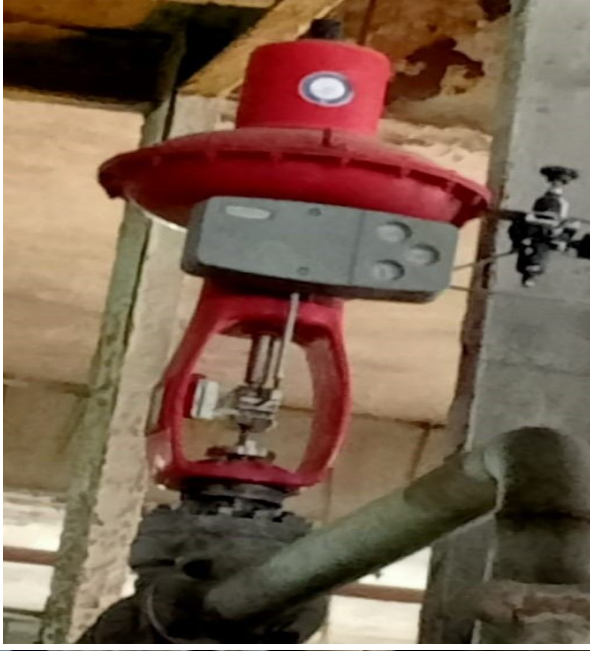
New M/s MIL make Control Valves in Filtration A & E.

1. Filtration area all control valves (3rd wash, 4th wash & cake wash) were removed from line for maintenance. Damaged control valves are replaced with new valves. Stroke checking & calibration of all the control valves are done.
2. Filtration area all seal tank dip tubes cleaning, maintenance done. Level transmitters proper mounting and calibration also done.
3. All magnetic flow heads of Filtration section are removed from line for cleaning, checking and maintenance. Faulty flow heads and flow converters are replaced.
4. Modification of SS tubing, damaged SS tubes & fittings replacement job done for selected control valves in Filtration area except G.
5. Filtration A & E cake wash steam control valves have been replaced with new valves.

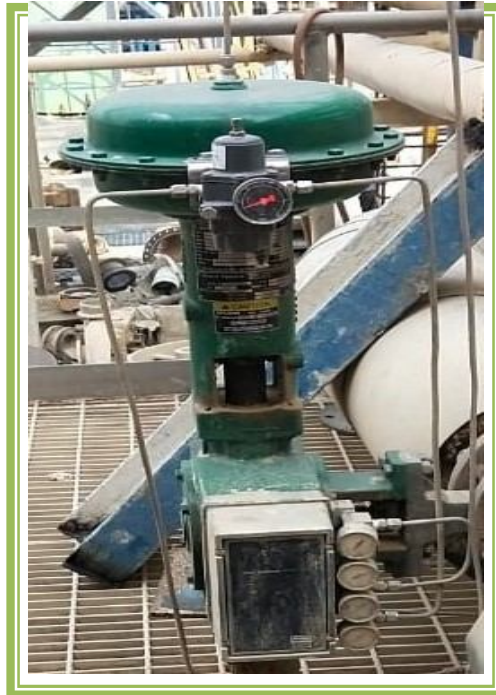
New M/s Fisher make Cloth was steam Control Valve

6. Damaged steam control valve is replaced with a new control valve in cloth wash tank.

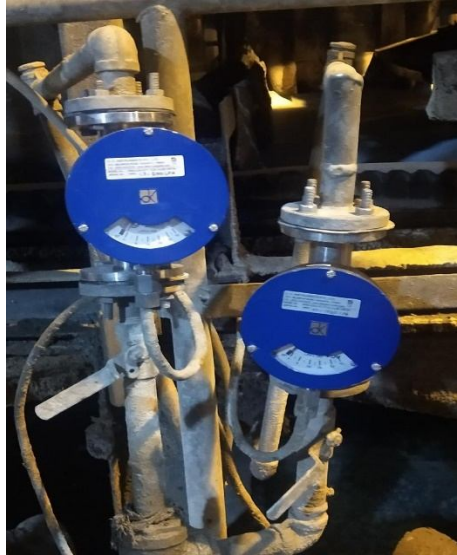
M/s D K Instruments make flow switches in Vacuum box of Belt Filters

8. Low range (0 - 1600 LPH & 0 - 2400 LPH) flow switches are replaced with higher range (0 - 4000 LPH) switches in the vacuum box section of the Belt Filters A, B, C, D & E).

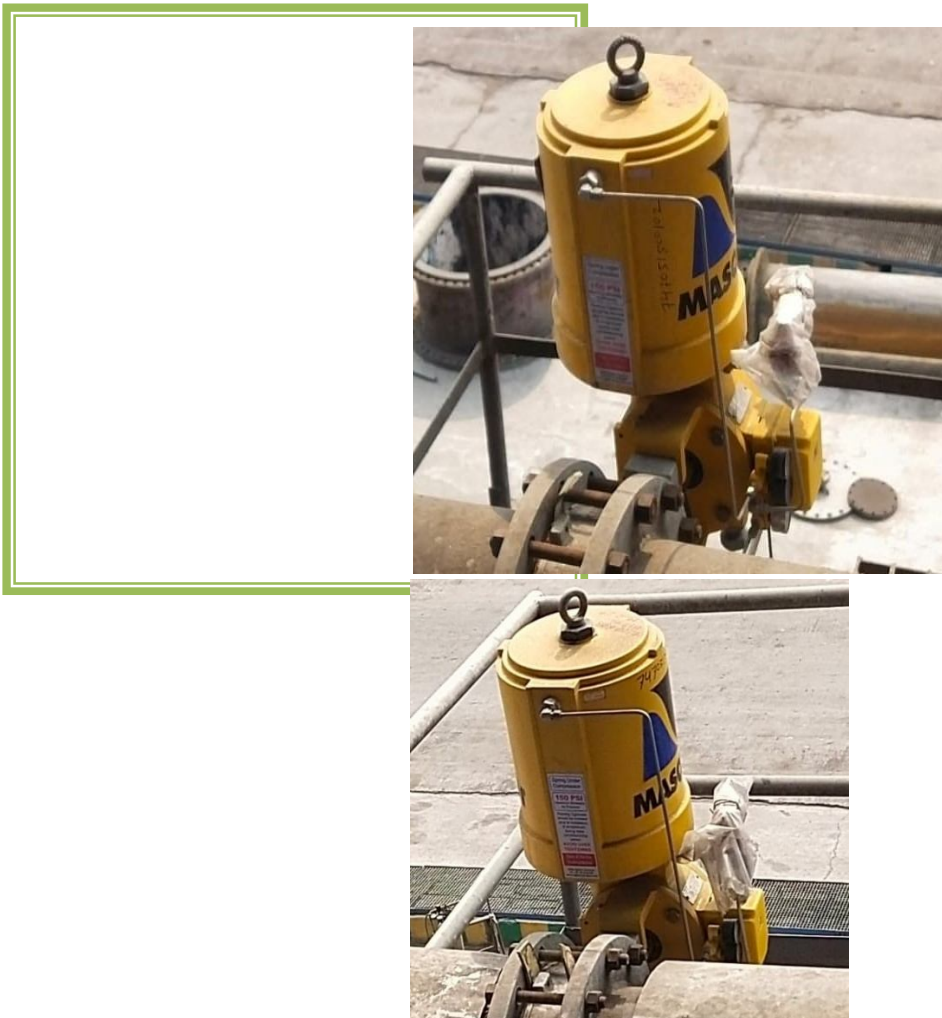
New M/s Mascot make valves replaced in Evaporator D, E & H LP steam

1. All feed flow heads (FIT-1005 A/BC/D/E/F/G/H) are removed from line for de scaling, checking, & maintenance.
2. Maintenance & repairing of feed control valves (FY- 1005A/B/C/D/E/F/G/H) have been done.
3. All feed control valves stroke checking and calibration done.
4. All LP steam control valves (FY- 1004A/B/C/D/E/F/G/H) are removed from line for inspection, checking & maintenance.
5. Evaporator area TIT-1006 A/B/C/D/E/F/G/H & TIT-1010 A/B/C/D/E/F/G/H all RTD's & thermowells removed for inspection & maintenance. One no thermowell set has been replaced in Evaporator F.
6. All steam flow (FIT-1004 A/B/C/D/E/F/G/H) transmitters checking, maintenance & calibration done.
7. Damaged LP steam control valves are replaced in Evaporators D, E, F, & H.

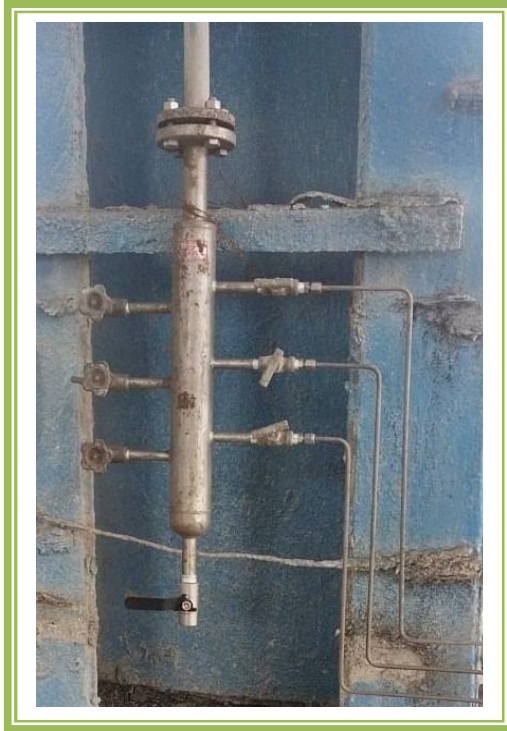
New Instrument Air Manifolds in Evaporator area

15. New SS tubing job has been done for all the bleed control valves from new instrument air header line.
16. Damaged & corroded Instrument air manifolds-Isolation valves were replaced with new air header manifolds with isolation ball valves in the ground floor of all the Evaporators. New SS tubing from these new manifolds to control valves & on off valves are also done.

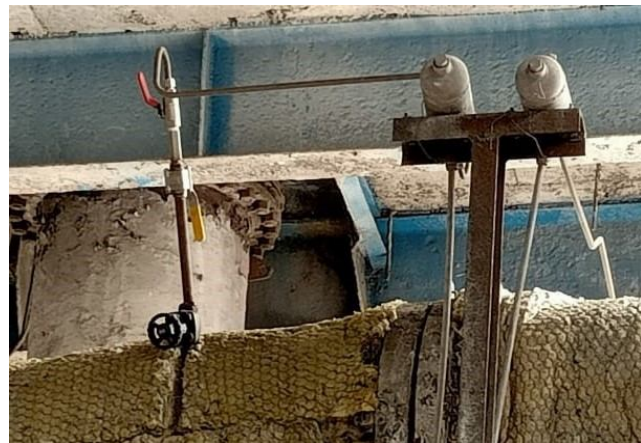
New Root isolation valves of Orifice tapings

17. Damaged root isolation valves of orifice meters (LP Steam flow meters) tapings are replaced with new isolation valves. New SS tubing from these isolation valves to steam flow transmitters are also done.

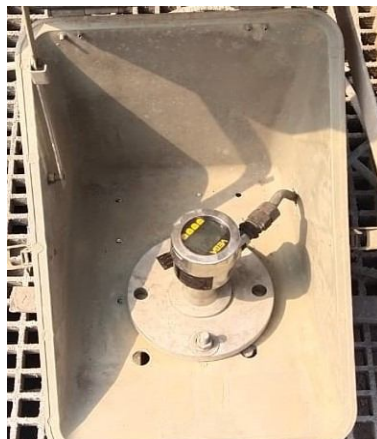
New M/s Vega make Radar level transmitter

1. Dip tube level meter in old cold well is replaced with new high frequency low beam radar level transmitter.

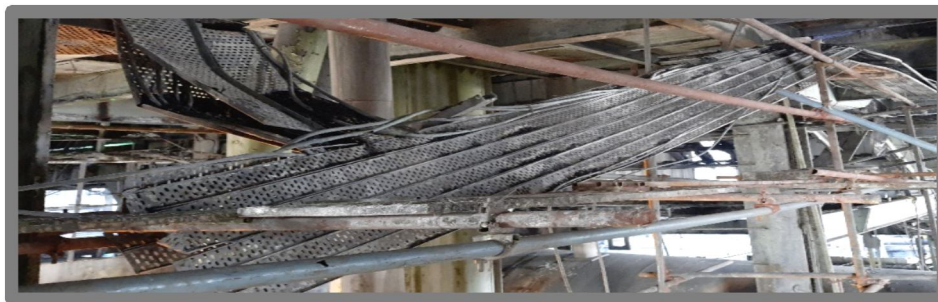
BEFORE

1. Damaged cable tray above Train B Fines conveyor drive end was removed.

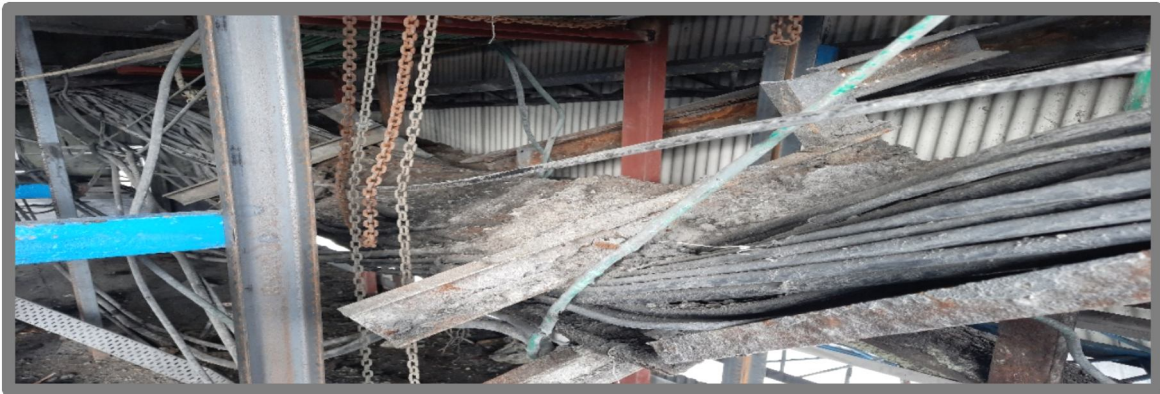
BEFORE

2. Damaged cable tray near Train C 70 Conveyor Tail end was restored by giving extra support for strength.

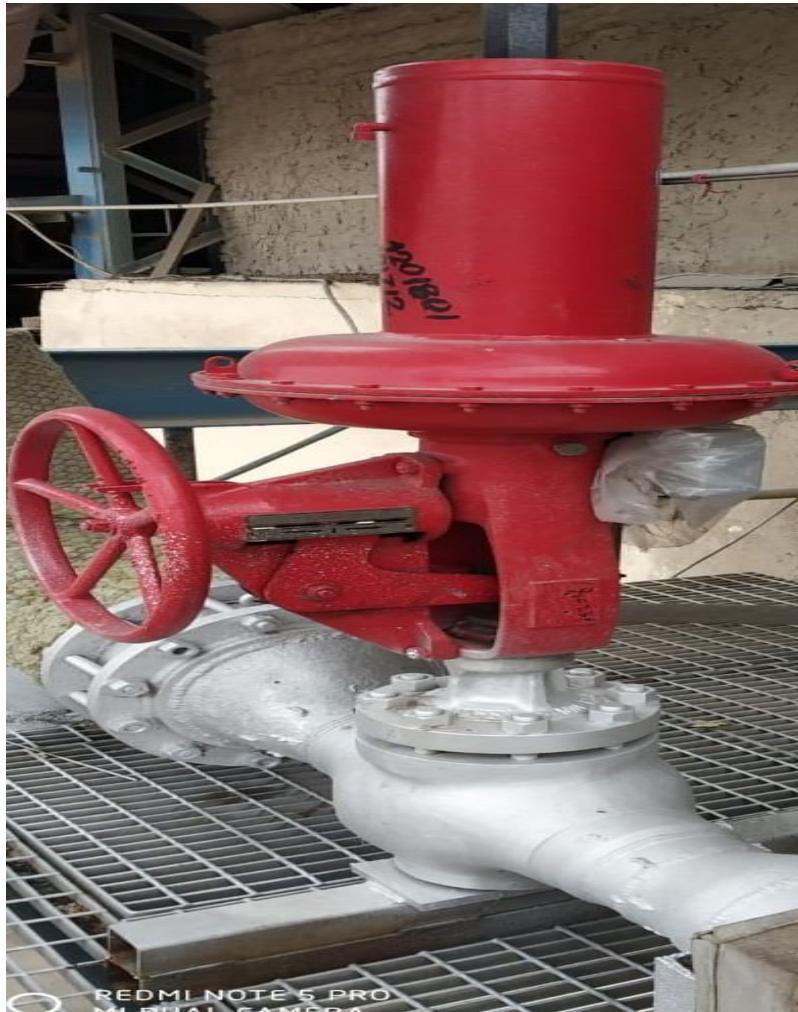
PCV1507: MP steam vent control valve

- Small cracks inside the valve body.

- Complete valve replaced.

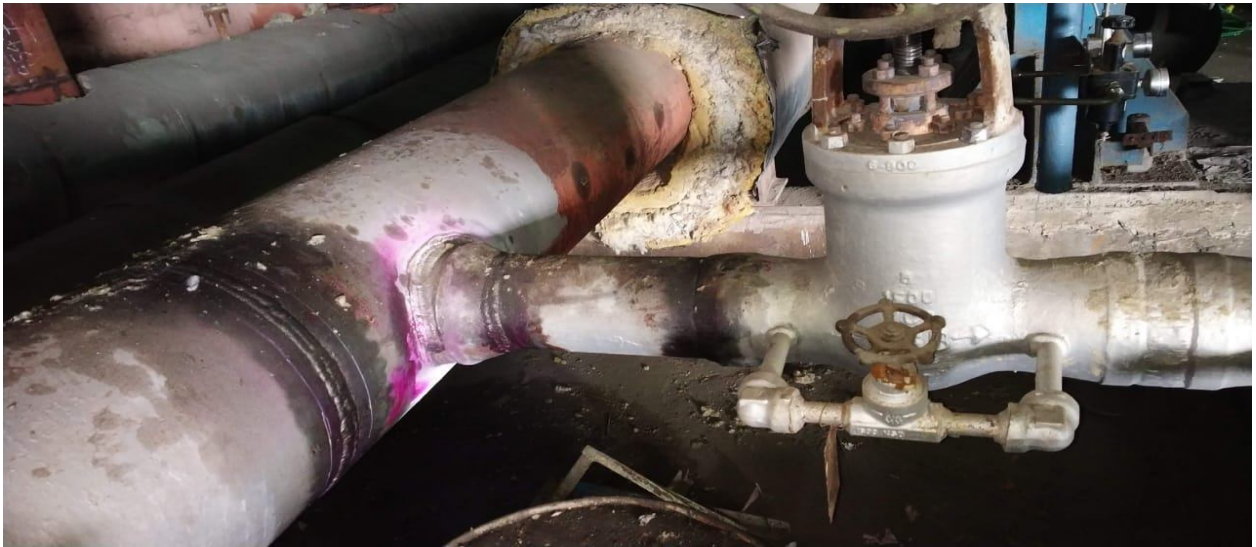
Figure 5: PAUT completed joints

- PAUT (Phased Array Ultrasonic Testing) was carried out to detect and image defects if any in welding joints of HP steam headers. Final report is awaited from Inspection section. HP steam header healthiness is checked every year during ATR in a phased manner. This year we have offered 18 nos. joints to be tested for HP steam header inside TG building.
- Then Inspection section team started testing of joints by DP test followed by PAUT.

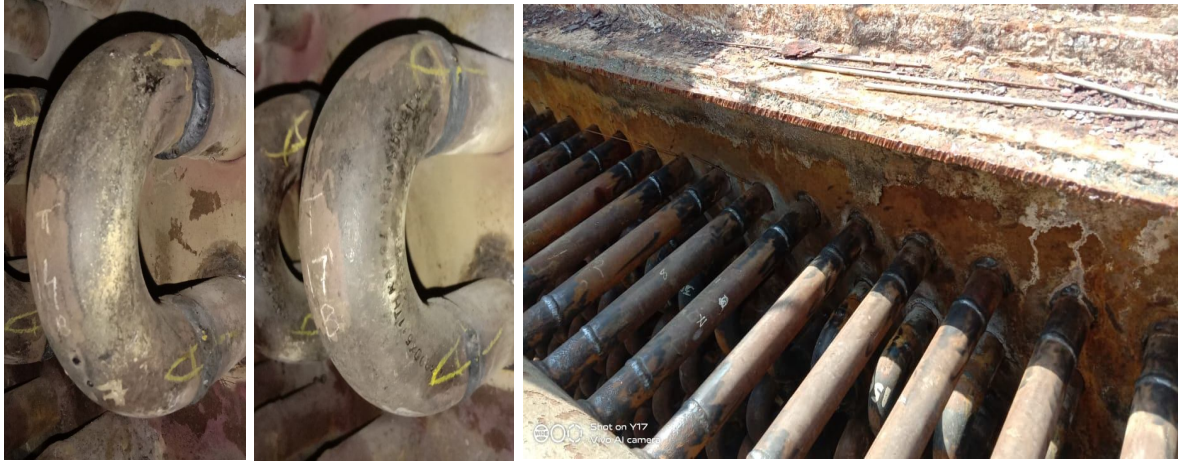
- It was planned to replace the top three rows of economizer top bank. As a result there were 272 joints for welding and inspection.

- Bends to be replaced were cut and new bends were fit up. Fit up was checked and root DP was checked after root welding. After fill up and final welding, radiography and Phased Array Ultrasonic Testing was carried out on final welding. The defects were marked and repaired till the joint was cleared.

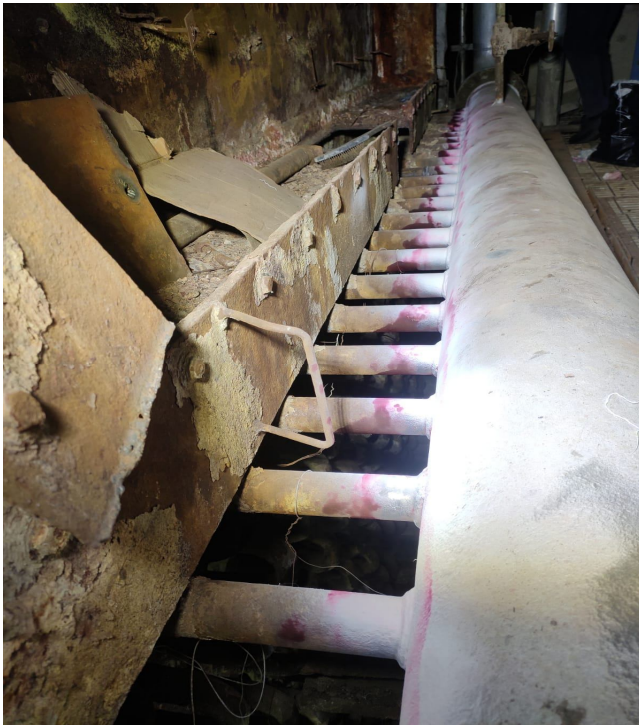
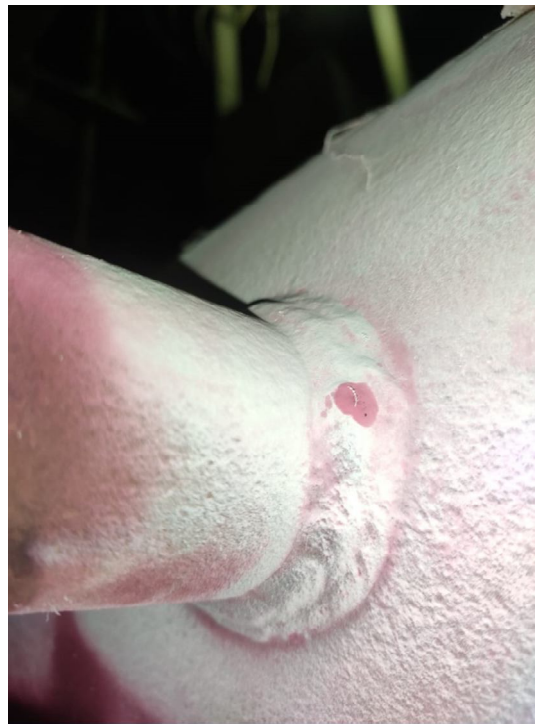
- DP test of header to straight tube joints, tube to tube sheet joints were also carried out. Repairs were marked and repaired. Drain line was found corroded. It was also replaced.

Header drain line was found corroded and was replaced

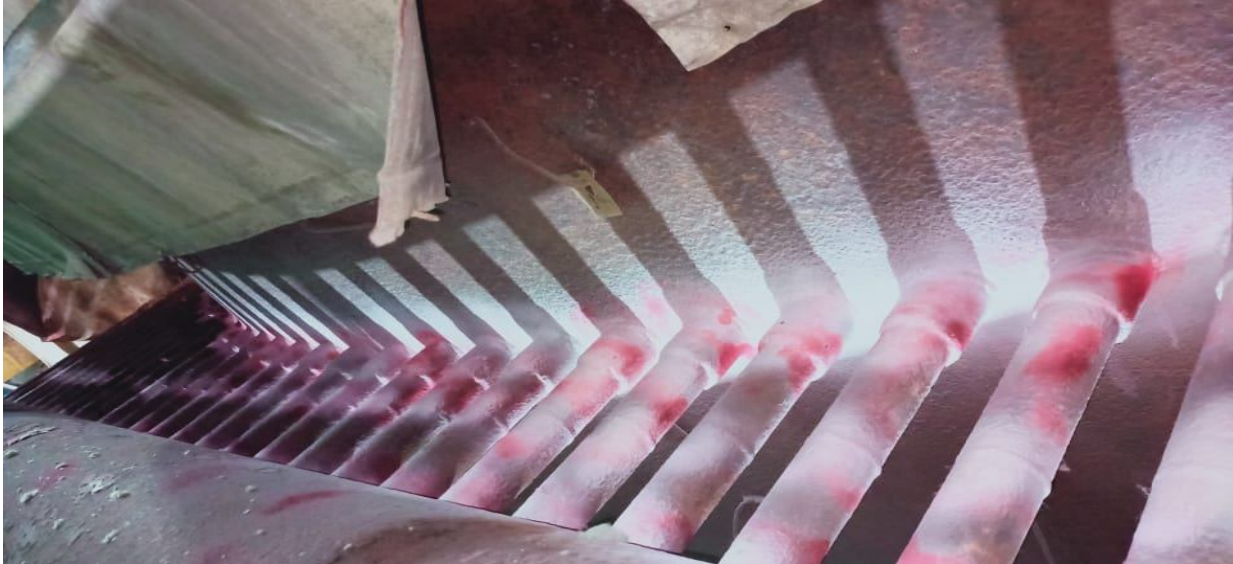
- After thickness survey, 8 bends in East side and 2 bends in West side were found to have thickness less than 3.25 mm. The bends were replaced with new ones. Fit up, Root DP test and radiography of final welding was carried out. The repairs were marked and repaired.

- DP, UT & MPI of header to straight tube joints, straight tubes butt joints, straight tubes to socket joint in Superheater 1 & 2 was carried out.

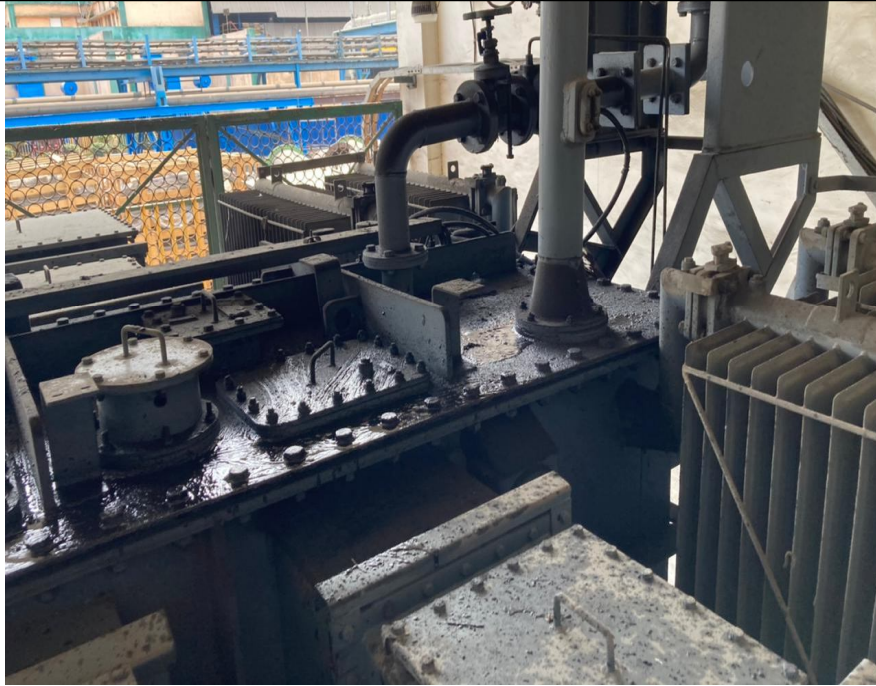
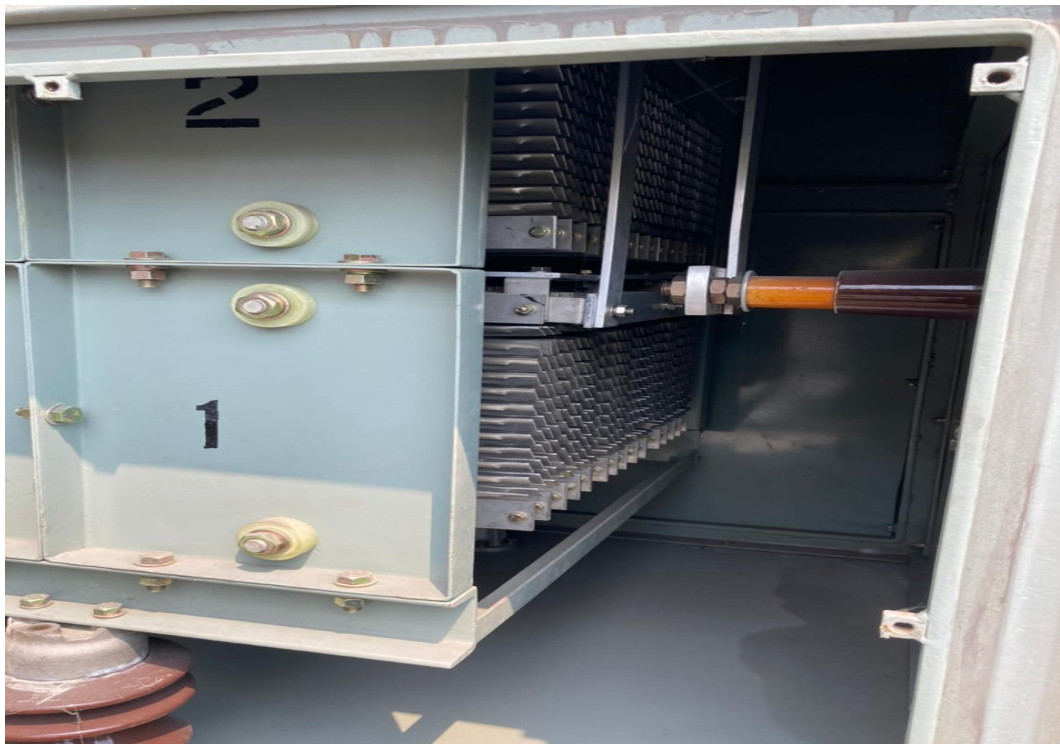
CONDITION OF 16 MVA TRANSFORMER BEFORE MAINTENANCE
